Mail Processing Facilities

TRUCK RESTRAINT PROGRAM – USPS P&DC- Boston, MA
25 Dorchester Ave. Boston, MA 02205-9761

SCOPE OF WORK PACKAGE (RFP 743672-31678P) Date 08/05/2022

General Findings and Condition Report (eCOMET Enhanced Deficiency Sheet Report)

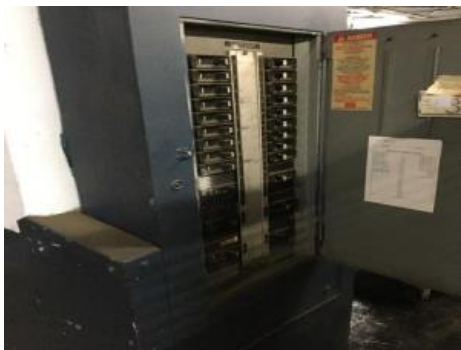
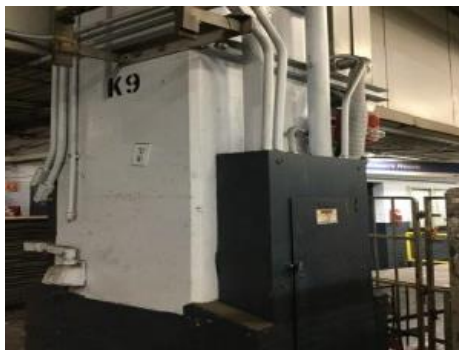
Subsystem Code:	D5010250	Surveyor / Update:	Stephen Butler	12/21/2021
Subsystem Description:	Panelboard	Qty:	1.00	
Material:				
Distress:	Inadequate	Deficiency Id:	313215	
Priority:	1 - Currently Critical (Immediate)	Location:	COL J8 (DOORS 12-21)	
Category:	Repair - Alteration			
Correction:	Provide New 30-kVA Step-down Transformer w/new 3P Circuit Breaker			
Notes:	For doors 12 - 21, the existing power panels in the area of these doors are Federal Pacific brand, are obsolete and not usable. Provide a new 30-kva, 480-208Y/120VAC step-down transformer to feed a new 3-phase, 208Y120VAC power panel at column J8 to support the TRS loads. Maximum distance from the panel to farthest door is 250'. In substation 12 on the second floor, add a new 100A, 3-pole, circuit breaker in one of the spaces. Circuit breaker to match existing type and kaic rating. Maximum feeder distance from substation 12 is 200'.

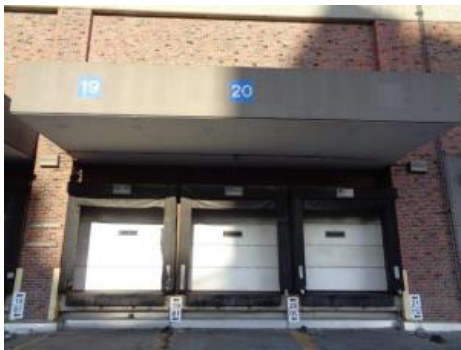
Subsystem Code:	E1030310	Surveyor / Update:	Dustin Hollenbeck	12/14/2021
Subsystem Description:	Loading Dock Equipment, EACH	Qty:	1.00	
Material:				
Distress:	Missing	Deficiency Id:	312715	
Priority:	1 - Currently Critical (Immediate)	Location:	DOOR 18 EXT	
Category:	Repair - Alteration			
Correction:	Install Kelley Dock Communication System			
Notes:	This dock is for small and medium delivery vehicles. It has no dock leveler or room a for truck restraint system.

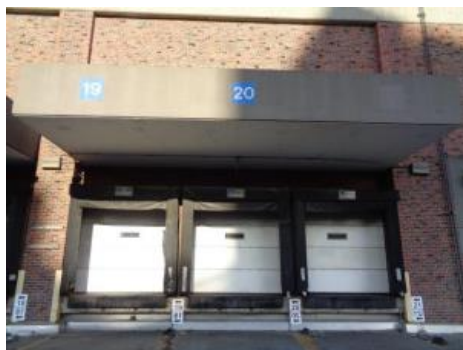
Subsystem Code:	E1030310	Surveyor / Update:	Dustin Hollenbeck	12/14/2021
Subsystem Description:	Loading Dock Equipment, EACH	Qty:	1.00	
Material:				
Distress:	Missing	Deficiency Id:	312717	
Priority:	1 - Currently Critical (Immediate)	Location:	DOOR 20 EXT	
Category:	Repair - Alteration			
Correction:	Install Kelley Dock Communication System			
Notes:	This dock is for small and medium delivery vehicles. It has no dock leveler or room for a truck restraint system.

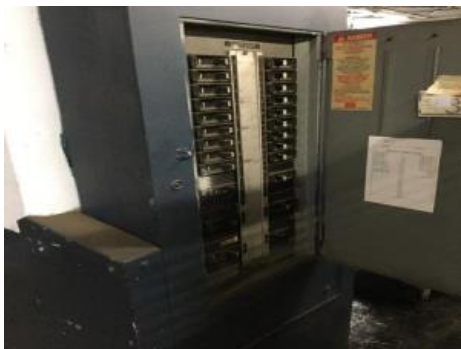
Subsystem Code:	D5010250	Surveyor / Update:	Stephen Butler	12/21/2021
Subsystem Description:	Panelboard	Qty:	1.00	
Material:				
Distress:	Inadequate	Deficiency Id:	313214	
Priority:	1 - Currently Critical (Immediate)	Location:	COL L11 (DOORS 22-45)	
Category:	Repair - Alteration			
Correction:	Provide New 30-kVA Step-down Transformer w/new 3P Circuit Breaker			
Notes:	For doors 22 - 45, the existing power panels in the area of these doors are Federal Pacific brand, are obsolete and not usable. Provide a new 30-kva, 480-208Y/120VAC step-down transformer to feed a new 3-phase, 208Y120VAC power panel at column L11 to support the TRS loads. Maximum distance from the panel to farthest door is 250'. In substation 12 on the second floor, add a new 100A, 3-pole, circuit breaker in one of the spaces. Circuit breaker to match existing type and kaic rating. Maximum feeder distance from substation 12 is 100'.

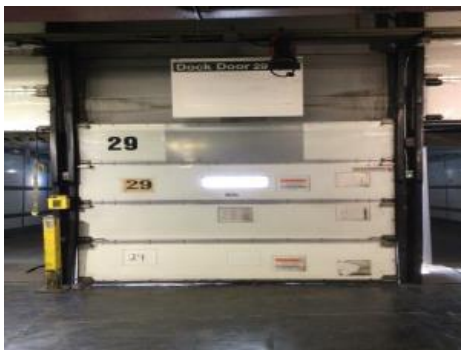
Subsystem Code:	E1030310	Surveyor / Update:	James Smith	11/30/2021
Subsystem Description:	Loading Dock Equipment, EACH	Qty:	1.00	
Material:				
Distress:	Missing	Deficiency Id:	311200	
Priority:	2 - Potentially Critical (Year 1)	Location:	DOOR 29 INT	
Category:	Safety			
Correction:	Install Star 4 Truck Restraint W/ Cantilever Mounting Bracket			
Notes:	Foundation wall to face of rubber bumper: 29 inch, SOG to bottom of dock leveler: 37 inches, Dock height: 54.5 inches. The dock face below the leveler is adequate. There is an existing red light/green light system. Remove the existing red light/green light and all of its components prior to installing the new system. A Yellow key box is mounted on the concrete column, this location and mounting bracket should be considered the future mounting location for the Star 4 control box.

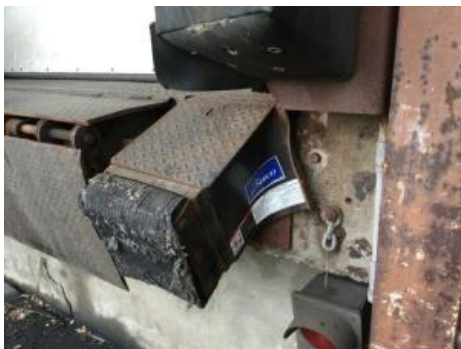
Subsystem Code:	E1030310	Surveyor / Update:	James Smith	11/30/2021
Subsystem Description:	Loading Dock Equipment, EACH	Qty:	1.00	
Material:				
Distress:	Damaged	Deficiency Id:	311233	
Priority:	3 - Necessary/Not Yet Critical (Years 2-5)	Location:	DOOR 36 EXT	
Category:	Repair - Alteration			
Correction:	Provide and Replace Rubber Dock Bumper			
Notes:	Both dock bumpers are crushed and need replaced.

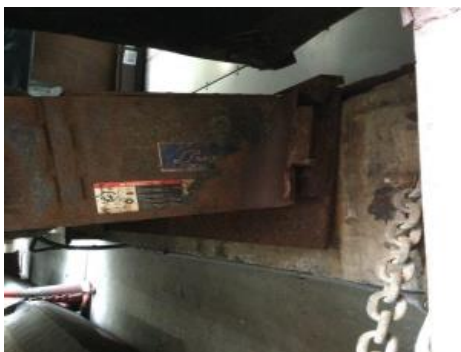
Subsystem Code:	E1030310	Surveyor / Update:	James Smith	12/06/2021
Subsystem Description:	Loading Dock Equipment, EACH	Qty:	1.00	
Material:				
Distress:	Damaged	Deficiency Id:	311574	
Priority:	3 - Necessary/Not Yet Critical (Years 2-5)	Location:	DOOR 45 EXT	
Category:	Repair - Alteration			
Correction:	Provide and Replace Rubber Dock Bumper			
Notes:	The dock bumper on the right side of the dock is damaged.

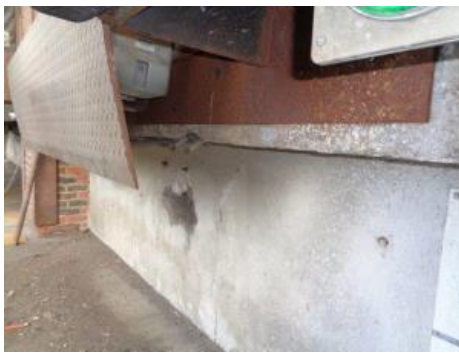
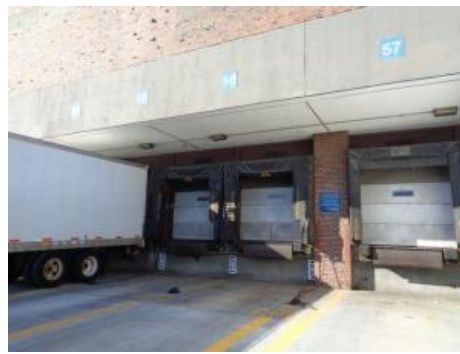
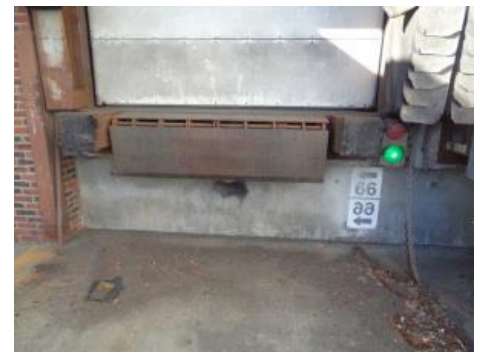
Subsystem Code:	E1030310	Surveyor / Update:	Dustin Hollenbeck	12/03/2021
Subsystem Description:	Loading Dock Equipment, EACH	Qty:	1.00	
Material:				
Distress:	Missing	Deficiency Id:	311461	
Priority:	1 - Currently Critical (Immediate)	Location:	DOOR 46 EXT	
Category:	Repair - Alteration			
Correction:	Install Star 4 Truck Restraint W/ Cantilever Mounting Bracket			
Notes:	Foundation wall to face of rubber bumper 28", over dock height 49". The dock face below the leveler is adequate. The Proper light height will require pendent mount or alternate location. There is an existing red light/green light system. Remove the existing red light/green light and all of its components prior to installing the new system.

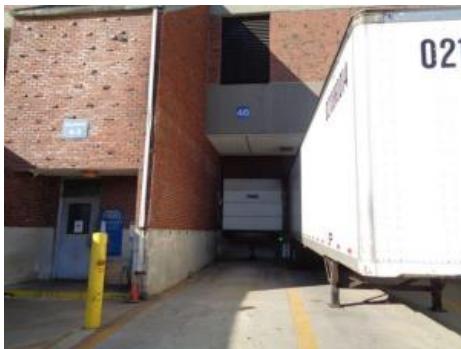
Subsystem Code:	E1030310	Surveyor / Update:	Dustin Hollenbeck	12/14/2021
Subsystem Description:	Loading Dock Equipment, EACH	Qty:	1.00	
Material:				
Distress:	Missing	Deficiency Id:	312543	
Priority:	1 - Currently Critical (Immediate)	Location:	DOOR 47 EXT	
Category:	Repair - Alteration			
Correction:	Install Star 4 Truck Restraint W/ Cantilever Mounting Bracket			
Notes:	Foundation wall to face of rubber bumper 28", over dock height 49". The dock face below the leveler is adequate. There is an existing red light/green light system. Remove the existing red light/green light and all of its components prior to installing the new system.

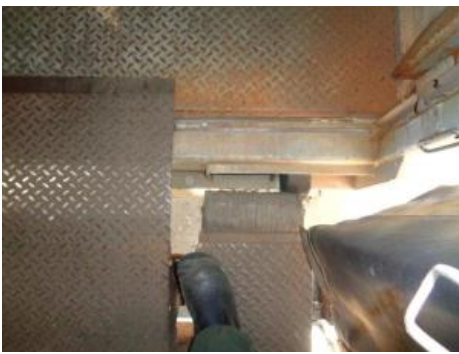
Subsystem Code:	E1030310	Surveyor / Update:	Dustin Hollenbeck	12/14/2021
Subsystem Description:	Loading Dock Equipment, EACH	Qty:	1.00	
Material:				
Distress:	Missing	Deficiency Id:	312544	
Priority:	1 - Currently Critical (Immediate)	Location:	DOOR 48 EXT	
Category:	Repair - Alteration			
Correction:	Install Star 4 Truck Restraint W/ Cantilever Mounting Bracket			
Notes:	Foundation wall to face of rubber bumper 28", over dock height 49". The dock face below the leveler is adequate. The Proper light height will require pendent mount or alternate location. There is an existing red light/green light system. Remove the existing red light/green light and all of its components prior to installing the new system.

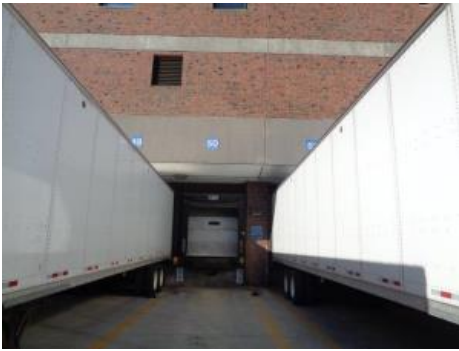
Subsystem Code:	E1030310	Surveyor / Update:	Dustin Hollenbeck	12/14/2021
Subsystem Description:	Loading Dock Equipment, EACH	Qty:	1.00	
Material:				
Distress:	Missing	Deficiency Id:	312565	
Priority:	1 - Currently Critical (Immediate)	Location:	DOOR 49 EXT	
Category:	Repair - Alteration			
Correction:	Install Star 4 Truck Restraint W/ Cantilever Mounting Bracket			
Notes:	Foundation wall to face of rubber bumper 28", over dock height 49". The dock face below the leveler is adequate. Proper light height will require pendent mount or alternate location. There is an existing red light/green light system. Remove the existing red light/green light and all of its components prior to installing the new system.

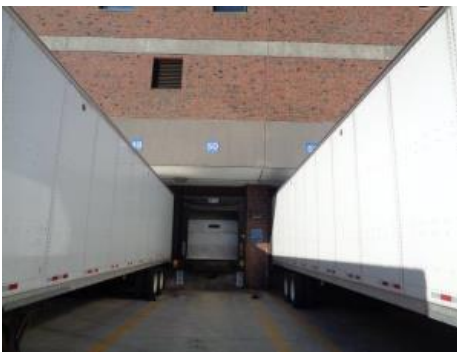
Subsystem Code:	E1030310	Surveyor / Update:	Dustin Hollenbeck	12/14/2021
Subsystem Description:	Loading Dock Equipment, EACH	Qty:	1.00	
Material:				
Distress:	Missing	Deficiency Id:	312566	
Priority:	1 - Currently Critical (Immediate)	Location:	DOOR 51 EXT	
Category:	Repair - Alteration			
Correction:	Install Star 4 Truck Restraint W/ Cantilever Mounting Bracket			
Notes:	Foundation wall to face of rubber bumper 28", over dock height 49". The dock face below the leveler is adequate. Proper light height will require pendent mount or alternate location. There is an existing red light/green light system. Remove the existing red light/green light and all of its components prior to installing the new system.

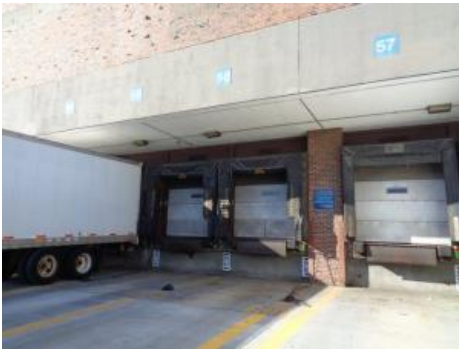
Subsystem Code:	E1030310	Surveyor / Update:	Dustin Hollenbeck	12/14/2021
Subsystem Description:	Loading Dock Equipment, EACH	Qty:	1.00	
Material:				
Distress:	Missing	Deficiency Id:	312569	
Priority:	1 - Currently Critical (Immediate)	Location:	DOOR 54 EXT	
Category:	Repair - Alteration			
Correction:	Install Star 4 Truck Restraint W/ Cantilever Mounting Bracket			
Notes:	Foundation wall to face of rubber bumper 28", over dock height 49". The dock face below the leveler is adequate. Proper light height will require pendent mount or alternate location. There is an existing red light/green light system. Remove the existing red light/green light and all of its components prior to installing the new system.

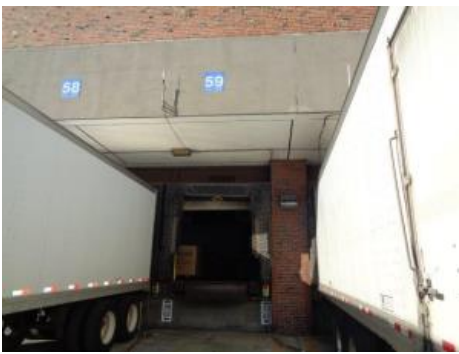
Subsystem Code:	E1030310	Surveyor / Update:	Dustin Hollenbeck	12/14/2021
Subsystem Description:	Loading Dock Equipment, EACH	Qty:	1.00	
Material:				
Distress:	Missing	Deficiency Id:	312573	
Priority:	1 - Currently Critical (Immediate)	Location:	DOOR 58 EXT	
Category:	Repair - Alteration			
Correction:	Install Star 4 Truck Restraint W/ Cantilever Mounting Bracket			
Notes:	Foundation wall to face of rubber bumper 28", over dock height 49". The dock face below the leveler is adequate. Proper light height will require pendent mount or alternate location. There is an existing red light/green light system. Remove the existing red light/green light and all of its components prior to installing the new system.

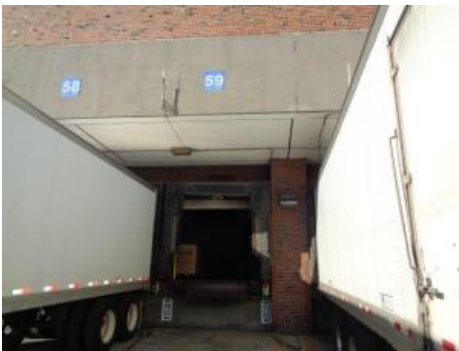
Subsystem Code:	E1030310	Surveyor / Update:	Dustin Hollenbeck	12/14/2021
Subsystem Description:	Loading Dock Equipment, EACH	Qty:	1.00	
Material:				
Distress:	Missing	Deficiency Id:	312555	
Priority:	1 - Currently Critical (Immediate)	Location:	DOOR 59 EXT	
Category:	Repair - Alteration			
Correction:	Install Star 4 Truck Restraint W/ Cantilever Mounting Bracket			
Notes:	Foundation wall to face of rubber bumper 28", over dock height 49". The dock face below the leveler is adequate. There is an existing red light/green light system. Remove the existing red light/green light and all of its components prior to installing the new system.

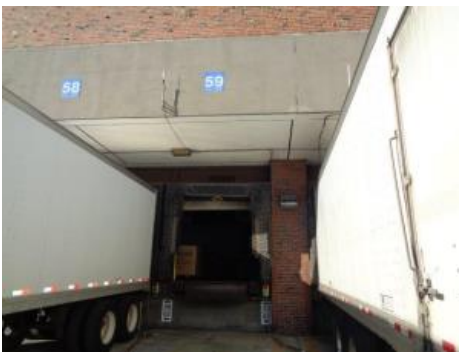
Subsystem Code:	E1030310	Surveyor / Update:	Dustin Hollenbeck	12/14/2021
Subsystem Description:	Loading Dock Equipment, EACH	Qty:	1.00	
Material:				
Distress:	Missing	Deficiency Id:	312574	
Priority:	1 - Currently Critical (Immediate)	Location:	DOOR 60 EXT	
Category:	Repair - Alteration			
Correction:	Install Star 4 Truck Restraint W/ Cantilever Mounting Bracket			
Notes:	Foundation wall to face of rubber bumper 28", over dock height 49". The dock face below the leveler is adequate. Proper light height will require pendent mount or alternate location. There is an existing red light/green light system. Remove the existing red light/green light and all of its components prior to installing the new system.

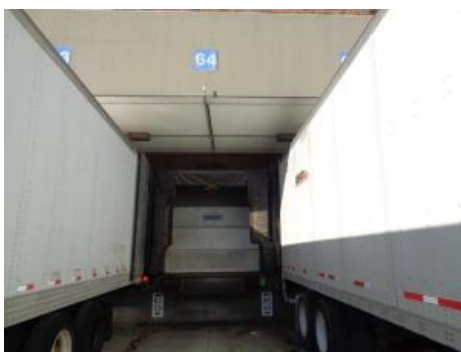
Subsystem Code:	E1030310	Surveyor / Update:	Dustin Hollenbeck	12/14/2021
Subsystem Description:	Loading Dock Equipment, EACH	Qty:	1.00	
Material:				
Distress:	Missing	Deficiency Id:	312577	
Priority:	1 - Currently Critical (Immediate)	Location:	DOOR 64 EXT	
Category:	Repair - Alteration			
Correction:	Install Star 4 Truck Restraint W/ Cantilever Mounting Bracket			
Notes:	Foundation wall to face of rubber bumper 28", over dock height 49". The dock face below the leveler is adequate. Proper light height will require pendent mount or alternate location. There is an existing red light/green light system. Remove the existing red light/green light and all of its components prior to installing the new system. The dock was partially obstructed from view, the full condition of all dock components could not be verified. Assumption of partial condition is based on the condition of adjacent docks.

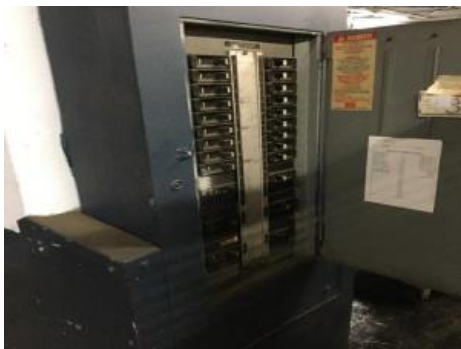
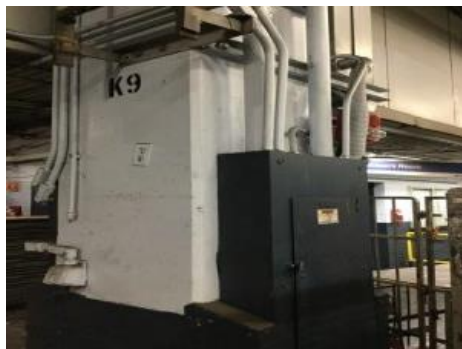
Subsystem Code:	D5010250	Surveyor / Update:	Stephen Butler	12/21/2021
Subsystem Description:	Panelboard	Qty:	1.00	
Material:				
Distress:	Inadequate	Deficiency Id:	313212	
Priority:	1 - Currently Critical (Immediate)	Location:	COL L28 (DOORS 68-90)	
Category:	Repair - Alteration			
Correction:	Provide New 30-kVA Step-down Transformer w/new 3P Circuit Breaker			
Notes:	For doors 68 - 90, the existing power panels in the area of these doors are Federal Pacific brand, are obsolete and not usable. Provide a new 30-kva, 480-208Y/120VAC step-down transformer to feed a new 3-phase, 208Y120VAC power panel at column L28 to support the TRS loads. Maximum distance from the panel to farthest door is 250'. In substation 32 on the second floor, add a new 50A, 3-pole, circuit breaker in one of the spaces. Circuit breaker to match existing type and kaic rating. Maximum feeder distance from substation 32 is 100'.

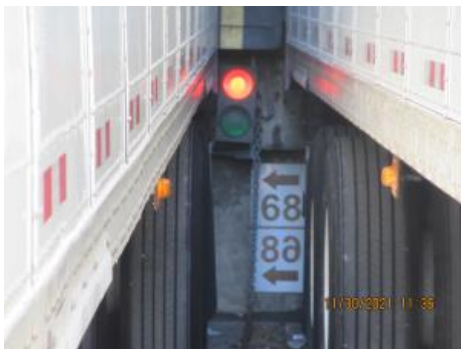
Subsystem Code:	E1030310	Surveyor / Update:	Brendan Baranek-Olmstead	11/30/2021
Subsystem Description:	Loading Dock Equipment, EACH	Qty:	1.00	
Material:				
Distress:	Missing	Deficiency Id:	311161	
Priority:	1 - Currently Critical (Immediate)	Location:	DOOR 68 EXT	
Category:	Repair - Alteration			
Correction:	Install Star 4 Truck Restraint W/ Cantilever Mounting Bracket			
Notes:	There is an existing red light/green light system. Remove the existing red light/green light and all of its components prior to installing the new system. The dock was partially obstructed from view, the full condition of all dock components could not be verified. Assumption of partial condition is based on the condition of adjacent docks.

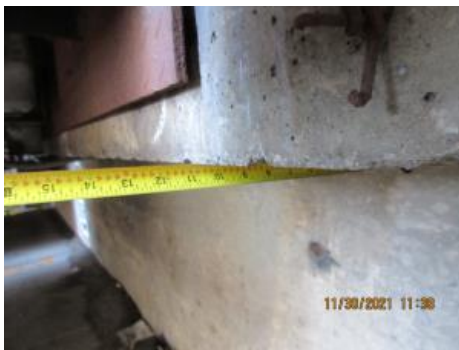
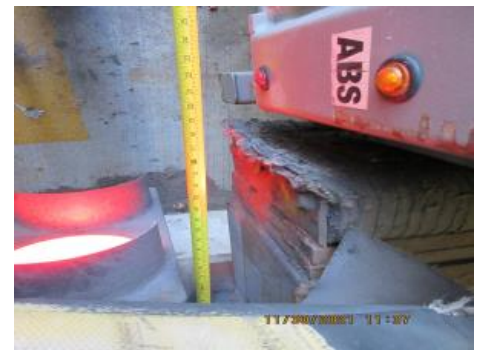
Subsystem Code:	E1030310	Surveyor / Update:	Brendan Baranek-Olmstead	12/14/2021
Subsystem Description:	Loading Dock Equipment, EACH	Qty:	1.00	
Material:				
Distress:	Missing	Deficiency Id:	312505	
Priority:	1 - Currently Critical (Immediate)	Location:	DOOR 69 EXT	
Category:	Repair - Alteration			
Correction:	Install Star 4 Truck Restraint W/ Cantilever Mounting Bracket			
Notes:	The foundation wall to face of rubber bumper is 19", SOG to bottom of the dock leveler 30.5", over dock height 49". The dock face below the leveler is adequate. There is an existing red light/green light system. Remove the existing red light/green light and all of its components prior to installing the new system. The dock was partially obstructed from view, the full condition of all dock components could not be verified. Assumption of partial condition is based on the condition of adjacent docks.

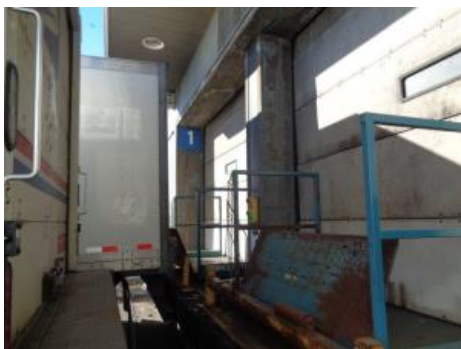
Subsystem Code:	E1030310	Surveyor / Update:	Dustin Hollenbeck	12/03/2021
Subsystem Description:	Loading Dock Equipment, EACH	Qty:	1.00	
Material:				
Distress:	Missing	Deficiency Id:	311424	
Priority:	1 - Currently Critical (Immediate)	Location:	OLD DOOR 01 EXT	
Category:	Repair - Alteration			
Correction:	Install Kelley Dock Communication System			
Notes:	This dock is for small and medium delivery vehicles. It has no dock leveler or room for a truck restraint system.
