TRUCK RESTRAINT PROGRAM – USPS P&DC- Hartford, CT
141 Weston ST, Hartford, CT 06101-9612

SCOPE OF WORK PACKAGE (RFP 743672-31678P) Date 08/5/2022

General Findings and Condition Report (eCOMET Enhanced Deficiency Sheet Report)

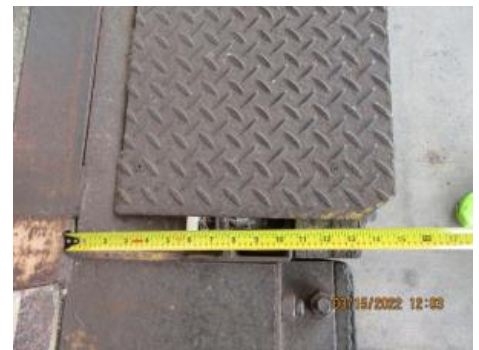
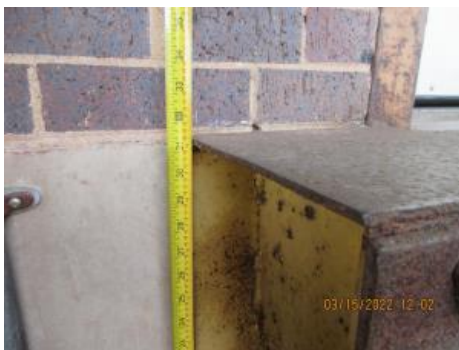
Subsystem Code:	E1030310	Surveyor / Update:	Brendan Baranek-Olmstead	03/23/2022
Subsystem Description:	Loading Dock Equipment, EACH	Qty:	1.00	
Material:				
Distress:	Missing	Deficiency Id:	316194	
Priority:	1 - Currently Critical (Immediate)	Location:	DOOR 04	
Category:	Repair - Alteration			
Correction:	Install Kelley Dock Communication System			
Notes:	No deficiencies observed. BMU area, not expected to receive trucks. The foundation wall to the face of the rubber bumper is 13", SOG to the bottom of the dock leveler 21.75", over all dock height 31". Dock extends 14.25" from foundation wall. The dock face below the leveler is adequate. BMU area, not expected to receive trucks. Docks for DOORS 04-07 are similar design. Install a new communications system only, including manual truck chocks.

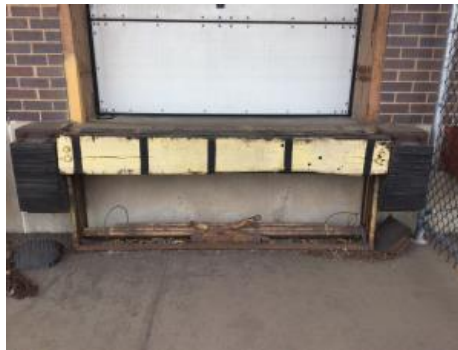
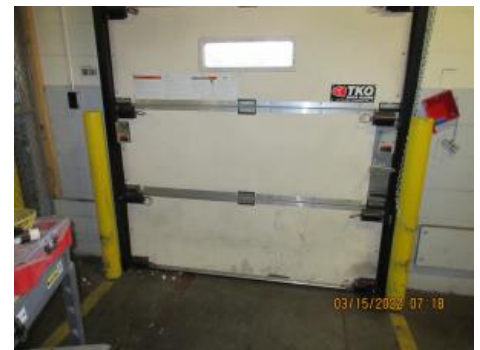
Subsystem Code:	E1030310	Surveyor / Update:	Brendan Baranek-Olmstead	03/23/2022
Subsystem Description:	Loading Dock Equipment, EACH	Qty:	1.00	
Material:				
Distress:	Missing	Deficiency Id:	316197	
Priority:	1 - Currently Critical (Immediate)	Location:	DOOR 07	
Category:	Repair - Alteration			
Correction:	Install Kelley Dock Communication System			
Notes:	No deficiencies observed. BMU area, not expected to receive trucks. The foundation wall to the face of the rubber bumper is 13", SOG to the bottom of the dock leveler 21.75", over all dock height 31". Dock extends 14.25" from foundation wall. The dock face below the leveler is adequate. BMU area, not expected to receive trucks. Docks for DOORS 04-07 are similar design. Install a new communications system only, including manual truck chocks. Left side, facing door, wall section abuts a security screen.

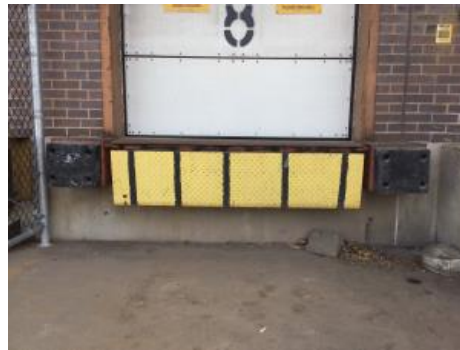
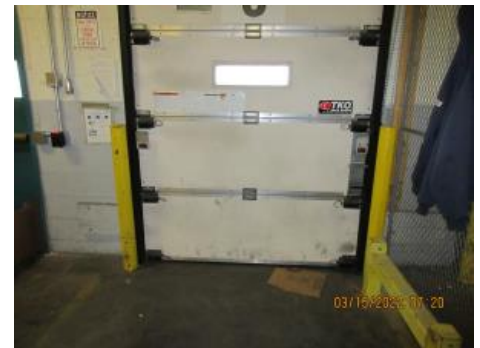
Subsystem Code:	E1030310	Surveyor / Update:	Brendan Baranek-Olmstead	03/23/2022
Subsystem Description:	Loading Dock Equipment, EACH	Qty:	1.00	
Material:				
Distress:	Missing	Deficiency Id:	316198	
Priority:	1 - Currently Critical (Immediate)	Location:	DOOR 08	
Category:	Repair - Alteration			
Correction:	Install Kelley Dock Communication System			
Notes:	No deficiencies observed. BMU area, not expected to receive trucks. The foundation wall to the face of the rubber bumper is 15.25", SOG to the bottom of the dock leveler 13.5", over all dock height 30.5". Dock extends 12.5" from foundation wall. The dock face below the leveler is inadequate. BMU area, not expected to receive trucks. Install a new communications system only, including manual truck chocks. The left side, facing the door, wall sections only available space due to security screen on right side.

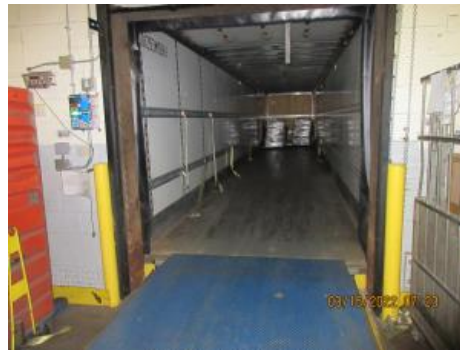
Subsystem Code:	E1030310	Surveyor / Update:	Brendan Baranek-Olmstead	03/23/2022
Subsystem Description:	Loading Dock Equipment, EACH	Qty:	1.00	
Material:				
Distress:	Inadequate	Deficiency Id:	316207	
Priority:	1 - Currently Critical (Immediate)	Location:	DOOR 09	
Category:	Repair - Alteration			
Correction:	Install Kelley Dock Communication System			
Notes:	The foundation wall to the face of the rubber bumper is 7", SOG to the bottom of the dock leveler 20.5", SOG to the bottom of the dock leveler metal frame 15", over all dock height 42". The dock face below the leveler is inadequate. There is an existing Red/Green light and signage mounted to exterior wall, and comm. box mounted on the interior side. Install a new communications system only, including manual truck chocks. Remove the existing Red/Green light and signage mounted to exterior wall, and remove the communication box mounted to the interior side. The dock was partially obstructed from view, the full condition of all dock components could not be verified. The assumption of partial condition is based on the condition of adjacent docks.

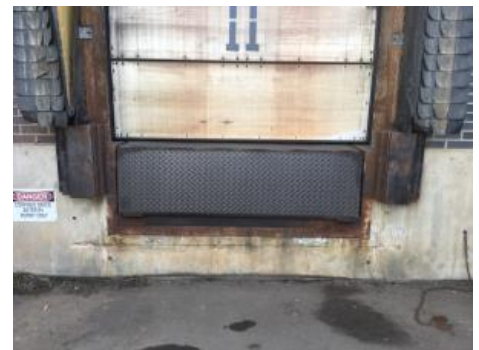
Subsystem Code:	E1030310	Surveyor / Update:	Brendan Baranek-Olmstead	03/23/2022
Subsystem Description:	Loading Dock Equipment, EACH	Qty:	1.00	
Material:				
Distress:	Inadequate	Deficiency Id:	316210	
Priority:	1 - Currently Critical (Immediate)	Location:	DOOR 11	
Category:	Repair - Alteration			
Correction:	Install Kelley Dock Communication System			
Notes:	The foundation wall to the face of the rubber bumper is 8", SOG to the bottom of the dock leveler 21", SOG to the bottom of the dock leveler metal frame 15", over all dock height 42". The dock face below the leveler is inadequate. There is an existing Red/Green light and signage mounted to exterior wall, and comm. box mounted interior side. Install a new communications system only, including manual truck chocks. Remove the existing Red/Green light and signage mounted to exterior wall, and comm. box mounted interior side.

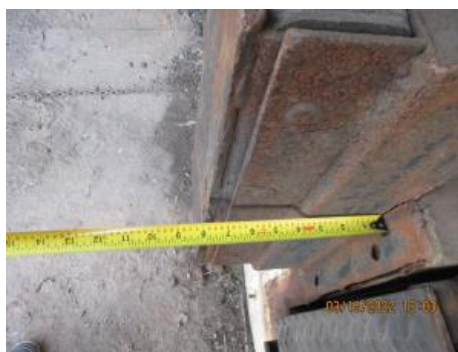
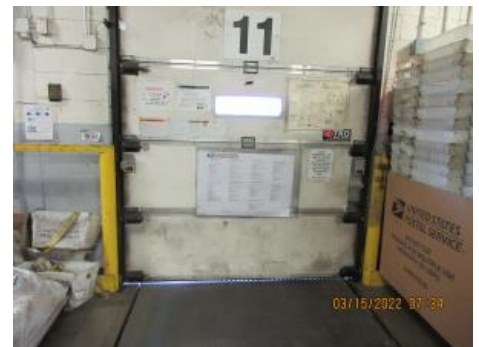
Comm box mounted on right wall

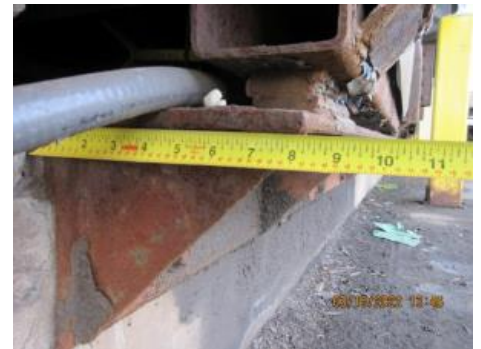
Distress:	Inadequate	Deficiency Id:	316214
Priority:	1 - Currently Critical (Immediate)	Location:	DOOR 15
Category:	Repair - Alteration		
Correction:	Install Kelley Dock Communication System		
Notes:	The foundation wall to the face of the rubber bumper is 12", SOG to the bottom of the dock leveler 17.25", SOG to the bottom of the dock leveler angled braces 13", over all dock height 42". Folded dock leveler extends 10" from foundation wall by angled braces. The dock face below the leveler is inadequate. There is an existing Red/Green light mounted to exterior wall, and comm. box mounted on the interior side. Install a new communications system only, including manual truck chocks. Remove the existing Red/Green light mounted to exterior wall, and comm. box mounted on the interior side.

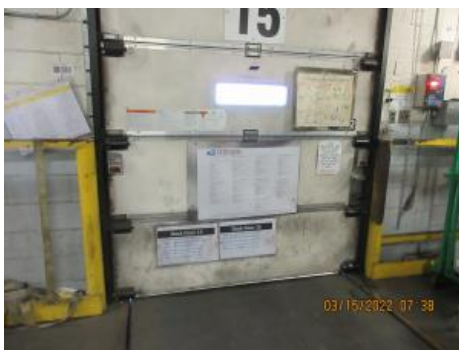
Red/Green light, but no signage

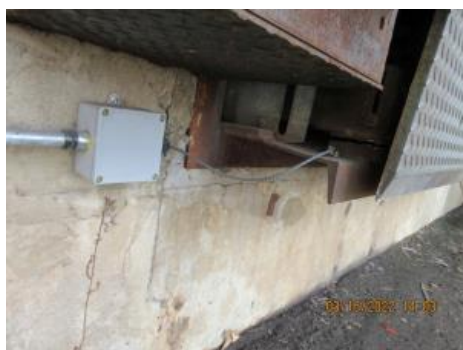
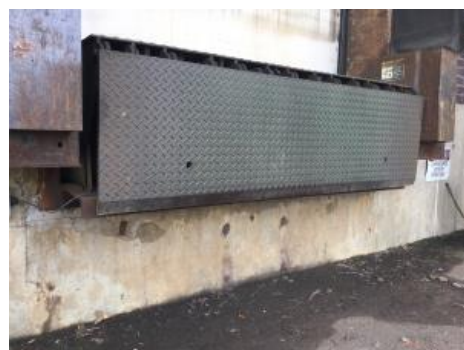
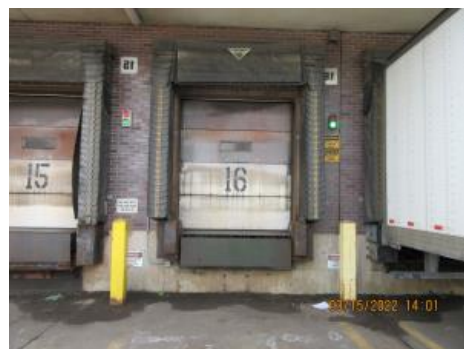
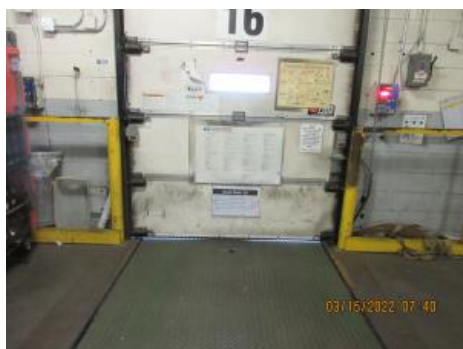
Subsystem Code:	E1030310	Surveyor / Update:	Brendan Baranek-Olmstead	03/24/2022
Subsystem Description:	Loading Dock Equipment, EACH	Qty:	1.00	
Material:				
Distress:	Inadequate	Deficiency Id:	316215	
Priority:	3 - Necessary/Not Yet Critical (Years 2-5)	Location:	DOOR 16	
Category:	Repair - Alteration			
Correction:	Install Kelley Dock Communication System			
Notes:	The foundation wall to the face of the rubber bumper is 12", SOG to the bottom of the dock leveler 19.5", over all dock height 42". Folded dock leveler extends 13" from foundation wall. The dock face below the leveler is inadequate. There is an existing Red/Green light and signage mounted to exterior wall, and comm. box mounted on the interior side. Install a new communications system only, including manual truck chocks. Remove the existing Red/Green light and signage mounted to exterior wall, and comm. box mounted on the interior side.

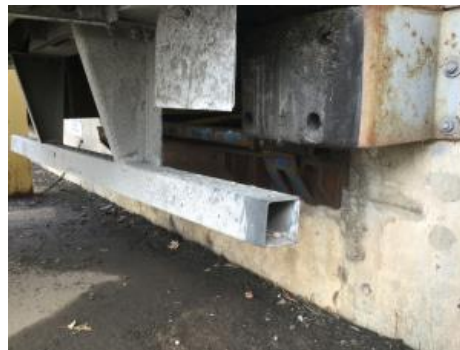
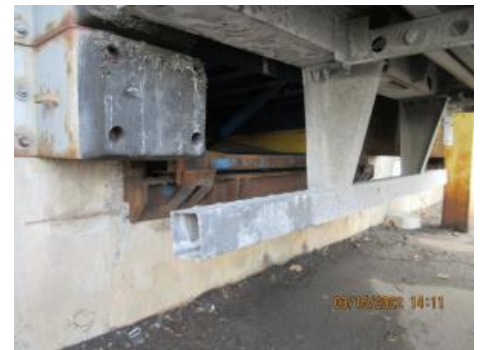
The foundation wall to the face of the rubber bumper is 15", SOG to the bottom of the dock leveler 16", over all dock height 42". The dock face below the leveler is inadequate. The folded dock leveler had 4" depth off foundation wall, distance between braces unknown. There is an existing Red/Green light and signage mounted to exterior wall, and comm. box mounted to the interior side. Install a new communications system only, including manual truck chocks. Remove the existing Red/Green light and signage mounted to exterior wall, and comm. box mounted to the interior side. The dock was partially obstructed from view, the full condition of all dock components could not be verified. The assumption of partial condition is based on the condition of adjacent docks.

Right side of door, on wall

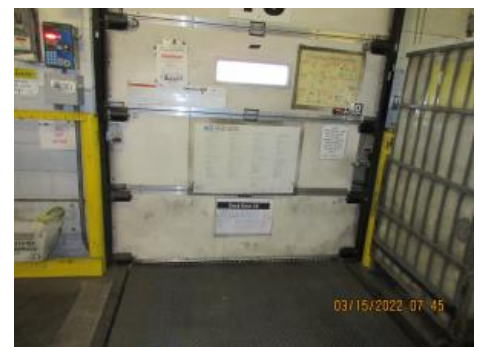
Subsystem Code:	E1030310	Surveyor / Update:	Brendan Baranek-Olmstead	03/24/2022
Subsystem Description:	Loading Dock Equipment, EACH	Qty:	1.00	
Material:				
Distress:	Inadequate	Deficiency Id:	316217	
Priority:	1 - Currently Critical (Immediate)	Location:	DOOR 18	
Category:	Repair - Alteration			
Correction:	Install Kelley Dock Communication System			
Notes:	The foundation wall to the face of the rubber bumper is 14.5", SOG to the bottom of the dock leveler 20.5", SOG to the bottom of the dock leveler angled braces 13", over all dock height 42". Folded dock leveler extends 10" from foundation wall by angled braces. The dock face below the leveler is inadequate. There is an existing Red/Green light and signage mounted to the exterior wall, and a comm. box mounted to the interior side. Install a new communications system only, including manual truck chocks. Remove the existing Red/Green light and signage mounted to the exterior wall, and a comm. box mounted to the interior side.

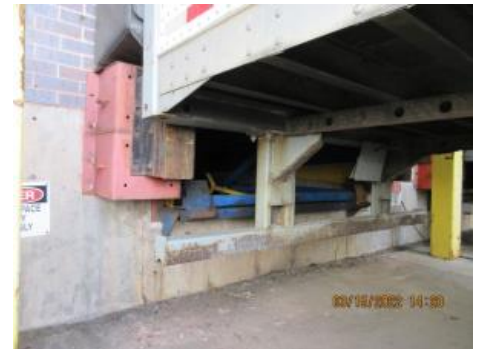
Missing reversed dock no sigh

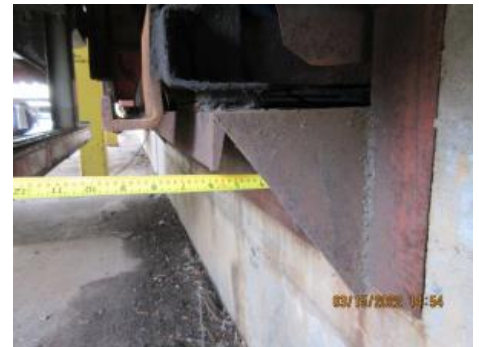
The foundation wall to the face of the rubber bumper is 16", SOG to the bottom of the dock leveler 20", SOG to the bottom of the dock leveler angled braces 14", over all dock height 42". Folded dock leveler extends 10" from foundation wall by angled braces. The dock face below the leveler is inadequate. There is an existing Red/Green light and signage mounted to the exterior wall, and a comm. box mounted to the interior side. Install a new communications system only, including manual truck chocks. Remove the existing Red/Green light and signage mounted to the exterior wall, and a comm. box mounted to the interior side. The dock was partially obstructed from view, the full condition of all dock components could not be verified. The assumption of partial condition is based on the condition of adjacent docks.

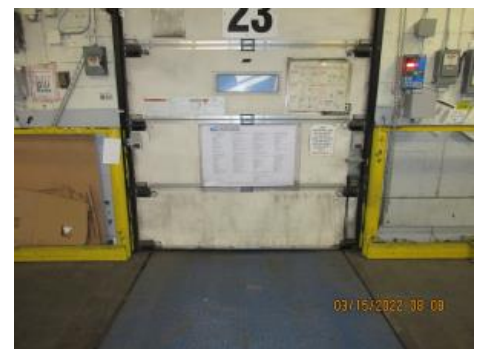
Subsystem Code:	E1030310	Surveyor / Update:	Brendan Baranek-Olmstead	03/24/2022
Subsystem Description:	Loading Dock Equipment, EACH	Qty:	1.00	
Material:				
Distress:	Inadequate	Deficiency Id:	316223	
Priority:	1 - Currently Critical (Immediate)	Location:	DOOR 23	
Category:	Repair - Alteration			
Correction:	Install Kelley Dock Communication System			
Notes:	The foundation wall to the face of the rubber bumper is 17.5", SOG to the bottom of the dock leveler 20", SOG to the bottom of the dock leveler angled braces 16", over all dock height 42". Folded dock leveler extends 8" from foundation wall by angled braces. The dock face below the leveler is inadequate. There is an existing Red/Green light and signage mounted to the exterior wall, and a comm. box mounted to the interior side. Install a new communications system only, including manual truck chocks. Removal of the existing Red/Green light and signage mounted to the exterior wall, and a comm. box mounted to the interior side.

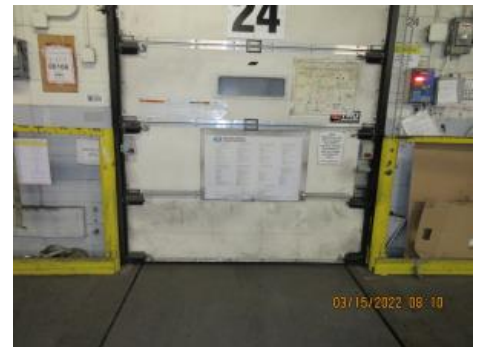
Subsystem Code:	E1030310	Surveyor / Update:	Brendan Baranek-Olmstead	03/24/2022
Subsystem Description:	Loading Dock Equipment, EACH	Qty:	1.00	
Material:				
Distress:	Inadequate	Deficiency Id:	316224	
Priority:	1 - Currently Critical (Immediate)	Location:	DOOR 24	
Category:	Repair - Alteration			
Correction:	Install Kelley Dock Communication System			
Notes:	The foundation wall to the face of the rubber bumper is 7", SOG to the bottom of the dock leveler 21.5", SOG to the bottom of the dock leveler metal frame 20", over all dock height 42". The dock face below the leveler is inadequate. Left side of dock has conduit to leveler. There is an existing Red/Green light and signage mounted to the exterior wall, and a comm. box mounted to the interior side. Install a new communications system only, including manual truck chocks. Removal of the existing Red/Green light and signage mounted to the exterior wall, and a comm. box mounted to the interior side.

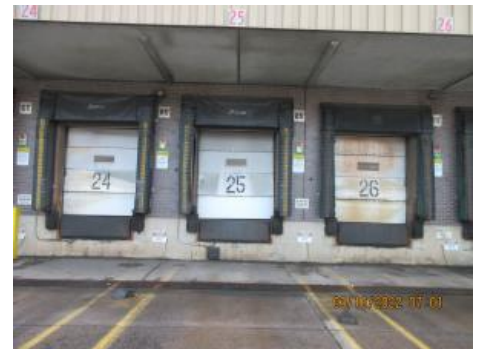
Subsystem Code:	E1030310	Surveyor / Update:	Brendan Baranek-Olmstead	03/28/2022
Subsystem Description:	Loading Dock Equipment, EACH	Qty:	1.00	
Material:				
Distress:	Inadequate	Deficiency Id:	316358	
Priority:	1 - Currently Critical (Immediate)	Location:	DOOR 25	
Category:	Repair - Alteration			
Correction:	Install Kelley Dock Communication System			
Notes:	The foundation wall to the face of the rubber bumper is 7", SOG to the bottom of the dock leveler 21", over all dock height 42". The dock face below the leveler is inadequate. Left side of dock has conduit to leveler. There is an existing Red/Green light and signage mounted to the exterior wall, and a comm. box mounted to the interior side. Install a new communications system only, including manual truck chocks. Removal of the existing Red/Green light and signage mounted to the exterior wall, and a comm. box mounted to the interior side.

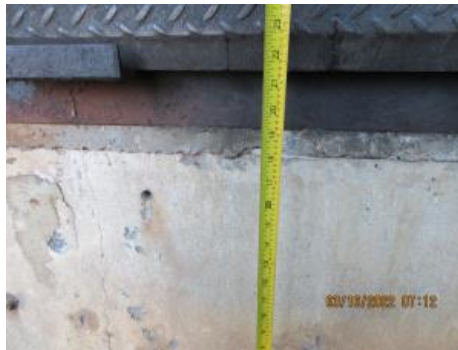
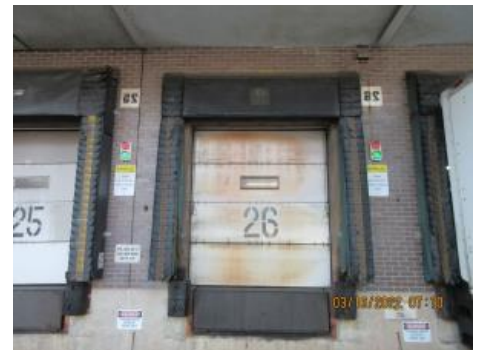
Subsystem Code:	E1030310	Surveyor / Update:	Brendan Baranek-Olmstead	03/28/2022
Subsystem Description:	Loading Dock Equipment, EACH	Qty:	1.00	
Material:				
Distress:	Inadequate	Deficiency Id:	316359	
Priority:	1 - Currently Critical (Immediate)	Location:	DOOR 26	
Category:	Repair - Alteration			
Correction:	Install Kelley Dock Communication System			
Notes:	The foundation wall to the face of the rubber bumper is 7", SOG to the bottom of the dock leveler 21", over all dock height 42". The dock face below the leveler is inadequate. There is an existing Red/Green light and signage mounted to the exterior wall, and a comm. box mounted interior side. Install a new communications system only, including manual truck chocks. Removal of the existing Red/Green light and signage mounted to the exterior wall, and a comm. box mounted interior side.

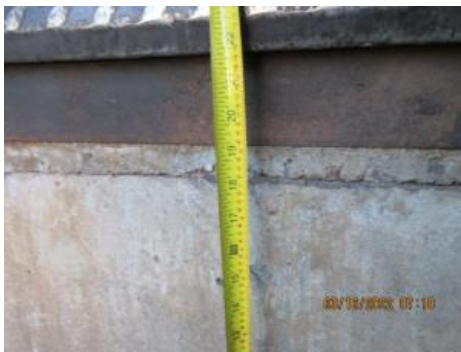
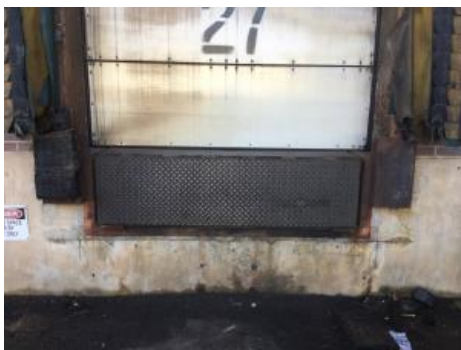
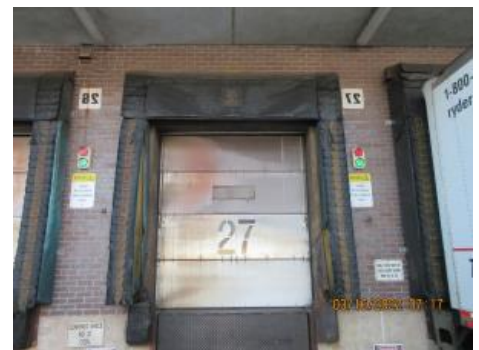
Subsystem Code:	E1030310	Surveyor / Update:	Brendan Baranek-Olmstead	03/28/2022
Subsystem Description:	Loading Dock Equipment, EACH	Qty:	1.00	
Material:				
Distress:	Inadequate	Deficiency Id:	316362	
Priority:	1 - Currently Critical (Immediate)	Location:	DOOR 27	
Category:	Repair - Alteration			
Correction:	Install Kelley Dock Communication System			
Notes:	The foundation wall to the face of the rubber bumper is 7", SOG to the bottom of the dock leveler 21", over all dock height 42". The dock face below the leveler is inadequate. There is an existing Red/Green light and signage mounted to the exterior wall, and a comm. box mounted to the interior side. Install a new communications system only, including manual truck chocks. Removal of the existing Red/Green light and signage mounted to the exterior wall, and a comm. box mounted to the interior side.

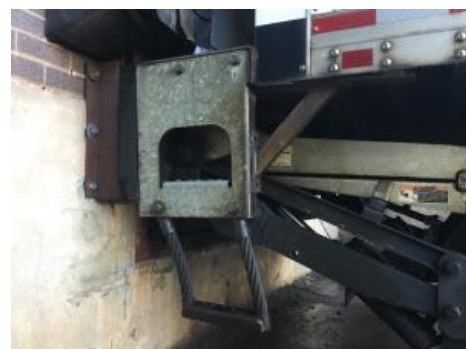
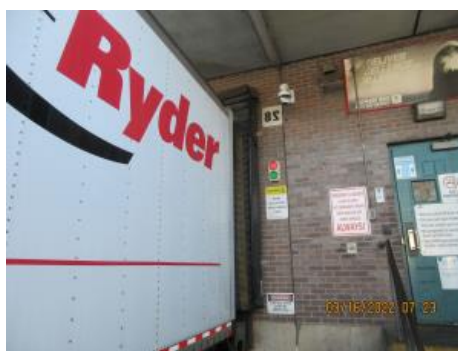
Subsystem Code:	E1030310	Surveyor / Update:	Brendan Baranek-Olmstead	03/28/2022
Subsystem Description:	Loading Dock Equipment, EACH	Qty:	1.00	
Material:				
Distress:	Inadequate	Deficiency Id:	316364	
Priority:	1 - Currently Critical (Immediate)	Location:	DOOR 28	
Category:	Repair - Alteration			
Correction:	Install Kelley Dock Communication System			
Notes:	The foundation wall to the face of the rubber bumper is 10", SOG to the bottom of the dock leveler 21", over all dock height 42". The dock face below the leveler is inadequate. There is an existing Red/Green light and signage mounted to the exterior wall, and a comm. box mounted to the interior side. Install a new communications system only, including manual truck chocks. Removal of the existing Red/Green light and signage mounted to the exterior wall, and a comm. box mounted to the interior side. The dock was partially obstructed from view, the full condition of all dock components could not be verified. The assumption of partial condition is based on the condition of adjacent docks.

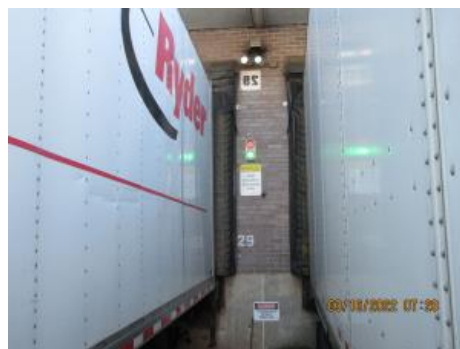
Subsystem Code:	E1030310	Surveyor / Update:	Brendan Baranek-Olmstead	03/28/2022
Subsystem Description:	Loading Dock Equipment, EACH	Qty:	1.00	
Material:				
Distress:	Inadequate	Deficiency Id:	316366	
Priority:	1 - Currently Critical (Immediate)	Location:	DOOR 29	
Category:	Repair - Alteration			
Correction:	Install Kelley Dock Communication System			
Notes:	The foundation wall to the face of the rubber bumper is 8", SOG to the bottom of the dock leveler 29", over all dock height 51". The dock face below the leveler is inadequate. There is an existing Red/Green light and signage mounted to the exterior wall, and a comm. box mounted to the interior side. Install a new communications system only, including manual truck chocks. Removal of the existing Red/Green light and signage mounted to the exterior wall, and a comm. box mounted to the interior side. The dock was partially obstructed from view, the full condition of all dock components could not be verified. The assumption of partial condition is based on the condition of adjacent docks.

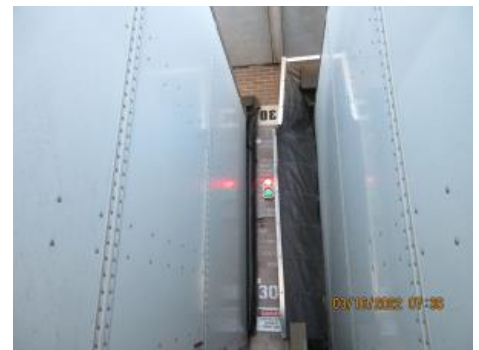
Subsystem Code:	E1030310	Surveyor / Update:	Brendan Baranek-Olmstead	03/28/2022
Subsystem Description:	Loading Dock Equipment, EACH	Qty:	1.00	
Material:				
Distress:	Inadequate	Deficiency Id:	316367	
Priority:	1 - Currently Critical (Immediate)	Location:	DOOR 30	
Category:	Repair - Alteration			
Correction:	Install Kelley Dock Communication System			
Notes:	The foundation wall to the face of the rubber bumper is 8", SOG to the bottom of the dock leveler 29", over all dock height 51". The dock face below the leveler is inadequate. There is an existing Red/Green light and signage mounted to the exterior wall, and a comm. box mounted to the interior side. Install a new communications system only, including manual truck chocks. Removal of the existing Red/Green light and signage mounted to the exterior wall, and a comm. box mounted to the interior side. The dock was partially obstructed from view, the full condition of all dock components could not be verified. The assumption of partial condition is based on the condition of adjacent docks.

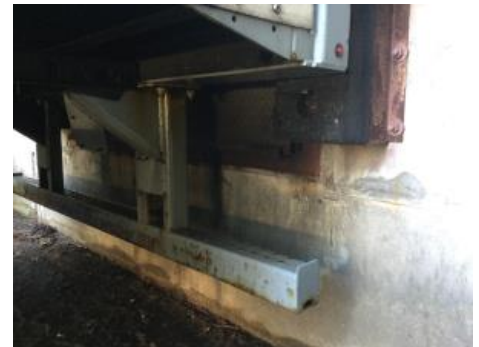
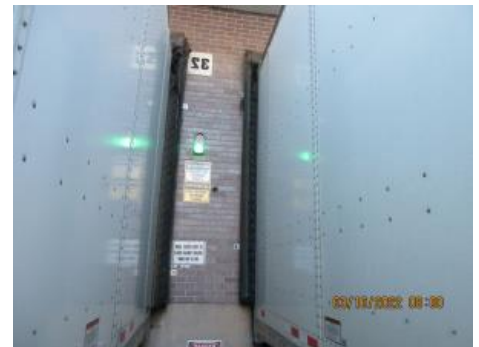
The foundation wall to the face of the rubber bumper is 7.5", SOG to the bottom of the dock leveler 29", over all dock height 51". The dock face below the leveler is inadequate. There is an existing Red/Green light and signage mounted to the exterior wall, and a comm. box mounted to the interior side. Install a new communications system only, including manual truck chocks. Removal of the existing Red/Green light and signage mounted to the exterior wall, and a comm. box mounted to the interior side. The dock was partially obstructed from view, the full condition of all dock components could not be verified. The assumption of partial condition is based on the condition of adjacent docks.

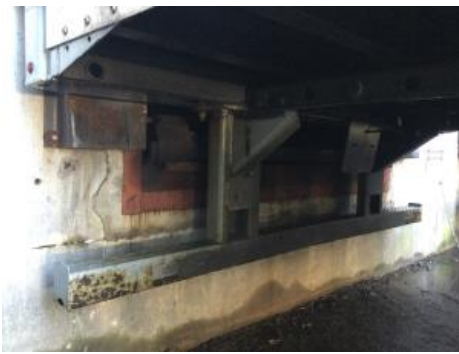
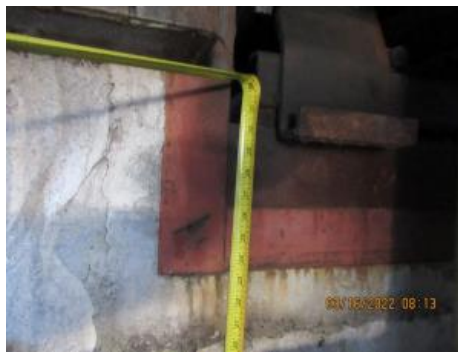
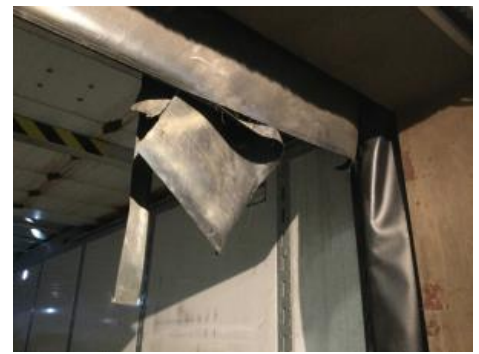
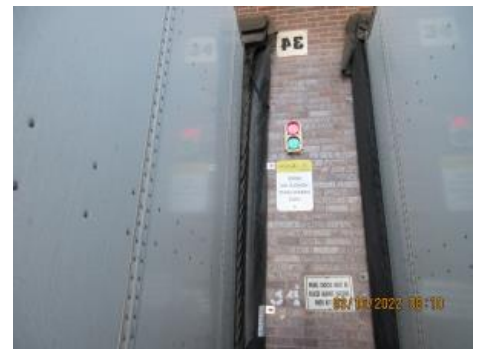
Distress:	Inadequate	Deficiency Id:	316386
Priority:	1 - Currently Critical (Immediate)	Location:	DOOR 34
Category:	Repair - Alteration		
Correction:	Install Kelley Dock Communication System		
Notes:	The foundation wall to the face of the metal bumper is 4.5", SOG to the bottom of the dock leveler 30", over all dock height 51". The dock face below the leveler is inadequate. There is an existing Red/Green light and signage mounted to the exterior wall, and a comm. box mounted to the interior side. Install a new communications system only, including manual truck chocks. Removal of the existing Red/Green light and signage mounted to the exterior wall, and a comm. box mounted to the interior side. The dock was partially obstructed from view, the full condition of all dock components could not be verified. The assumption of partial condition is based on the condition of adjacent docks.

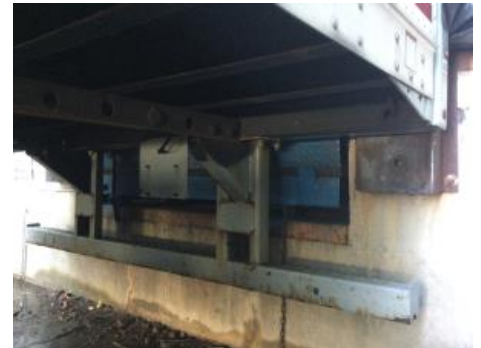
The foundation wall to the face of the metal bumper is 4.5", SOG to the bottom of the dock leveler 30", over all dock height 51". The dock face below the leveler is inadequate. There is an existing Red/Green light and signage mounted to the exterior wall, and a comm. box mounted to the interior side. Install a new communications system only, including manual truck chocks Removal of the . existing Red/Green light and signage mounted to the exterior wall, and a comm. box mounted to the interior side. The dock was partially obstructed from view, the full condition of all dock components could not be verified. The assumption of partial condition is based on the condition of adjacent docks.

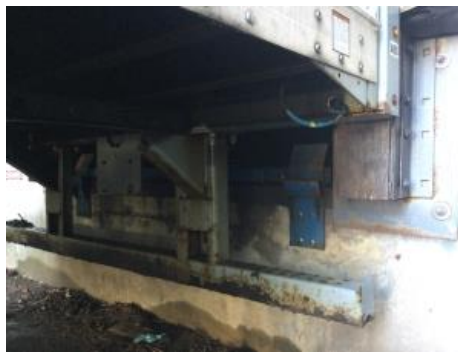
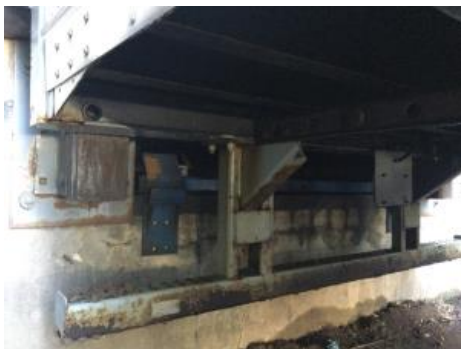
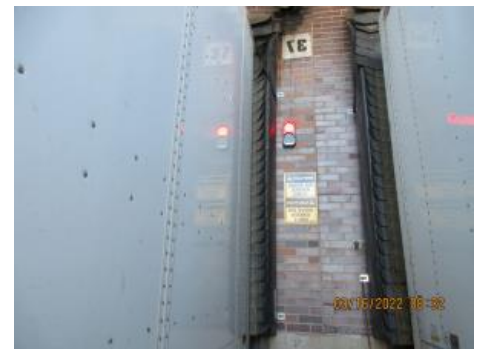
Distress:	Inadequate	Deficiency Id:	316401
Priority:	1 - Currently Critical (Immediate)	Location:	DOOR 37
Category:	Repair - Alteration		
Correction:	Install Kelley Dock Communication System		
Notes:	The foundation wall to the face of the metal bumper is 4.5", SOG to the bottom of the dock leveler 27.5", over all dock height 51". The dock face below the leveler is inadequate. There is an existing Red/Green light and signage mounted to the exterior wall, and a comm. box mounted to the interior side. Install a new communications system only, including manual truck chocks. Removal of the existing Red/Green light and signage mounted to the exterior wall, and a comm. box mounted to the interior side. The dock was partially obstructed from view, the full condition of all dock components could not be verified. The assumption of partial condition is based on the condition of adjacent docks.

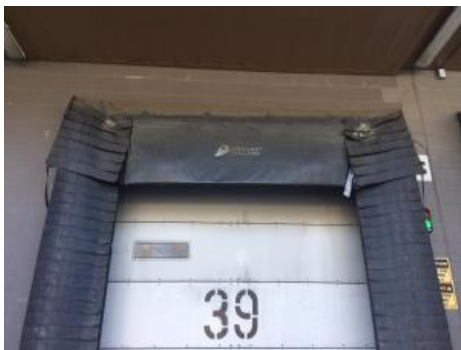
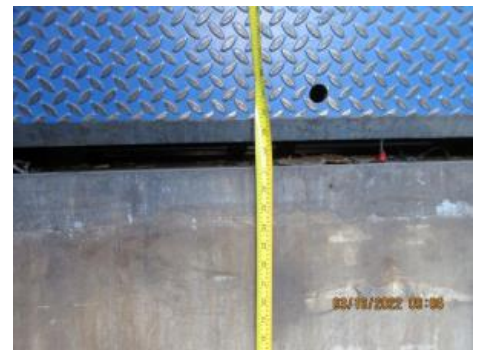
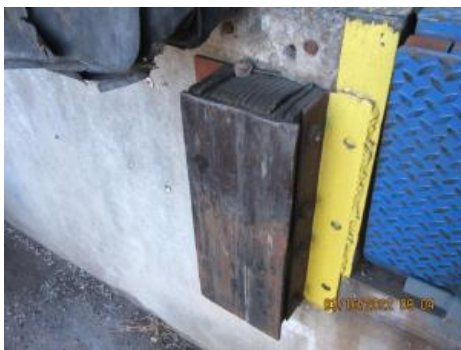
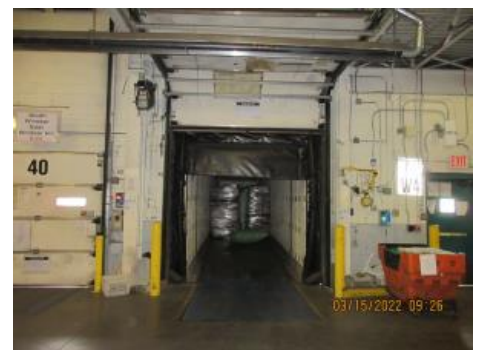
Subsystem Code:	E1030310	Surveyor / Update:	Brendan Baranek-Olmstead	03/28/2022
Subsystem Description:	Loading Dock Equipment, EACH	Qty:	1.00	
Material:				
Distress:	Inadequate	Deficiency Id:	316407	
Priority:	1 - Currently Critical (Immediate)	Location:	DOOR 39	
Category:	Repair - Alteration			
Correction:	Install Kelley Dock Communication System			
Notes:	The foundation wall to the face of the metal bumper is 5", SOG to the bottom of the dock leveler 28.5", over all dock height 51". The dock face below the leveler is inadequate. There is an existing Red/Green light and signage mounted to the exterior wall, and a comm. box mounted the interior side. Install a new communications system only, including manual truck chocks. Removal of the existing Red/Green light and signage mounted to the exterior wall, and a comm. box mounted the interior side.

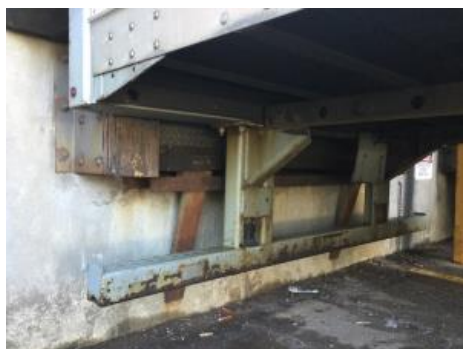
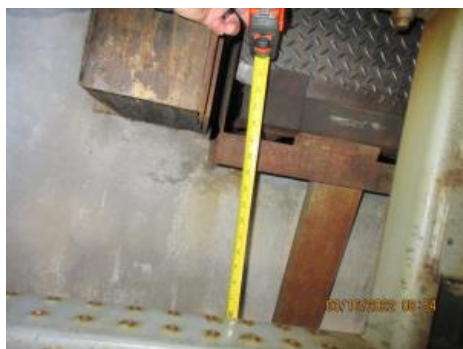
Subsystem Code:	E1030310	Surveyor / Update:	Brendan Baranek-Olmstead	03/28/2022
Subsystem Description:	Loading Dock Equipment, EACH	Qty:	1.00	
Material:				
Distress:	Inadequate	Deficiency Id:	316408	
Priority:	1 - Currently Critical (Immediate)	Location:	DOOR 40	
Category:	Repair - Alteration			
Correction:	Install Kelley Dock Communication System			
Notes:	The foundation wall to the face of the rubber bumper is 13.5", SOG to the bottom of the dock leveler 25", over all dock height 51". Dock leveler extends 7.5" from foundation wall. The dock face below the leveler is inadequate. Beneath dock leveler ramp extension from foundation wall are angled supports. 49" clearance between supports. 26" clearance height to bottom plate. There is an existing Red/Green light and signage mounted to the exterior wall, and a comm. box mounted to the interior side. Install a new communications system only, including manual truck chocks. Removal of the existing Red/Green light and signage mounted to the exterior wall, and a comm. box mounted to the interior side. The dock was partially obstructed from view, the full condition of all dock components could not be verified. The assumption of partial condition is based on the condition of adjacent docks.

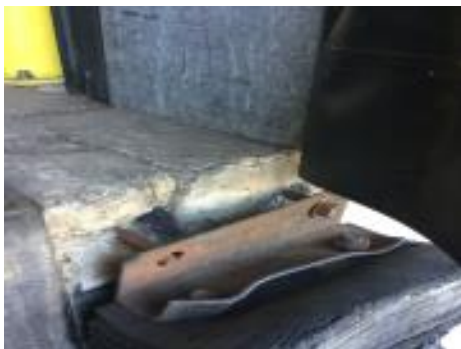
Right bumper

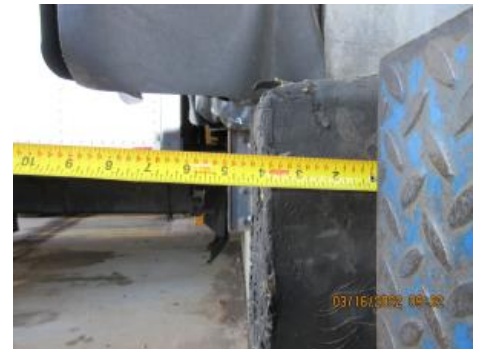
Subsystem Code:	E1030310	Surveyor / Update:	Brendan Baranek-Olmstead	03/16/2022
Subsystem Description:	Loading Dock Equipment, EACH	Qty:	1.00	
Material:				
Distress:	Missing	Deficiency Id:	315962	
Priority:	1 - Currently Critical (Immediate)	Location:	DOOR 43	
Category:	Repair - Alteration			
Correction:	Install Star 4 Truck Restraint			
Notes:	The foundation wall to the face of the rubber bumper is 4", SOG to the bottom of the dock leveler 30.5", SOG to top of leveler clip 31.5", over all dock height 48". The dock face below the leveler is adequate. Dock lip pivot guard should be mounted to outer edge of leveler clip. There is an existing Red/Green light and signage mounted to the exterior wall, and a comm. box mounted to the interior side. Removal of the existing Red/Green light and signage mounted to the exterior wall, and a comm. box mounted to the interior side.

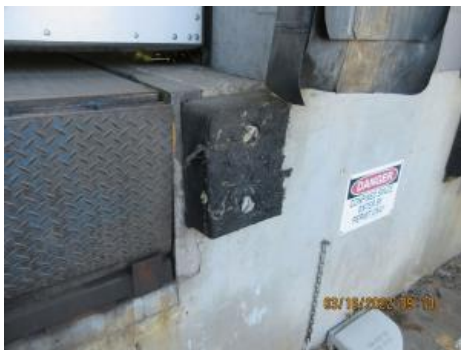
connection bolts heads exposed

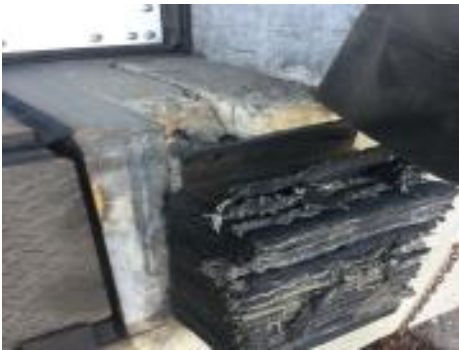
Right bumper missing top bolt

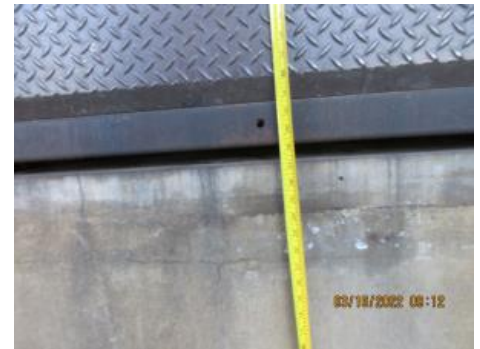
Subsystem Code:	E1030310	Surveyor / Update:	Brendan Baranek-Olmstead	03/16/2022
Subsystem Description:	Loading Dock Equipment, EACH	Qty:	1.00	
Material:				
Distress:	Missing	Deficiency Id:	315972	
Priority:	1 - Currently Critical (Immediate)	Location:	DOOR 45	
Category:	Repair - Alteration			
Correction:	Install Star 4 Truck Restraint			
Notes:	The foundation wall to the face of the rubber bumper is 6", SOG to the bottom of the dock leveler 30.5", SOG to top of leveler clip 31.5", over all dock height 48". The dock face below the leveler is adequate. Dock lip pivot guard should be mounted to outer edge of leveler clip. There is an existing Red/Green light and signage mounted to the exterior wall, and a comm. box mounted to the interior side. Removal of the existing Red/Green light and signage mounted to the exterior wall, and a comm. box mounted to the interior side.

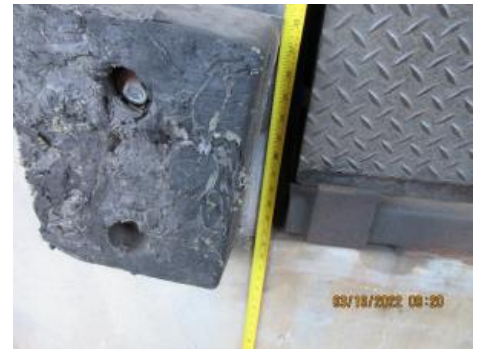
Subsystem Code:	E1030310	Surveyor / Update:	Brendan Baranek-Olmstead	03/16/2022
Subsystem Description:	Loading Dock Equipment, EACH	Qty:	1.00	
Material:				
Distress:	Missing	Deficiency Id:	315976	
Priority:	1 - Currently Critical (Immediate)	Location:	DOOR 46	
Category:	Repair - Alteration			
Correction:	Install Star 4 Truck Restraint			
Notes:	The foundation wall to the face of the rubber bumper is 6", SOG to the bottom of the dock leveler 31", SOG to top of leveler clip 31.5", over all dock height 48". The dock face below the leveler is adequate. Dock lip pivot guard should be mounted to outer edge of leveler clip. There is an existing Red/Green light and signage mounted to the exterior wall, and a comm. box mounted to the interior side. Removal of the existing Red/Green light and signage mounted to the exterior wall, and a comm. box mounted to the interior side.

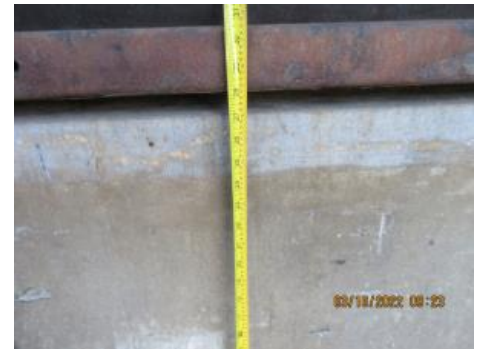
Subsystem Code:	E1030310	Surveyor / Update:	Brendan Baranek-Olmstead	03/16/2022
Subsystem Description:	Loading Dock Equipment, EACH	Qty:	1.00	
Material:				
Distress:	Missing	Deficiency Id:	315978	
Priority:	1 - Currently Critical (Immediate)	Location:	DOOR 47	
Category:	Repair - Alteration			
Correction:	Install Star 4 Truck Restraint			
Notes:	The foundation wall to the face of the rubber bumper is 5", SOG to the bottom of the dock leveler 30.5", SOG to top of leveler clip 31.5", over all dock height 48". The dock face below the leveler is adequate. Dock lip pivot guard should be mounted to outer edge of leveler clip. There is an existing Red/Green light and signage mounted to the exterior wall, and a comm. box mounted to the interior side. Removal of the existing Red/Green light and signage mounted to the exterior wall, and a comm. box mounted to the interior side.

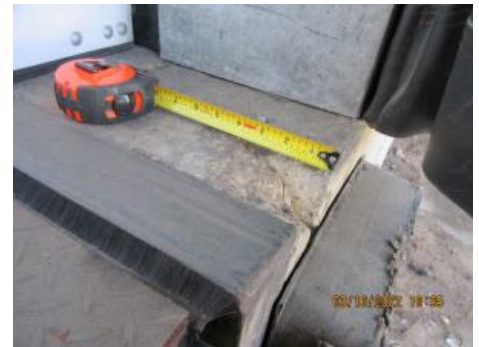
Subsystem Code:	E1030310	Surveyor / Update:	Brendan Baranek-Olmstead	03/16/2022
Subsystem Description:	Loading Dock Equipment, EACH	Qty:	1.00	
Material:				
Distress:	Damaged	Deficiency Id:	315981	
Priority:	3 - Necessary/Not Yet Critical (Years 2-5)	Location:	DOOR 48	
Category:	Repair - Alteration			
Correction:	Provide and Replace Rubber Dock Bumper			
Notes:	The rubber dock bumper located on the right side of the loading dock is damaged. bumper is rotated 90 degrees. Top connection bolt location is missing concrete
