## **Mail Processing Facilities**

TRUCK RESTRAINT PROGRAM – USPS P&DC- Stamford, CT  
427 West Ave., Stamford, CT 06910-1002

SCOPE OF WORK PACKAGE (RFP 743672-31678P) Date: 08/05/2022

## eCOMET USPS Detailed Deficiency Sheet

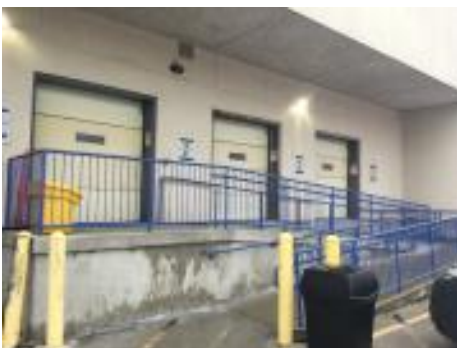
Subsystem Code:	E1030310	Surveyor / Update:	Brendan Baranek-Olmstead	03/17/2022
Subsystem Description:	Loading Dock Equipment, EACH	Qty:		
Material:				
Distress:	N/A	Deficiency Id:	316018	
Priority:		Location:	DOOR 02	
Category:	N/A			
Correction:				
Notes:	Door 2 is not used for direct truck loading and unloading, there is a permanent concrete pedestrian ramp in front of the door as well as adjacent doors 1 and 3.

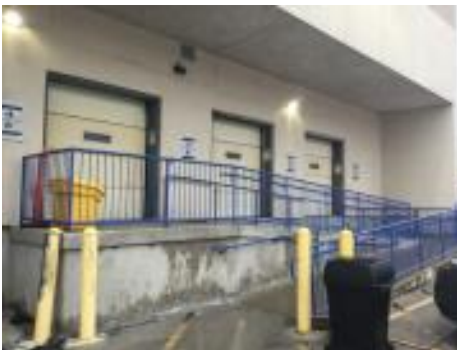
Subsystem Code:	E1030310	Surveyor / Update:	Brendan Baranek-Olmstead	03/17/2022
Subsystem Description:	Loading Dock Equipment, EACH	Qty:		
Material:				
Distress:	N/A	Deficiency Id:	316019	
Priority:		Location:	DOOR 03	
Category:	N/A			
Correction:				
Notes:	Door 3 is not used for direct truck loading and unloading, there is a permanent concrete pedestrian ramp in front of the door as well as adjacent doors 1 and 2.

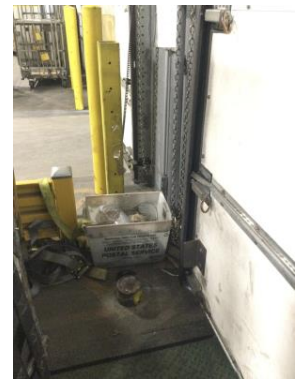
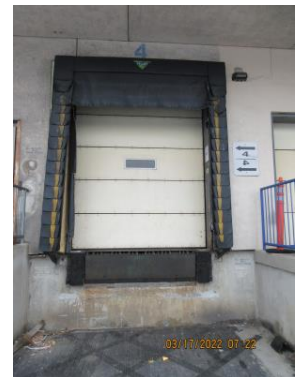
Subsystem Code:	E1030310	Surveyor / Update:	Brendan Baranek-Olmstead	03/29/2022
Subsystem Description:	Loading Dock Equipment, EACH	Qty:	1.00	
Material:				
Distress:	Inadequate	Deficiency Id:	316449	
Priority:	1 - Currently Critical (Immediate)	Location:	DOOR 04	
Category:	Repair - Alteration			
Correction:	Install Kelley Dock Communication System			
Notes:	Door 4 is used by carrier vehicles and vendors box trucks. Trailers and large trucks do not use this door. The foundation wall to the face of the rubber bumper is 4.5", SOG to the bottom of the dock leveler 28", over all dock height 48". The dock face below the leveler is inadequate. Install a Red Light/Green Light Kelley communication system to include manual wheel chocks.

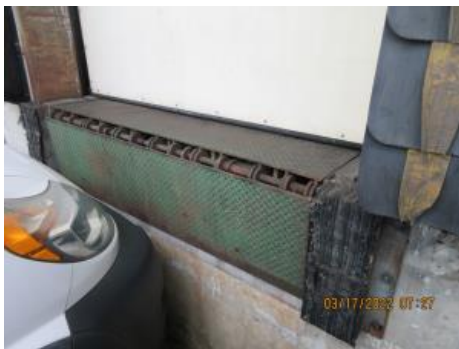
Subsystem Code:	E1030310	Surveyor / Update:	Brendan Baranek-Olmstead	03/29/2022
Subsystem Description:	Loading Dock Equipment, EACH	Qty:	1.00	
Material:				
Distress:	Inadequate	Deficiency Id:	316450	
Priority:	1 - Currently Critical (Immediate)	Location:	DOOR 05	
Category:	Repair - Alteration			
Correction:	Install Kelley Dock Communication System			
Notes:	Door 5 is used by carrier vehicles and vendors box trucks. Trailers and large trucks do not use this door. The foundation wall to the face of the rubber bumper is 4", SOG to the bottom of the dock leveler 28", over all dock height 48". The dock face below the leveler is inadequate. Install a Red Light/Green Light Kelley communication system to include manual wheel chocks.

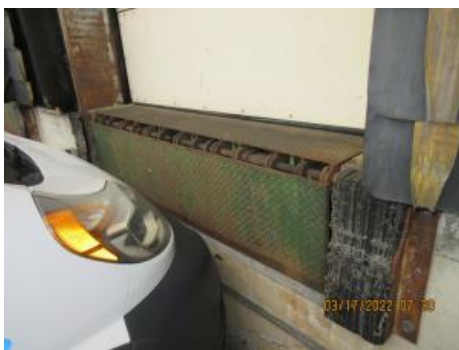
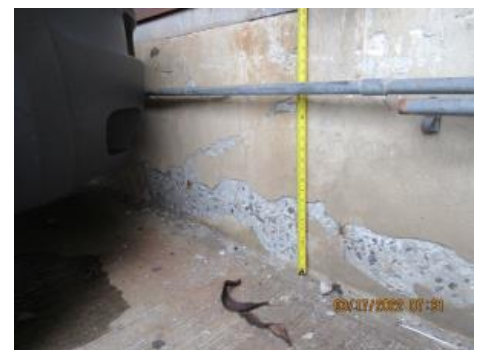
Subsystem Code:	E1030310	Surveyor / Update:	Brendan Baranek-Olmstead	03/29/2022
Subsystem Description:	Loading Dock Equipment, EACH	Qty:	1.00	
Material:				
Distress:	Inadequate	Deficiency Id:	316451	
Priority:	1 - Currently Critical (Immediate)	Location:	DOOR 06	
Category:	Repair - Alteration			
Correction:	Install Kelley Dock Communication System			
Notes:	Door 6 is used by carrier vehicles and vendors box trucks. Trailers and large trucks do not use this door. The foundation wall to the face of the rubber bumper is 4", SOG to the bottom of the dock leveler 28", over all dock height 48". The dock face below the leveler is inadequate. Install a Red Light/Green Light Kelley communication system to include manual wheel chocks.

conduit on left side of dock

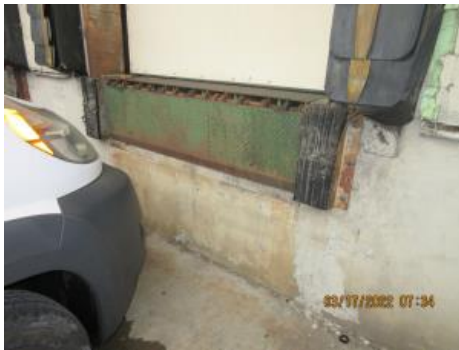
Subsystem Code:	E1030310	Surveyor / Update:	Brendan Baranek-Olmstead	03/29/2022
Subsystem Description:	Loading Dock Equipment, EACH	Qty:	1.00	
Material:				
Distress:	Inadequate	Deficiency Id:	316452	
Priority:	1 - Currently Critical (Immediate)	Location:	DOOR 07	
Category:	Repair - Alteration			
Correction:	Install Kelley Dock Communication System			
Notes:	Door 7 is used by carrier vehicles and vendors box trucks. Trailers and large trucks do not use this door. The foundation wall to the face of the rubber bumper is 4", SOG to the bottom of the dock leveler 28", over all dock height 48". The dock face below the leveler is inadequate. Install a Red Light/Green Light Kelley communication system to include manual wheel chocks.

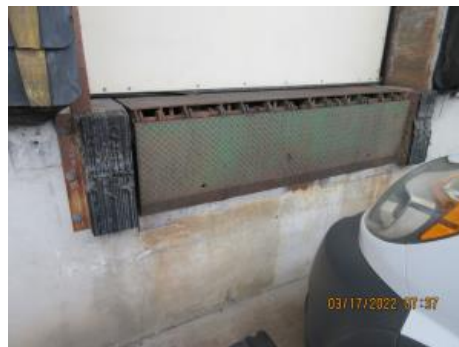
Subsystem Code:	E1030310	Surveyor / Update:	Brendan Baranek-Olmstead	03/29/2022
Subsystem Description:	Loading Dock Equipment, EACH	Qty:	1.00	
Material:				
Distress:	Inadequate	Deficiency Id:	316456	
Priority:	1 - Currently Critical (Immediate)	Location:	DOOR 08	
Category:	Repair - Alteration			
Correction:	Install Kelley Dock Communication System			
Notes:	Door 8 is used by carrier vehicles and vendors box trucks. Trailers and large trucks do not use this door. The foundation wall to the face of the rubber bumper is 4", SOG to the bottom of the dock leveler 28", over all dock height 48". The dock face below the leveler is inadequate. Install a Red Light/Green Light Kelley communication system to include manual wheel chocks.

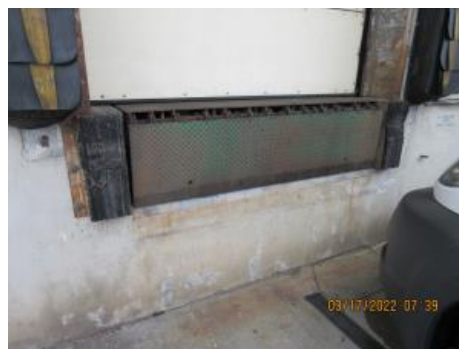
Subsystem Code:	E1030310	Surveyor / Update:	Brendan Baranek-Olmstead	03/29/2022
Subsystem Description:	Loading Dock Equipment, EACH	Qty:	1.00	
Material:				
Distress:	Inadequate	Deficiency Id:	316458	
Priority:	1 - Currently Critical (Immediate)	Location:	DOOR 09	
Category:	Repair - Alteration			
Correction:	Install Kelley Dock Communication System			
Notes:	Door 9 is used by carrier vehicles and vendors box trucks. Trailers and large trucks do not use this door. The foundation wall to the face of the rubber bumper is 3.5" - 4.5", SOG to the bottom of the dock leveler 28", over all dock height 48". The dock face below the leveler is inadequate. Install a Red Light/Green Light Kelley communication system to include manual wheel chocks.

Left side 4.5" depth

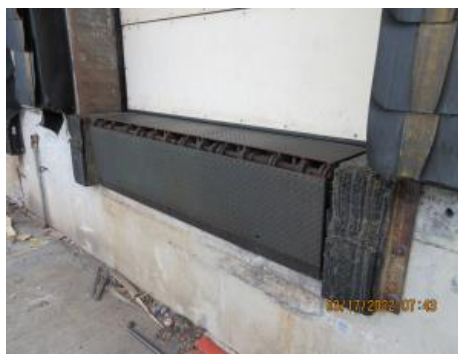
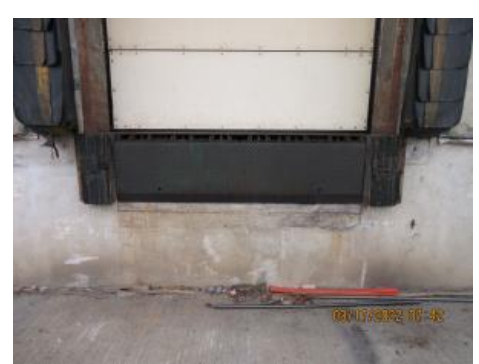
Subsystem Code:	E1030310	Surveyor / Update:	Brendan Baranek-Olmstead	03/29/2022
Subsystem Description:	Loading Dock Equipment, EACH	Qty:	1.00	
Material:				
Distress:	Inadequate	Deficiency Id:	316460	
Priority:	1 - Currently Critical (Immediate)	Location:	DOOR 10	
Category:	Repair - Alteration			
Correction:	Install Kelley Dock Communication System			
Notes:	Door 10 is used by carrier vehicles and vendors box trucks. Trailers and large trucks do not use this door. The foundation wall to the face of the rubber bumper is 3.5" - 4", SOG to the bottom of the dock leveler 28", over all dock height 48". The dock face below the leveler is inadequate. Install a Red Light/Green Light Kelley communication system to include manual wheel chocks.

Left bumper 4" depth

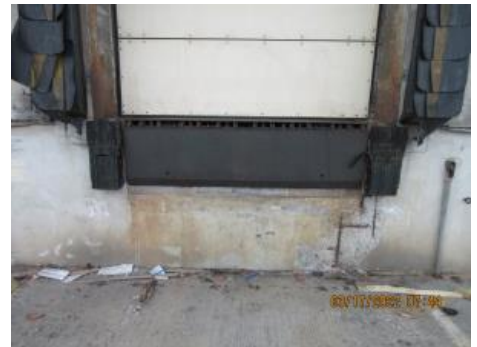
Subsystem Code:	E1030310	Surveyor / Update:	Brendan Baranek-Olmstead	03/29/2022
Subsystem Description:	Loading Dock Equipment, EACH	Qty:	1.00	
Material:				
Distress:	Inadequate	Deficiency Id:	316462	
Priority:	1 - Currently Critical (Immediate)	Location:	DOOR 11	
Category:	Repair - Alteration			
Correction:	Install Kelley Dock Communication System			
Notes:	Door 11 is used by carrier vehicles and vendors box trucks. Trailers and large trucks do not use this door. The foundation wall to the face of the rubber bumper is 3.5", SOG to the bottom of the dock leveler 28.5", over all dock height 48". The dock face below the leveler is inadequate. Install a Red Light/Green Light Kelley communication system to include manual wheel chocks.

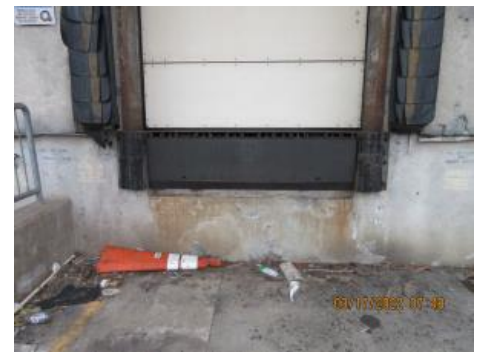
Subsystem Code:	E1030310	Surveyor / Update:	Brendan Baranek-Olmstead	03/30/2022
Subsystem Description:	Loading Dock Equipment, EACH	Qty:	1.00	
Material:				
Distress:	Inadequate	Deficiency Id:	316667	
Priority:	1 - Currently Critical (Immediate)	Location:	DOOR 12	
Category:	Repair - Alteration			
Correction:	Install Kelley Dock Communication System			
Notes:	Door 12 is used by carrier vehicles and vendors box trucks. Trailers and large trucks do not use this door. The foundation wall to the face of the rubber bumper is 3.5", SOG to the bottom of the dock leveler 28.5", over all dock height 48". The dock face below the leveler is inadequate. Install a Red Light/Green Light Kelley communication system to include manual wheel chocks.

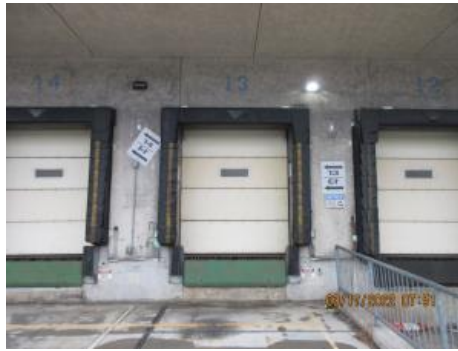
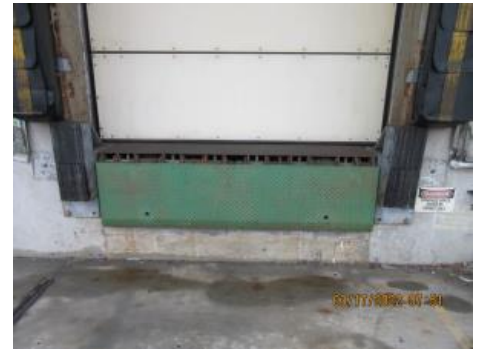
Subsystem Code:	E1030310	Surveyor / Update:	Brendan Baranek-Olmstead	03/30/2022
Subsystem Description:	Loading Dock Equipment, EACH	Qty:	1.00	
Material:				
Distress:	Inadequate	Deficiency Id:	316669	
Priority:	1 - Currently Critical (Immediate)	Location:	DOOR 13	
Category:	Repair - Alteration			
Correction:	Install Kelley Dock Communication System			
Notes:	Door 13 is used by carrier vehicles and vendors box trucks. Trailers and large trucks do not use this door. The foundation wall to the face of the rubber bumper is 6", SOG to the bottom of the dock leveler 10.5", over all dock height 31". The dock face below the leveler is inadequate. Install a Red Light/Green Light Kelley communication system to include manual wheel chocks.

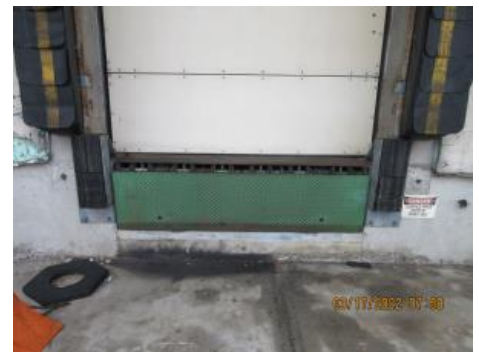
Subsystem Code:	E1030310	Surveyor / Update:	Brendan Baranek-Olmstead	03/30/2022
Subsystem Description:	Loading Dock Equipment, EACH	Qty:	1.00	
Material:				
Distress:	Inadequate	Deficiency Id:	316673	
Priority:	1 - Currently Critical (Immediate)	Location:	DOOR 15	
Category:	Repair - Alteration			
Correction:	Install Kelley Dock Communication System			
Notes:	Door 15 is used by carrier vehicles and vendors box trucks. Trailers and large trucks do not use this door. The foundation wall to the face of the rubber bumper is 5.5", SOG to the bottom of the dock leveler 9.5", over all dock height 30.5". The dock face below the leveler is inadequate. Install a Red Light/Green Light Kelley communication system to include manual wheel chocks.

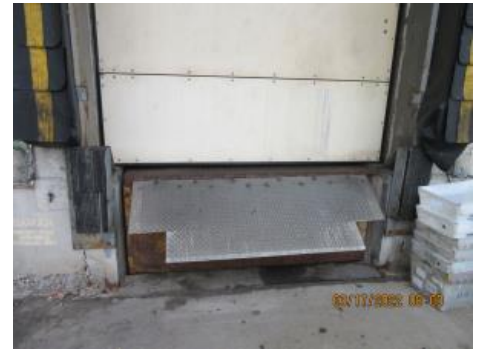
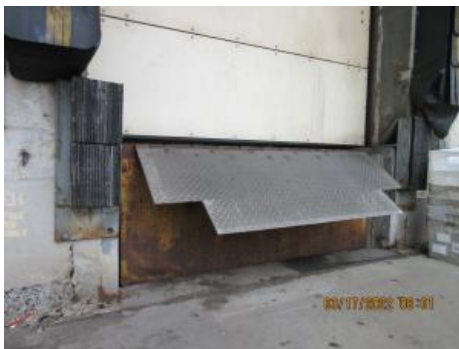
Subsystem Code:	E1030310	Surveyor / Update:	Brendan Baranek-Olmstead	03/30/2022
Subsystem Description:	Loading Dock Equipment, EACH	Qty:	1.00	
Material:				
Distress:	Inadequate	Deficiency Id:	316674	
Priority:	1 - Currently Critical (Immediate)	Location:	DOOR 16	
Category:	Repair - Alteration			
Correction:	Install Kelley Dock Communication System			
Notes:	The foundation wall to the face of the rubber bumper is 6", SOG to the bottom of the dock leveler 17", dock leveler stored at 45 degree and extends over 12" from foundation wall, over all dock height 30.5". The dock face below the leveler is inadequate. The dock does not except tractor trailers and is for smaller vehicles only. Install a Red/Greenlight communications system to include manual chocks.

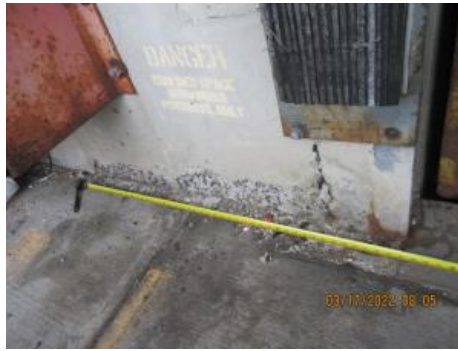
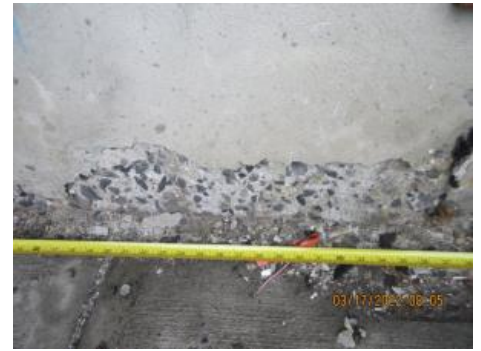
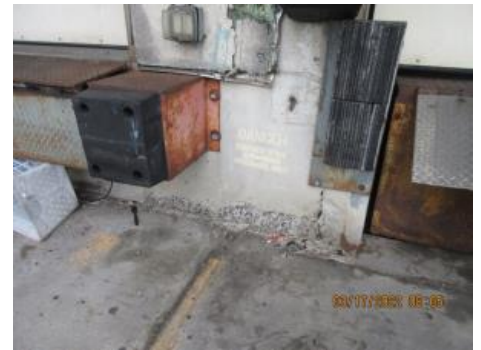
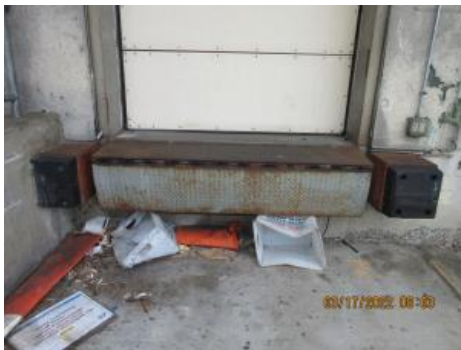
Subsystem Code:	E1030310	Surveyor / Update:	Brendan Baranek-Olmstead	03/30/2022
Subsystem Description:	Loading Dock Equipment, EACH	Qty:	1.00	
Material:				
Distress:	Inadequate	Deficiency Id:	316675	
Priority:	1 - Currently Critical (Immediate)	Location:	DOOR 17	
Category:	Repair - Alteration			
Correction:	Install Kelley Dock Communication System			
Notes:	The foundation wall to the face of the rubber bumper is 18", SOG to the bottom of the dock leveler 11", over all dock height 30". The dock face below the leveler is inadequate. The dock does not except tractor trailers and is for smaller vehicles only. Install a Red/Greenlight communications system to include manual chocks.

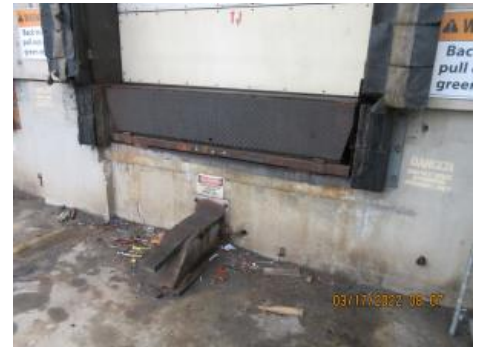
Subsystem Code:	E1030310	Surveyor / Update:	Brendan Baranek-Olmstead	03/30/2022
Subsystem Description:	Loading Dock Equipment, EACH	Qty:	1.00	
Material:				
Distress:	Beyond Service Life	Deficiency Id:	316676	
Priority:	1 - Currently Critical (Immediate)	Location:	DOOR 18	
Category:	Repair - Alteration			
Correction:	Install Star 4 Truck Restraint			
Notes:	The foundation wall to the face of the rubber bumper is 3.75", SOG to the bottom of the dock leveler 33", over all dock height 49". The dock face below the leveler is adequate. Horizontal mounting plate may be needed. There is an existing non-operational hydraulic truck restraint system, and a separate Red/Green light system on the exterior wall with a comm. box mounted to the interior side. Install a new truck restraint system. Remove the existing Red/Green light and signage mounted to exterior wall, and comm. box mounted interior side as well as the removal of the existing truck restraint system.

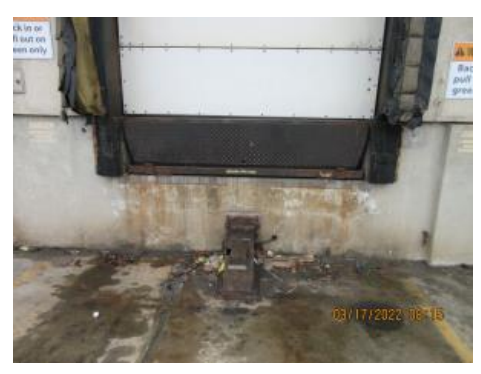
33" SOG to bottom of leveler lip

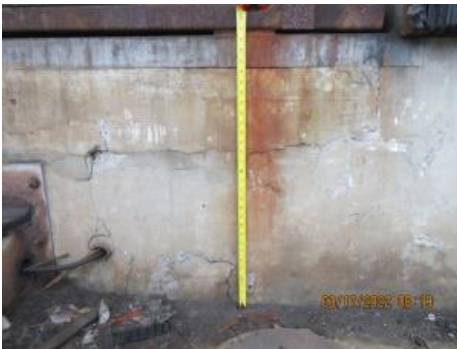
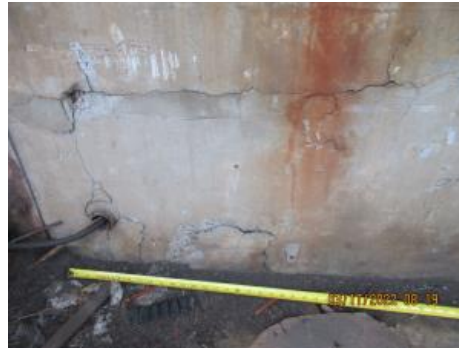
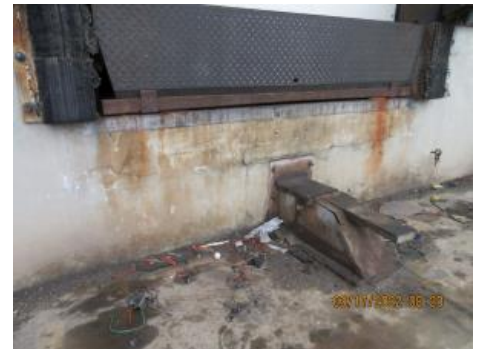
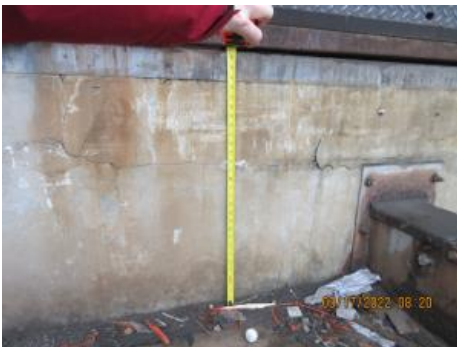
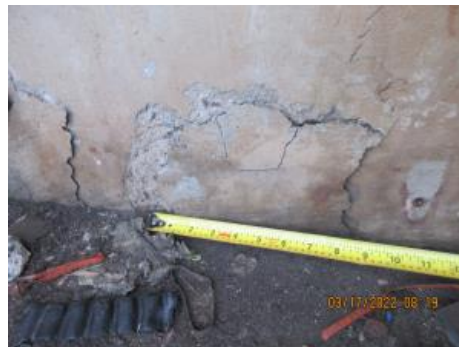
Subsystem Code:	B2010101	Surveyor / Update:	Brendan Baranek-Olmstead	04/04/2022
Subsystem Description:	Cast In Place Concrete	Qty:	12.00	
Material:				
Distress:	Damaged	Deficiency Id:	317318	
Priority:	1 - Currently Critical (Immediate)	Location:	DOOR 20	
Category:	Repair - Alteration			
Correction:	Repair Spalled Concrete			
Notes:	Foundation wall beneath dock leveler is spalling.

- The contractor shall provide all labor and materials necessary to perform concrete repairs at docks 18, 19, 20, 21, 22, 25 and 30. Refer to eCOMET® Enhanced Deficiency Sheet Report for additional information regarding the scope of work items.

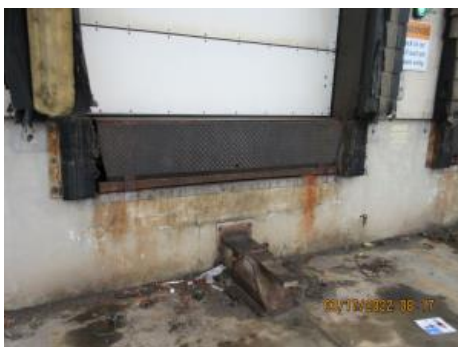
Subsystem Code:	E1030310	Surveyor / Update:	Brendan Baranek-Olmstead	04/04/2022
Subsystem Description:	Loading Dock Equipment, EACH	Qty:	1.00	
Material:				
Distress:	Beyond Service Life	Deficiency Id:	317315	
Priority:	1 - Currently Critical (Immediate)	Location:	DOOR 20	
Category:	Repair - Alteration			
Correction:	Install Star 4 Truck Restraint			
Notes:	The foundation wall to the face of the rubber bumper is 3.75", SOG to the bottom of the dock leveler 33", over all dock height 49". The dock face below the leveler is adequate. Horizontal mounting plate may be needed. There is an existing non-operational hydraulic truck restraint system, and a separate Red/Green light system to exterior wall with a comm. box mounted interior side. Install a new truck restraint system. Remove the existing Red/Green light and signage mounted to exterior wall, and comm. box mounted interior side, as well as the removal of the existing truck restraint system.

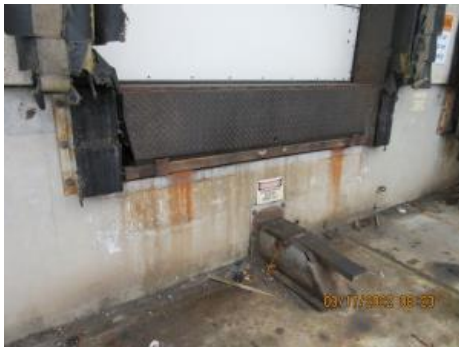
Subsystem Code:	B2010101	Surveyor / Update:	Brendan Baranek-Olmstead	04/04/2022
Subsystem Description:	Cast In Place Concrete	Qty:	12.00	
Material:				
Distress:	Damaged	Deficiency Id:	317322	
Priority:	2 - Potentially Critical (Year 1)	Location:	DOOR 21	
Category:	Repair - Alteration			
Correction:	Repair Spalled Concrete			
Notes:	Foundation wall beneath dock leveler is spalling.

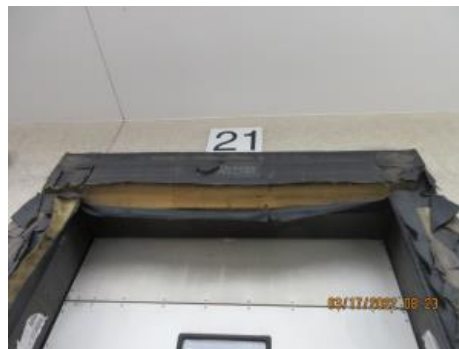
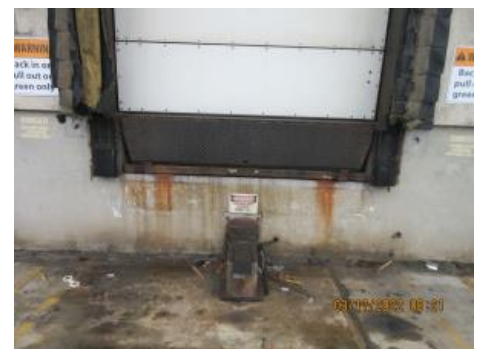
Subsystem Code:	E1030310	Surveyor / Update:	Brendan Baranek-Olmstead	04/04/2022
Subsystem Description:	Loading Dock Equipment, EACH	Qty:	1.00	
Material:				
Distress:	Beyond Service Life	Deficiency Id:	317320	
Priority:	1 - Currently Critical (Immediate)	Location:	DOOR 21	
Category:	Repair - Alteration			
Correction:	Install Star 4 Truck Restraint			
Notes:	The foundation wall to the face of the rubber bumper is 3.75", SOG to the bottom of the dock leveler 33.5", over all dock height 49". The dock face below the leveler is adequate. There is an existing non-operational hydraulic truck restraint system, and a separate Red/Green light system to exterior wall with a comm. box mounted interior side. Install a new truck restraint system. Remove the existing Red/Green light and signage mounted to exterior wall, and comm. box mounted interior side, as well as the removal of the existing truck restraint system.

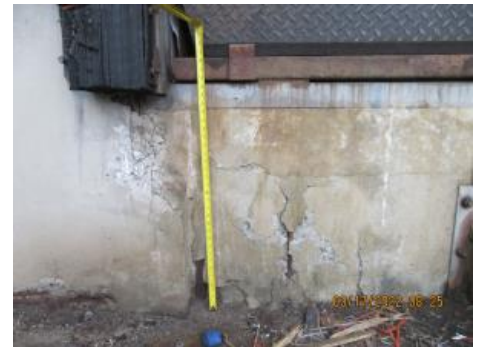
Subsystem Code:	B2010101	Surveyor / Update:	Brendan Baranek-Olmstead	04/04/2022
Subsystem Description:	Cast In Place Concrete	Qty:	12.00	
Material:				
Distress:	Damaged	Deficiency Id:	317327	
Priority:	1 - Currently Critical (Immediate)	Location:	DOOR 22	
Category:	Repair - Alteration			
Correction:	Repair Spalled Concrete			
Notes:	Foundation wall beneath dock leveler is spalling. Exposed rebar.

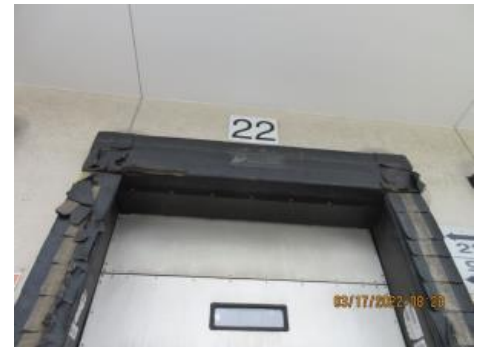
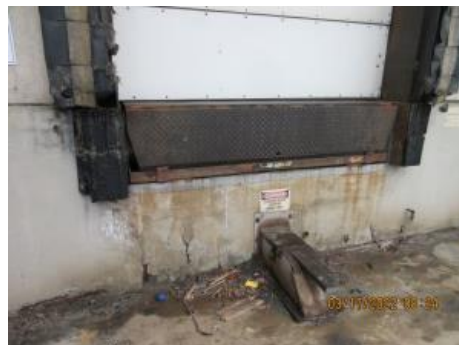
Subsystem Code:	E1030310	Surveyor / Update:	Brendan Baranek-Olmstead	04/04/2022
Subsystem Description:	Loading Dock Equipment, EACH	Qty:	1.00	
Material:				
Distress:	Beyond Service Life	Deficiency Id:	317325	
Priority:	1 - Currently Critical (Immediate)	Location:	DOOR 22	
Category:	Repair - Alteration			
Correction:	Install Star 4 Truck Restraint			
Notes:	The foundation wall to the face of the rubber bumper is 6", SOG to the bottom of the dock leveler 33", over all dock height 49". The dock face below the leveler is adequate. Horizontal mounting plate may be needed. There is an existing non-operational hydraulic truck restraint system, and a separate Red/Green light system to exterior wall with a comm. box mounted interior side. Install a new truck restraint system. Remove the existing Red/Green light and signage mounted to exterior wall, and comm. box mounted interior side, as well as the removal of the existing truck restraint system.

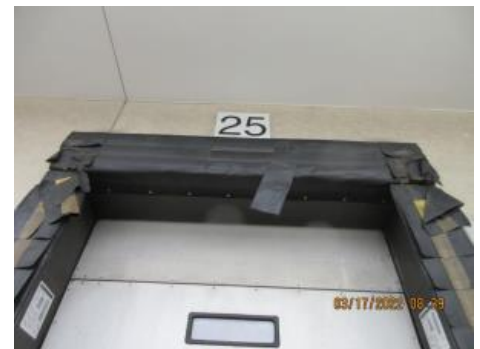
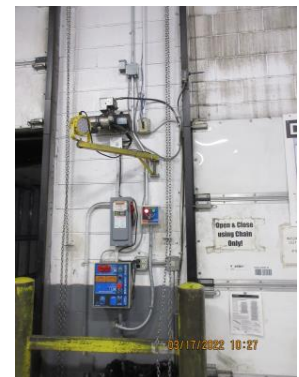
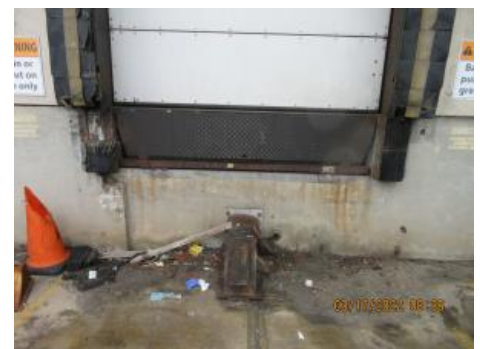
Subsystem Code:	E1030310	Surveyor / Update:	Brendan Baranek-Olmstead	04/04/2022
Subsystem Description:	Loading Dock Equipment, EACH	Qty:	1.00	
Material:				
Distress:	Beyond Service Life	Deficiency Id:	317336	
Priority:	1 - Currently Critical (Immediate)	Location:	DOOR 25	
Category:	Repair - Alteration			
Correction:	Install Star 4 Truck Restraint			
Notes:	The foundation wall to the face of the rubber bumper is 3.75", SOG to the bottom of the dock leveler 33", over all dock height 49". The dock face below the leveler is adequate. There is an existing non-operational hydraulic truck restraint system, and a separate Red/Green light system to exterior wall with a comm. box mounted interior side. Install a new truck restraint system. Remove the existing Red/Green light and signage mounted to exterior wall, and comm. box mounted interior side, as well as the removal of the existing truck restraint system.

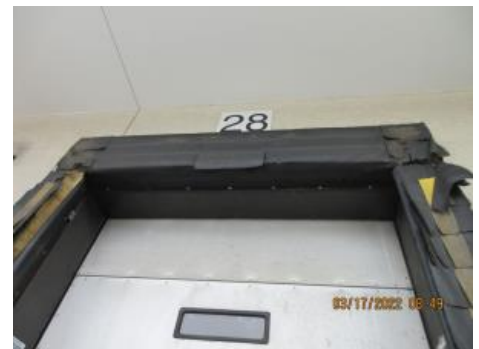
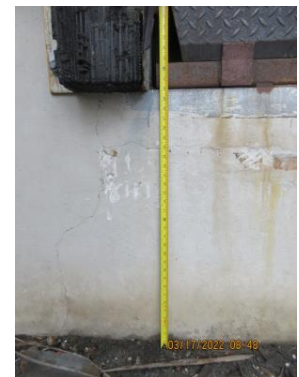
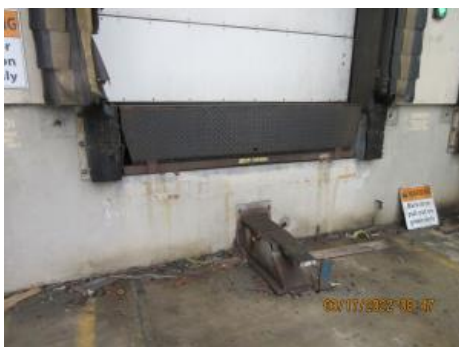
Subsystem Code:	E1030310	Surveyor / Update:	Brendan Baranek-Olmstead	04/04/2022
Subsystem Description:	Loading Dock Equipment, EACH	Qty:	1.00	
Material:				
Distress:	Beyond Service Life	Deficiency Id:	317348	
Priority:	1 - Currently Critical (Immediate)	Location:	DOOR 28	
Category:	Repair - Alteration			
Correction:	Install Star 4 Truck Restraint			
Notes:	The foundation wall to the face of the rubber bumper is 3.75", SOG to the bottom of the dock leveler 33", over all dock height 49". The dock face below the leveler is adequate. There is an existing non-operational hydraulic truck restraint system, and a separate Red/Green light system to exterior wall with a comm. box mounted interior side. Install a new truck restraint system. Remove the existing Red/Green light and signage mounted to exterior wall, and comm. box mounted interior side, as well as the removal of the existing truck restraint system.

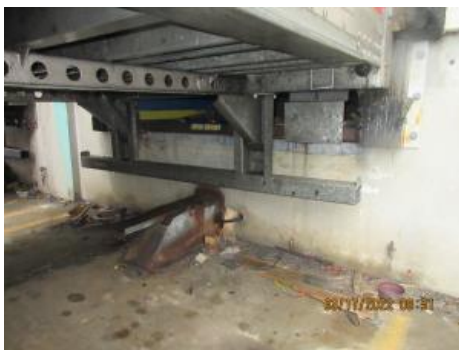
Subsystem Code:	E1030310	Surveyor / Update:	Brendan Baranek-Olmstead	04/04/2022
Subsystem Description:	Loading Dock Equipment, EACH	Qty:	1.00	
Material:				
Distress:	Beyond Service Life	Deficiency Id:	317350	
Priority:	1 - Currently Critical (Immediate)	Location:	DOOR 29	
Category:	Repair - Alteration			
Correction:	Install Star 4 Truck Restraint			
Notes:	The foundation wall to the face of the rubber bumper is 4", SOG to the bottom of the dock leveler 33", over all dock height 49". The dock face below the leveler is adequate. There is an existing non-operational hydraulic truck restraint system, and a separate Red/Green light system to exterior wall with a comm. box mounted interior side. Install a new truck restraint system. Remove the existing Red/Green light and signage mounted to exterior wall, and comm. box mounted interior side, as well as the removal of the existing truck restraint system. The dock was partially obstructed from view, the full condition of all dock components could not be verified. The assumption of partial condition is based on the condition of adjacent docks.
