Mail Processing Facilities

TRUCK RESTRAINT PROGRAM – USPS P&DC- Boston, MA
25 Dorchester Ave. Boston, MA 02205-9761

SCOPE OF WORK PACKAGE (RFP 743672-31678P) Date 08/05/2022

General Findings and Condition Report (eCOMET Enhanced Deficiency Sheet Report)

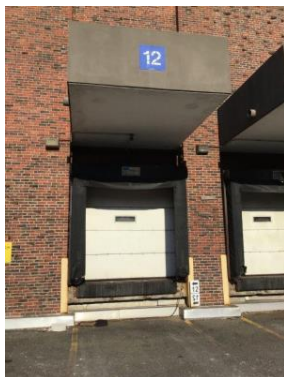
Subsystem Code:	E1030310	Surveyor / Update:	Todd Murphy	07/25/2022
Subsystem Description:	Loading Dock Equipment, EACH	Qty:	1.00	
Material:				
Distress:	Missing	Deficiency Id:	321682	
Priority:	1 - Currently Critical (Immediate)	Location:	DOOR 12	
Category:	Repair - Alteration			
Correction:	Install Kelley Dock Communication System			
Notes:	The dock will not except a full restraint. Install a Kelley Communication package to include manual chocks, brackets and chains.

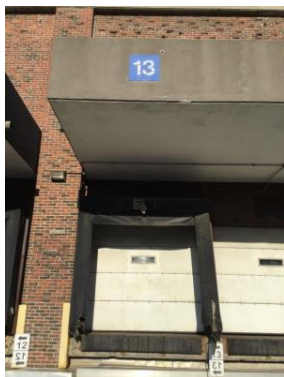
USPS TRSP\Atlantic\Massachusetts\Boston P-DC - 240801-GO6\DOOR 13

Subsystem Code:	E1030310	Surveyor / Update:	Stephen Butler	11/29/2021
Subsystem Description:	Loading Dock Equipment, EACH	Qty:	1.00	
Material:				
Distress:	Missing	Deficiency Id:	311072	
Priority:	1 - Currently Critical (Immediate)	Location:	DOOR 13 EXT	
Category:	Repair - Alteration			
Correction:	Install Kelley Dock Communication System			
Notes:	This dock is for small and medium delivery vehicles. It has no dock leveler or room for a truck restraint system.

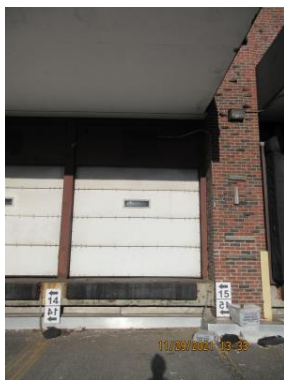
USPS TRSP\Atlantic\Massachusetts\Boston P-DC - 240801-GO6\DOOR 14

Subsystem Code:	E1030310	Surveyor / Update:	Stephen Butler	11/29/2021
Subsystem Description:	Loading Dock Equipment, EACH	Qty:	1.00	
Material:				
Distress:	Missing	Deficiency Id:	311073	
Priority:	1 - Currently Critical (Immediate)	Location:	DOOR 14 EXT	
Category:	Repair - Alteration			
Correction:	Install Kelley Dock Communication System			
Notes:	This dock is for small and medium delivery vehicles. It has no dock leveler or room for a truck restraint system. There is inadequate space between Door 14 and Door 15 for red light/green light. A Kelley Stanchion normally used to mount the control box has been included as a proposed mount for the exterior red light/green light.

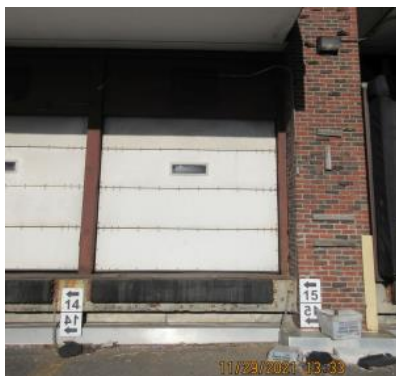
USPS TRSP\Atlantic\Massachusetts\Boston P-DC - 240801-GO6\DOOR 15

Subsystem Code:	E1030310	Surveyor / Update:	Brendan Baranek-Olmstead	11/29/2021
Subsystem Description:	Loading Dock Equipment, EACH	Qty:	1.00	
Material:				
Distress:	Missing	Deficiency Id:	311067	
Priority:	1 - Currently Critical (Immediate)	Location:	DOOR 15 EXT	
Category:	Repair - Alteration			
Correction:	Install Kelley Dock Communication System			
Notes:	This dock is for small and medium delivery vehicles. It has no dock leveler or room for a truck restraint system.

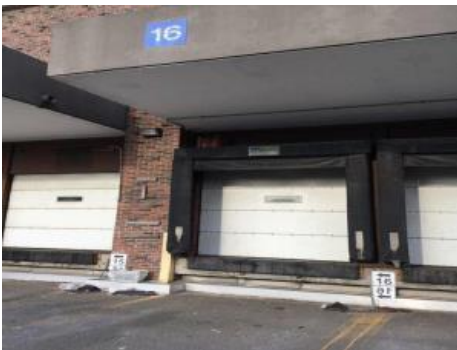
USPS TRSP\Atlantic\Massachusetts\Boston P-DC - 240801-GO6\DOOR 16

Subsystem Code:	E1030310	Surveyor / Update:	Dustin Hollenbeck	12/14/2021
Subsystem Description:	Loading Dock Equipment, EACH	Qty:	1.00	
Material:				
Distress:	Missing	Deficiency Id:	312712	
Priority:	1 - Currently Critical (Immediate)	Location:	DOOR 16 EXT	
Category:	Repair - Alteration			
Correction:	Install Kelley Dock Communication System			
Notes:	This dock is for small and medium delivery vehicles. It has no dock leveler or room a for truck restraint system.

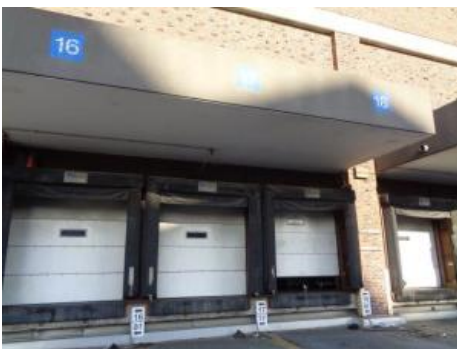
USPS TRSP\Atlantic\Massachusetts\Boston P-DC - 240801-GO6\DOOR 17

Subsystem Code:	E1030310	Surveyor / Update:	Dustin Hollenbeck	12/14/2021
Subsystem Description:	Loading Dock Equipment, EACH	Qty:	1.00	
Material:				
Distress:	Missing	Deficiency Id:	312714	
Priority:	1 - Currently Critical (Immediate)	Location:	DOOR 17 EXT	
Category:	Repair - Alteration			
Correction:	Install Kelley Dock Communication System			
Notes:	This dock is for small and medium delivery vehicles. It has no dock leveler or room a for truck restraint system.

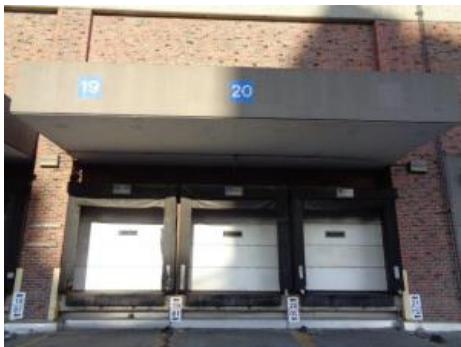
Subsystem Code:	E1030310	Surveyor / Update:	Dustin Hollenbeck	12/14/2021
Subsystem Description:	Loading Dock Equipment, EACH	Qty:	1.00	
Material:				
Distress:	Missing	Deficiency Id:	312716	
Priority:	1 - Currently Critical (Immediate)	Location:	DOOR 19 EXT	
Category:	Repair - Alteration			
Correction:	Install Kelley Dock Communication System			
Notes:	This dock is for small and medium delivery vehicles. It has no dock leveler or room for a truck restraint system.

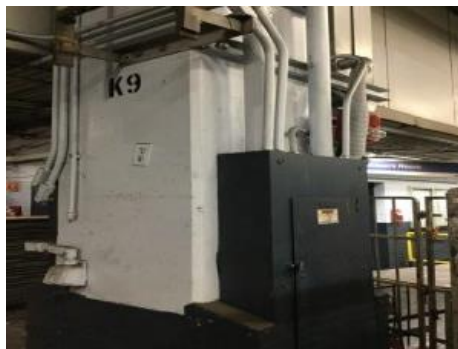
Subsystem Code:	D5010250	Surveyor / Update:	Stephen Butler	12/21/2021
Subsystem Description:	Panelboard	Qty:	1.00	
Material:				
Distress:	Inadequate	Deficiency Id:	313214	
Priority:	1 - Currently Critical (Immediate)	Location:	COL L11 (DOORS 22-45)	
Category:	Repair - Alteration			
Correction:	Provide New 30-kVA Step-down Transformer w/new 3P Circuit Breaker			
Notes:	For doors 22 - 45, the existing power panels in the area of these doors are Federal Pacific brand, are obsolete and not usable. Provide a new 30-kva, 480-208Y/120VAC step-down transformer to feed a new 3-phase, 208Y120VAC power panel at column L11 to support the TRS loads. Maximum distance from the panel to farthest door is 250'. In substation 12 on the second floor, add a new 100A, 3-pole, circuit breaker in one of the spaces. Circuit breaker to match existing type and kaic rating. Maximum feeder distance from substation 12 is 100'.

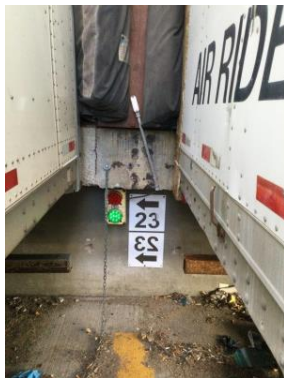
Subsystem Code:	E1030310	Surveyor / Update:	James Smith	11/30/2021
Subsystem Description:	Loading Dock Equipment, EACH	Qty:	1.00	
Material:				
Distress:	Missing	Deficiency Id:	311208	
Priority:	1 - Currently Critical (Immediate)	Location:	DOOR 23 EXT	
Category:	Repair - Alteration			
Correction:	Install Star 4 Truck Restraint W/ Cantilever Mounting Bracket			
Notes:	Foundation wall to face of rubber bumper 15 inch, SOG to bottom of dock leveler: 38.5 inches, Dock height: 55.5 inches. The dock face below the leveler is adequate. The dock was partially obstructed from view, the full condition of all dock components could not be verified. Assumption of partial condition is based on the condition of adjacent docks.

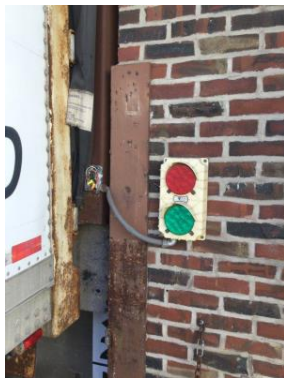
USPS TRSP\Atlantic\Massachusetts\Boston P-DC - 240801-GO6\DOOR 24

Subsystem Code:	E1030310	Surveyor / Update:	James Smith	11/30/2021
Subsystem Description:	Loading Dock Equipment, EACH	Qty:	1.00	
Material:				
Distress:	Missing	Deficiency Id:	311209	
Priority:	1 - Currently Critical (Immediate)	Location:	DOOR 24 EXT	
Category:	Repair - Alteration			
Correction:	Install Star 4 Truck Restraint W/ Cantilever Mounting Bracket			
Notes:	Foundation wall to face of rubber bumper: 15 inch, SOG to bottom of dock leveler: 37 inches, Dock height: 54 inches. The dock face below the leveler is adequate. The dock was partially obstructed from view, the full condition of all dock components could not be verified. Assumption of partial condition is based on the condition of adjacent docks.

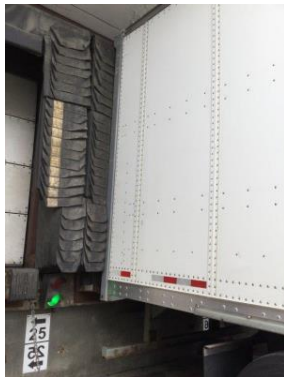
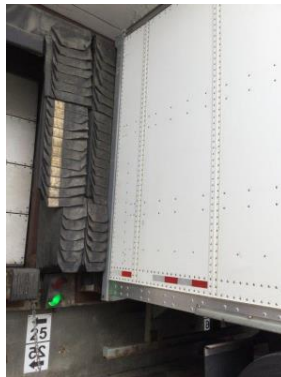
USPS TRSP\Atlantic\Massachusetts\Boston P-DC - 240801-GO6\DOOR 25

Subsystem Code:	E1030310	Surveyor / Update:	James Smith	11/30/2021
Subsystem Description:	Loading Dock Equipment, EACH	Qty:	1.00	
Material:				
Distress:	Missing	Deficiency Id:	311212	
Priority:	1 - Currently Critical (Immediate)	Location:	DOOR 25 EXT	
Category:	Repair - Alteration			
Correction:	Install Star 4 Truck Restraint W/ Cantilever Mounting Bracket			
Notes:	Foundation wall to face of rubber bumper: 29 inch, SOG to bottom of dock leveler: 36.5 inches, Dock height: 52.5 inches. There is an existing red light/green light system. Remove the existing red light/green light and all of its components prior to installing the new system.

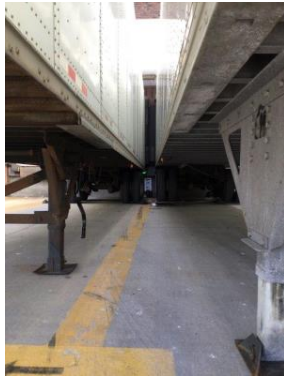
USPS TRSP\Atlantic\Massachusetts\Boston P-DC - 240801-GO6\DOOR 26

Subsystem Code:	E1030310	Surveyor / Update:	James Smith	11/30/2021
Subsystem Description:	Loading Dock Equipment, EACH	Qty:	1.00	
Material:				
Distress:	Missing	Deficiency Id:	311214	
Priority:	1 - Currently Critical (Immediate)	Location:	DOOR 26 EXT	
Category:	Repair - Alteration			
Correction:	Install Star 4 Truck Restraint W/ Cantilever Mounting Bracket			
Notes:	Foundation wall to face of rubber bumper: 31 inch, SOG to bottom of dock leveler: 36.5 inches, Dock height: 55 inches. The dock face below the leveler is adequate. There is an existing red light/green light system. Remove the existing red light/green light and all of its components prior to installing the new system. The dock was partially obstructed from view, the full condition of all dock components could not be verified. Assumption of partial condition is based on the condition of adjacent docks.

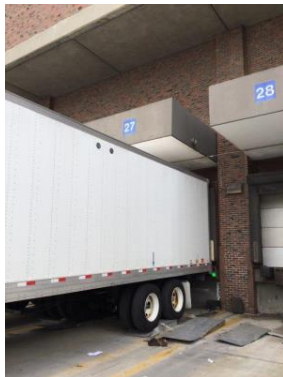
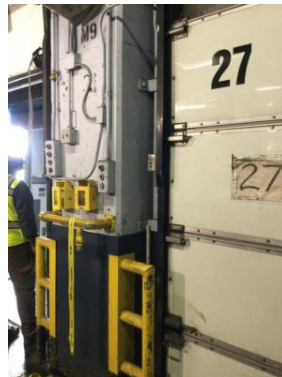
USPS TRSP\Atlantic\Massachusetts\Boston P-DC - 240801-GO6\DOOR 27

Subsystem Code:	E1030310	Surveyor / Update:	James Smith	11/30/2021
Subsystem Description:	Loading Dock Equipment, EACH	Qty:	1.00	
Material:				
Distress:	Missing	Deficiency Id:	311215	
Priority:	1 - Currently Critical (Immediate)	Location:	DOOR 27 EXT	
Category:	Repair - Alteration			
Correction:	Install Star 4 Truck Restraint W/ Cantilever Mounting Bracket			
Notes:	Foundation wall to face of rubber bumper: 29 inch, SOG to bottom of dock leveler: 37 inches, Dock height: 55 inches. The dock face below the leveler is adequate. There is an existing red light/green light system. Remove the existing red light/green light and all of its components prior to installing the new system. A Yellow key box is mounted on the concrete column, this location and mounting bracket should be considered the future mounting location for the Star 4 control box. The dock was partially obstructed from view, the full condition of all dock components could not be verified. Assumption of partial condition is based on the condition of adjacent docks.

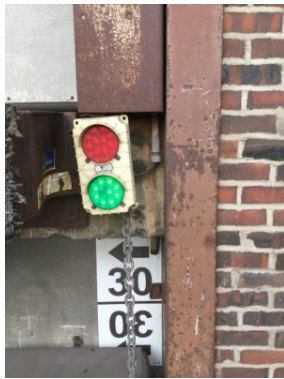
Subsystem Code:	E1030310	Surveyor / Update:	James Smith	11/30/2021
Subsystem Description:	Loading Dock Equipment, EACH	Qty:	1.00	
Material:				
Distress:	Missing	Deficiency Id:	311221	
Priority:	1 - Currently Critical (Immediate)	Location:	DOOR 30 EXT	
Category:	Repair - Alteration			
Correction:	Install Star 4 Truck Restraint W/ Cantilever Mounting Bracket			
Notes:	Foundation wall to face of rubber bumper: 28 inch, SOG to bottom of dock leveler: 36.5 inches, Dock height: 53.5 inches. The dock face below the leveler is adequate. There is an existing red light/green light system. Remove the existing red light/green light and all of its components prior to installing the new system. A Yellow key box is mounted on the concrete column, this location and mounting bracket should be considered the future mounting location for the Star 4 control box. The dock was partially obstructed from view, the full condition of all dock components could not be verified. Assumption of partial condition is based on the condition of adjacent docks.

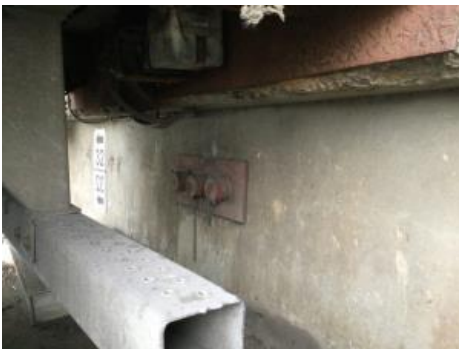
Subsystem Code:	E1030310	Surveyor / Update:	James Smith	11/30/2021
Subsystem Description:	Loading Dock Equipment, EACH	Qty:	1.00	
Material:				
Distress:	Missing	Deficiency Id:	311227	
Priority:	1 - Currently Critical (Immediate)	Location:	DOOR 33 EXT	
Category:	Repair - Alteration			
Correction:	Install Kelley Dock Communication System			
Notes:	Foundation wall to face of rubber bumper: 27 inch, SOG to bottom of dock leveler: 36 inches, Dock height: 53 inches. There is an existing red light/green light system. Remove the existing red light/green light and all of its components prior to installing the new system. Fire suppression connections centered below the dock leveler. The communications system will be priced for this dock. A Yellow key box is mounted on the concrete column, this location and mounting bracket should be considered the future mounting location for the control box. The dock was partially obstructed from view, the full condition of all dock components could not be verified. Assumption of partial condition is based on the condition of adjacent docks.

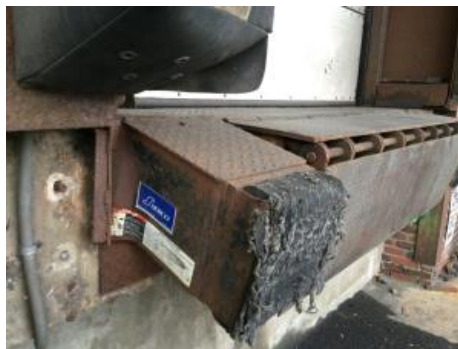
Subsystem Code:	E1030310	Surveyor / Update:	James Smith	11/30/2021
Subsystem Description:	Loading Dock Equipment, EACH	Qty:	1.00	
Material:				
Distress:	Damaged	Deficiency Id:	311233	
Priority:	3 - Necessary/Not Yet Critical (Years 2-5)	Location:	DOOR 36 EXT	
Category:	Repair - Alteration			
Correction:	Provide and Replace Rubber Dock Bumper			
Notes:	Both dock bumpers are crushed and need replaced.

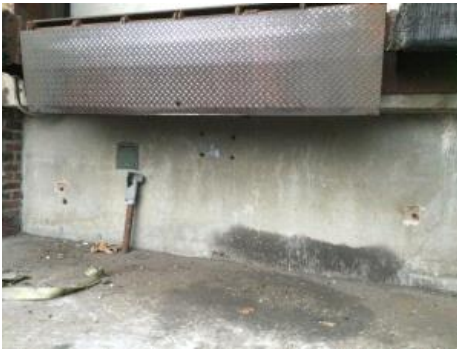
Subsystem Code:	E1030310	Surveyor / Update:	James Smith	12/06/2021
Subsystem Description:	Loading Dock Equipment, EACH	Qty:	1.00	
Material:				
Distress:	Missing	Deficiency Id:	311576	
Priority:	1 - Currently Critical (Immediate)	Location:	DOOR 40 EXT	
Category:	Repair - Alteration			
Correction:	Install Star 4 Truck Restraint W/ Cantilever Mounting Bracket			
Notes:	Foundation wall to face of rubber bumper 26", SOG to bottom of the dock leveler 35.5", overall dock height 53". The dock face below the leveler is adequate. There is an existing red light/green light system. Remove the existing red light/green light and all of its components prior to installing the new system. Conduit is stubbed up and a box is present at the dock face. Truck restraint will need to be offset to accommodate current conditions. A Yellow key box is mounted on the concrete column, this location and mounting bracket should be considered the future mounting location for the Star 4 control box.

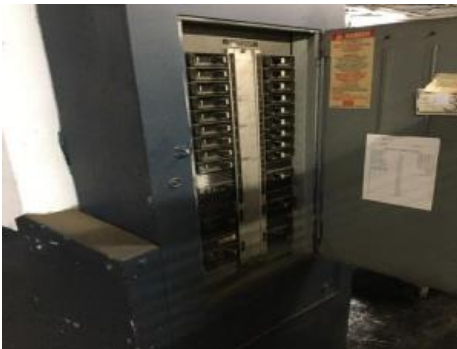
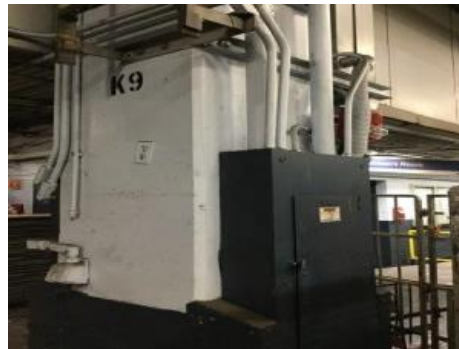
Subsystem Code:	D5010250	Surveyor / Update:	Stephen Butler	12/21/2021
Subsystem Description:	Panelboard	Qty:	1.00	
Material:				
Distress:	Inadequate	Deficiency Id:	313213	
Priority:	1 - Currently Critical (Immediate)	Location:	COL L22 (DOORS 46-67)	
Category:	Repair - Alteration			
Correction:	Provide New 30-kVA Step-down Transformer w/new 3P Circuit Breaker			
Notes:	For doors 46 - 67, the existing power panels in the area of these doors are Federal Pacific brand, are obsolete and not usable. Provide a new 30-kva, 480-208Y/120VAC step-down transformer to feed a new 3-phase, 208Y120VAC power panel at column L22 to support the TRS loads. Maximum distance from the panel to farthest door is 250'. In substation 22 on the second floor, add a new 50A, 3-pole, circuit breaker in one of the spaces. Circuit breaker to match existing type and kaic rating. Maximum feeder distance from substation 22 is 100'.

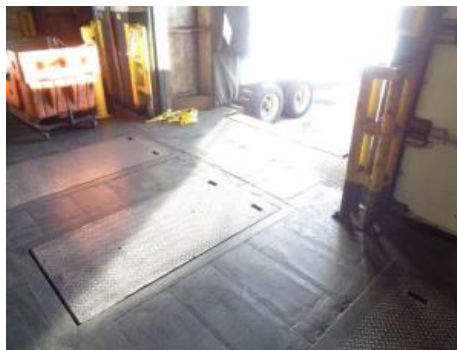
Subsystem Code:	E1030310	Surveyor / Update:	Dustin Hollenbeck	12/14/2021
Subsystem Description:	Loading Dock Equipment, EACH	Qty:	1.00	
Material:				
Distress:	Missing	Deficiency Id:	312543	
Priority:	1 - Currently Critical (Immediate)	Location:	DOOR 47 EXT	
Category:	Repair - Alteration			
Correction:	Install Star 4 Truck Restraint W/ Cantilever Mounting Bracket			
Notes:	Foundation wall to face of rubber bumper 28", over dock height 49". The dock face below the leveler is adequate. There is an existing red light/green light system. Remove the existing red light/green light and all of its components prior to installing the new system.

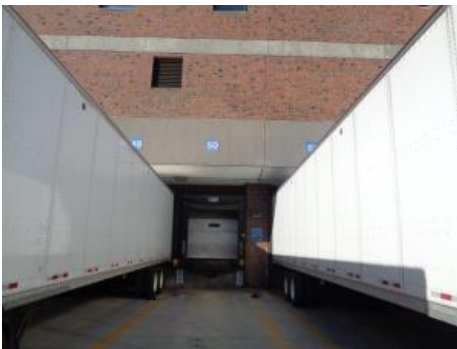
Subsystem Code:	E1030310	Surveyor / Update:	Todd Murphy	12/16/2021
Subsystem Description:	Loading Dock Equipment, EACH	Qty:	1.00	
Material:				
Distress:	Missing	Deficiency Id:	313069	
Priority:	1 - Currently Critical (Immediate)	Location:	DOOR 50 EXT	
Category:	Repair - Alteration			
Correction:	Install Star 4 Truck Restraint W/ Cantilever Mounting Bracket			
Notes:	Foundation wall to face of rubber bumper 28", over dock height 49".The dock face below the leveler is adequate. There is an existing red light/green light system. Remove the existing red light/green light and all of its components prior to installing the new system.

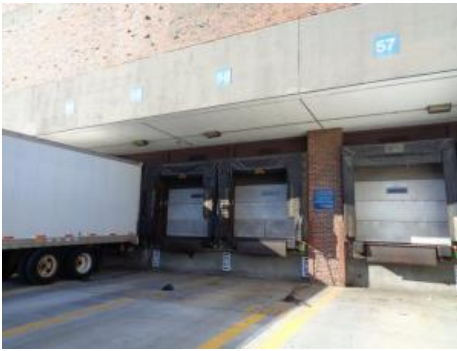
Subsystem Code:	E1030310	Surveyor / Update:	Dustin Hollenbeck	12/14/2021
Subsystem Description:	Loading Dock Equipment, EACH	Qty:	1.00	
Material:				
Distress:	Missing	Deficiency Id:	312567	
Priority:	1 - Currently Critical (Immediate)	Location:	DOOR 52 EXT	
Category:	Repair - Alteration			
Correction:	Install Star 4 Truck Restraint W/ Cantilever Mounting Bracket			
Notes:	Foundation wall to face of rubber bumper 28", over dock height 49". The dock face below the leveler is adequate. Proper light height will require pendent mount or alternate location. There is an existing red light/green light system. Remove the existing red light/green light and all of its components prior to installing the new system.

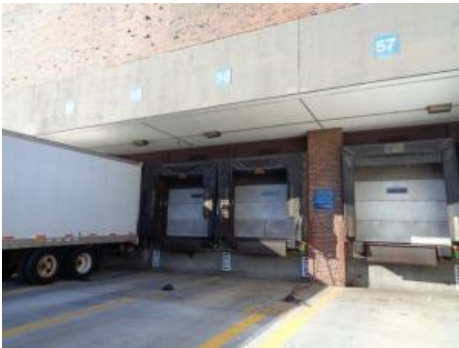
Subsystem Code:	E1030310	Surveyor / Update:	Dustin Hollenbeck	12/14/2021
Subsystem Description:	Loading Dock Equipment, EACH	Qty:	1.00	
Material:				
Distress:	Missing	Deficiency Id:	312568	
Priority:	1 - Currently Critical (Immediate)	Location:	DOOR 53 EXT	
Category:	Repair - Alteration			
Correction:	Install Star 4 Truck Restraint W/ Cantilever Mounting Bracket			
Notes:	Foundation wall to face of rubber bumper 28", over dock height 49". The dock face below the leveler is adequate. Proper light height will require pendent mount or alternate location. There is an existing red light/green light system. Remove the existing red light/green light and all of its components prior to installing the new system.

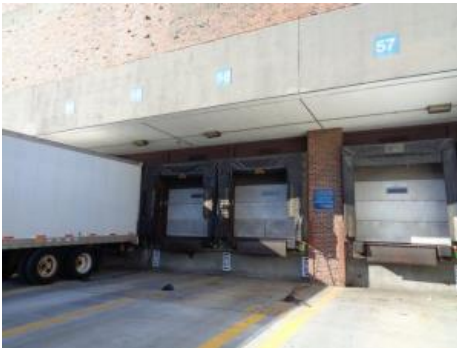
Subsystem Code:	E1030310	Surveyor / Update:	Dustin Hollenbeck	12/14/2021
Subsystem Description:	Loading Dock Equipment, EACH	Qty:	1.00	
Material:				
Distress:	Missing	Deficiency Id:	312570	
Priority:	1 - Currently Critical (Immediate)	Location:	DOOR 55 EXT	
Category:	Repair - Alteration			
Correction:	Install Star 4 Truck Restraint W/ Cantilever Mounting Bracket			
Notes:	Foundation wall to face of rubber bumper 28", over dock height 49". The dock face below the leveler is adequate. Proper light height will require pendent mount or alternate location. There is an existing red light/green light system. Remove the existing red light/green light and all of its components prior to installing the new system.

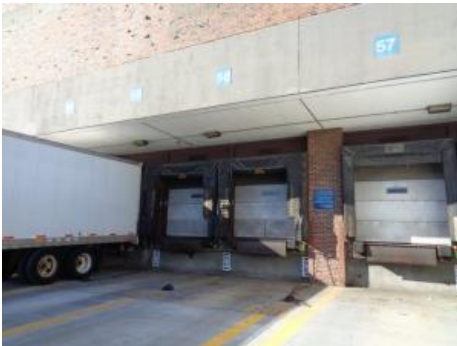
USPS TRSP\Atlantic\Massachusetts\Boston P-DC - 240801-GO6\DOOR 56

Subsystem Code:	E1030310	Surveyor / Update:	Dustin Hollenbeck	12/14/2021
Subsystem Description:	Loading Dock Equipment, EACH	Qty:	1.00	
Material:				
Distress:	Missing	Deficiency Id:	312571	
Priority:	1 - Currently Critical (Immediate)	Location:	DOOR 56 EXT	
Category:	Repair - Alteration			
Correction:	Install Star 4 Truck Restraint W/ Cantilever Mounting Bracket			
Notes:	Foundation wall to face of rubber bumper 28", over dock height 49". The dock face below the leveler is adequate. Proper light height will require pendent mount or alternate location. There is an existing red light/green light system. Remove the existing red light/green light and all of its components prior to installing the new system.

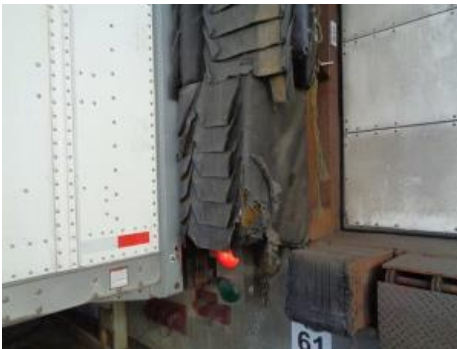
Subsystem Code:	E1030310	Surveyor / Update:	Dustin Hollenbeck	12/14/2021
Subsystem Description:	Loading Dock Equipment, EACH	Qty:	1.00	
Material:				
Distress:	Inadequate	Deficiency Id:	312575	
Priority:	1 - Currently Critical (Immediate)	Location:	DOOR 61 EXT	
Category:	Repair - Alteration			
Correction:	Install Kelley Dock Communication System			
Notes:	Foundation wall to face of rubber bumper 28", over dock height 49". The dock face below the leveler is adequate. Proper light height will require pendent mount or alternate location. There is an existing red light/green light system. Remove the existing red light/green light and all of its components prior to installing the new system. Fire department connections are directly below the loading dock. They would have to be moved to install a truck restraint system. The communications system will be priced for this dock.

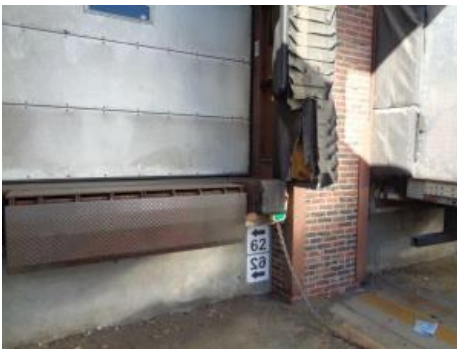
USPS TRSP\Atlantic\Massachusetts\Boston P-DC - 240801-GO6\DOOR 62

Subsystem Code:	E1030310	Surveyor / Update:	Dustin Hollenbeck	12/14/2021
Subsystem Description:	Loading Dock Equipment, EACH	Qty:	1.00	
Material:				
Distress:	Missing	Deficiency Id:	312558	
Priority:	1 - Currently Critical (Immediate)	Location:	DOOR 62 EXT	
Category:	Repair - Alteration			
Correction:	Install Star 4 Truck Restraint W/ Cantilever Mounting Bracket			
Notes:	Foundation wall to face of rubber bumper 28", over dock height 49". The dock face below the leveler is adequate. There is an existing red light/green light system. Remove the existing red light/green light and all of its components prior to installing the new system.

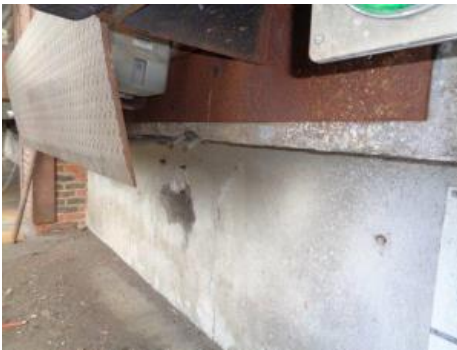
Subsystem Code:	E1030310	Surveyor / Update:	Dustin Hollenbeck	12/14/2021
Subsystem Description:	Loading Dock Equipment, EACH	Qty:	1.00	
Material:				
Distress:	Missing	Deficiency Id:	312561	
Priority:	1 - Currently Critical (Immediate)	Location:	DOOR 65 EXT	
Category:	Repair - Alteration			
Correction:	Install Star 4 Truck Restraint W/ Cantilever Mounting Bracket			
Notes:	Foundation wall to face of rubber bumper 28", over dock height 49". The dock face below the leveler is adequate. There is an existing red light/green light system. Remove the existing red light/green light and all of its components prior to installing the new system. The dock was partially obstructed from view, the full condition of all dock components could not be verified. Assumption of partial condition is based on the condition of adjacent docks.

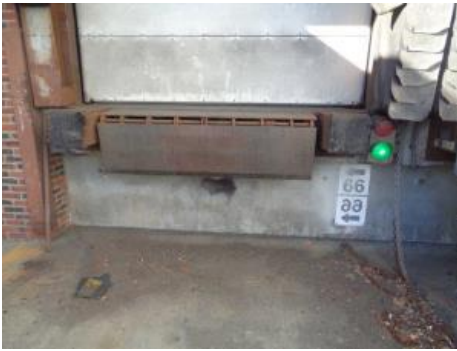
USPS TRSP\Atlantic\Massachusetts\Boston P-DC - 240801-GO6\DOOR 66

Subsystem Code:	E1030310	Surveyor / Update:	Dustin Hollenbeck	12/14/2021
Subsystem Description:	Loading Dock Equipment, EACH	Qty:	1.00	
Material:				
Distress:	Missing	Deficiency Id:	312578	
Priority:	1 - Currently Critical (Immediate)	Location:	DOOR 66 EXT	
Category:	Repair - Alteration			
Correction:	Install Star 4 Truck Restraint W/ Cantilever Mounting Bracket			
Notes:	Foundation wall to face of rubber bumper 28", over dock height 49". The dock face below the leveler is adequate. Proper light height will require pendent mount or alternate location. There is an existing red light/green light system. Remove the existing red light/green light and all of its components prior to installing the new system.

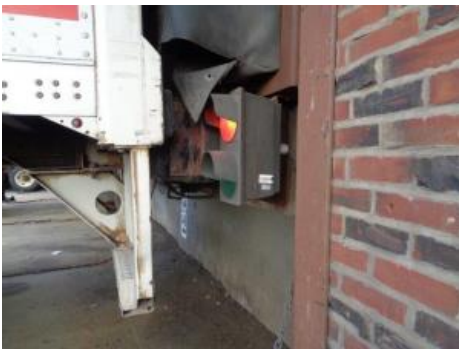
USPS TRSP\Atlantic\Massachusetts\Boston P-DC - 240801-GO6\DOOR 67

Subsystem Code:	E1030310	Surveyor / Update:	Dustin Hollenbeck	12/14/2021
Subsystem Description:	Loading Dock Equipment, EACH	Qty:	1.00	
Material:				
Distress:	Missing	Deficiency Id:	312563	
Priority:	1 - Currently Critical (Immediate)	Location:	DOOR 67 EXT	
Category:	Repair - Alteration			
Correction:	Install Star 4 Truck Restraint W/ Cantilever Mounting Bracket			
Notes:	Foundation wall to face of rubber bumper 28", over dock height 49". The dock face below the leveler is adequate. There is an existing red light/green light system. Remove the existing red light/green light and all of its components prior to installing the new system.

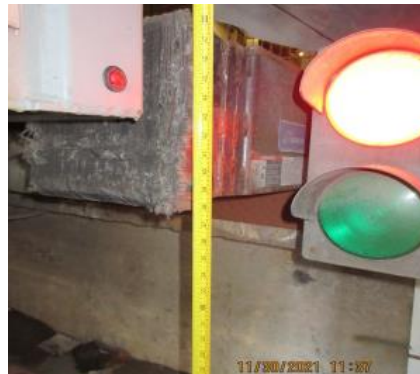
Subsystem Code:	E1030310	Surveyor / Update:	Brendan Baranek-Olmstead	12/14/2021
Subsystem Description:	Loading Dock Equipment, EACH	Qty:	1.00	
Material:				
Distress:	Missing	Deficiency Id:	312505	
Priority:	1 - Currently Critical (Immediate)	Location:	DOOR 69 EXT	
Category:	Repair - Alteration			
Correction:	Install Star 4 Truck Restraint W/ Cantilever Mounting Bracket			
Notes:	The foundation wall to face of rubber bumper is 19", SOG to bottom of the dock leveler 30.5", over dock height 49". The dock face below the leveler is adequate. There is an existing red light/green light system. Remove the existing red light/green light and all of its components prior to installing the new system. The dock was partially obstructed from view, the full condition of all dock components could not be verified. Assumption of partial condition is based on the condition of adjacent docks.

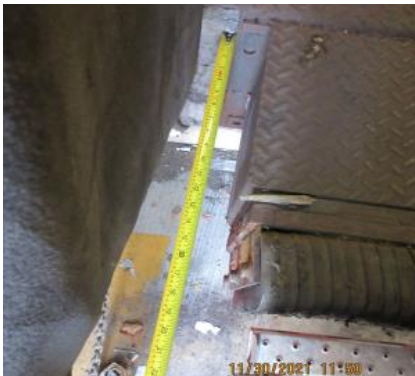
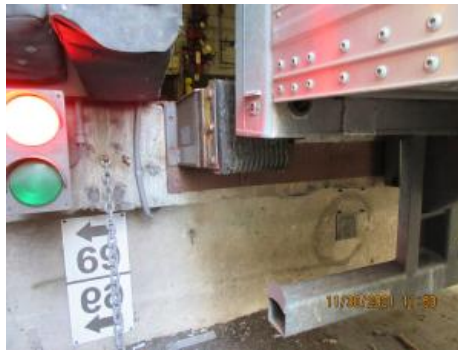
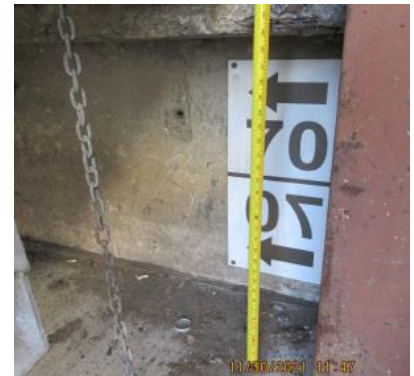
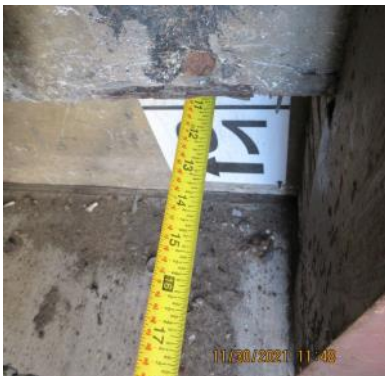
USPS TRSP\Atlantic\Massachusetts\Boston P-DC - 240801-GO6\DOOR 70

Subsystem Code:	E1030310	Surveyor / Update:	Brendan Baranek-Olmstead	12/14/2021
Subsystem Description:	Loading Dock Equipment, EACH	Qty:	1.00	
Material:				
Distress:	Missing	Deficiency Id:	312509	
Priority:	1 - Currently Critical (Immediate)	Location:	DOOR 70 EXT	
Category:	Repair - Alteration			
Correction:	Install Star 4 Truck Restraint W/ Cantilever Mounting Bracket			
Notes:	The dock was partially obstructed from view, the full condition of all dock components could not be verified. Assumption of partial condition is based on the condition of adjacent docks. Foundation wall to face of rubber bumper 18", SOG to bottom of the dock leveler 29", over dock height 46.5". The dock face below the leveler is adequate. There is an existing red light/green light system. Remove the existing red light/green light and all of its components prior to installing the new system.

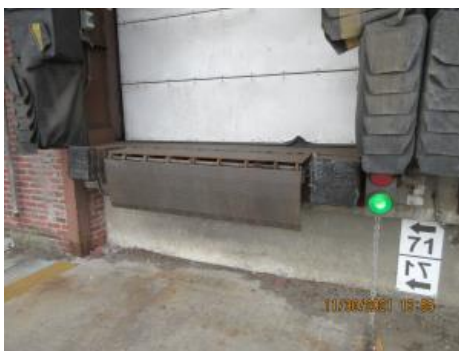
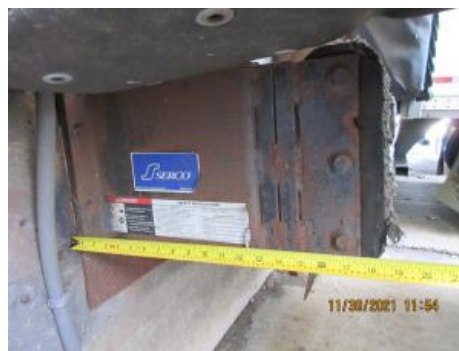
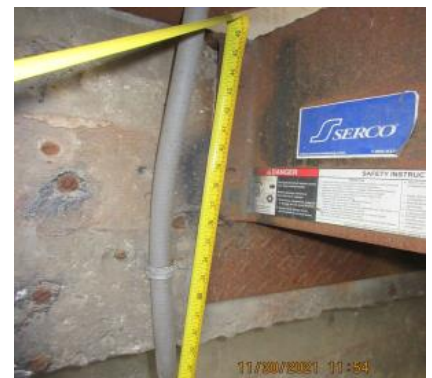
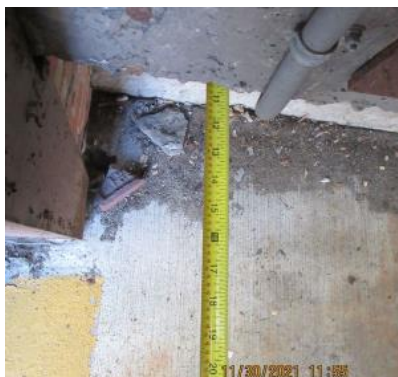
USPS TRSP\Atlantic\Massachusetts\Boston P-DC - 240801-GO6\DOOR 71

Subsystem Code:	E1030310	Surveyor / Update:	Brendan Baranek-Olmstead	11/30/2021
Subsystem Description:	Loading Dock Equipment, EACH	Qty:	1.00	
Material:				
Distress:	Missing	Deficiency Id:	311164	
Priority:	1 - Currently Critical (Immediate)	Location:	DOOR 71 EXT	
Category:	Repair - Alteration			
Correction:	Install Star 4 Truck Restraint W/ Cantilever Mounting Bracket			
Notes:	Foundation wall to face of rubber bumper 18", SOG to bottom of the dock leveler 29", over dock height 46". The dock face below the leveler is (Pick one) inadequate or adequate. There is an existing red light/green light system. Remove the existing red light/green light and all of its components prior to installing the new system.

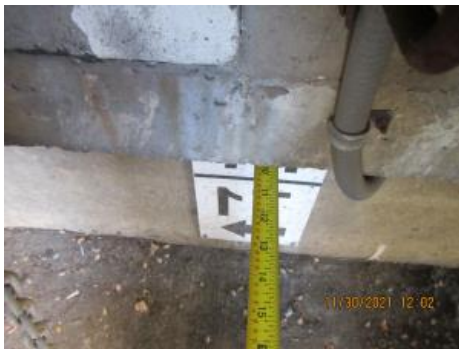
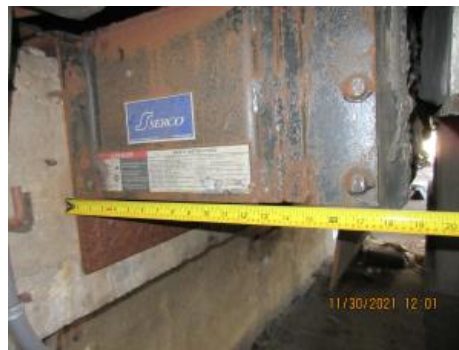
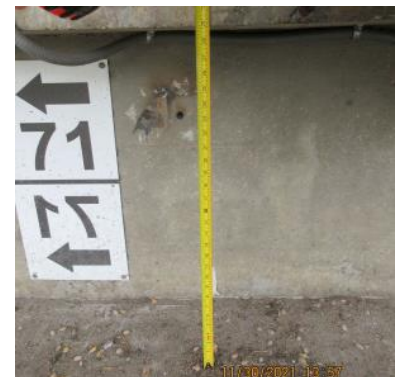
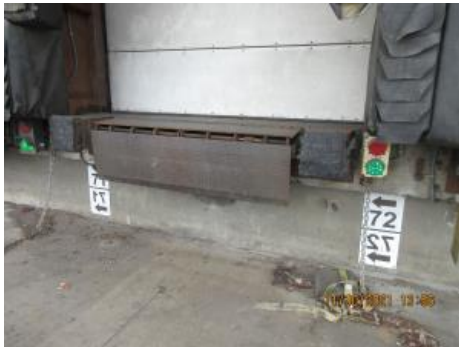
USPS TRSP\Atlantic\Massachusetts\Boston P-DC - 240801-GO6\DOOR 72

Subsystem Code:	E1030310	Surveyor / Update:	Brendan Baranek-Olmstead	11/30/2021
Subsystem Description:	Loading Dock Equipment, EACH	Qty:	1.00	
Material:				
Distress:	Missing	Deficiency Id:	311165	
Priority:	1 - Currently Critical (Immediate)	Location:	DOOR 72 EXT	
Category:	Repair - Alteration			
Correction:	Install Star 4 Truck Restraint W/ Cantilever Mounting Bracket			
Notes:	Foundation wall to face of rubber bumper 18", SOG to bottom of the dock leveler 30", over dock height 47". The dock face below the leveler is adequate. There is an existing red light/green light system. Remove the existing red light/green light and all of its components prior to installing the new system.

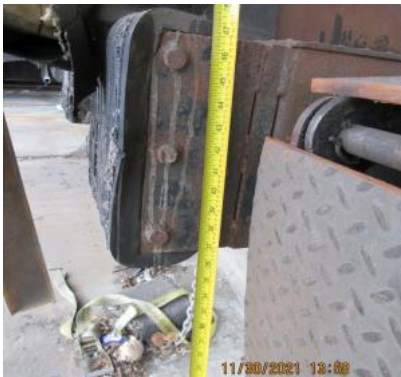
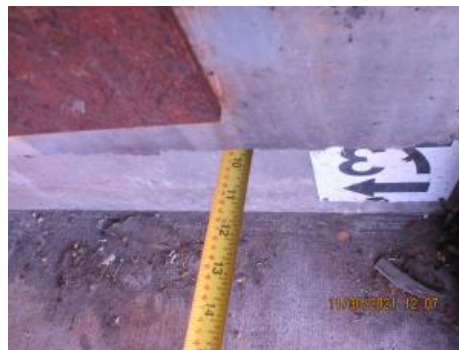
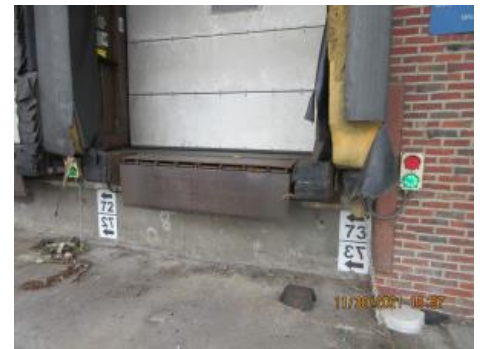
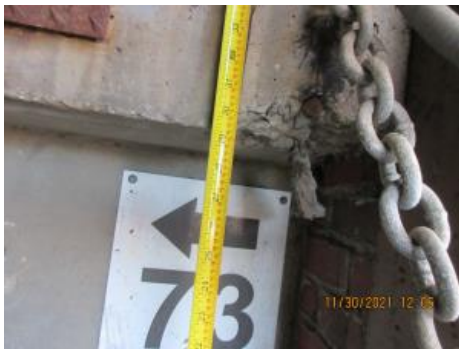
USPS TRSP\Atlantic\Massachusetts\Boston P-DC - 240801-GO6\DOOR 73

Subsystem Code:	E1030310	Surveyor / Update:	Brendan Baranek-Olmstead	11/30/2021
Subsystem Description:	Loading Dock Equipment, EACH	Qty:	1.00	
Material:				
Distress:	Missing	Deficiency Id:	311166	
Priority:	1 - Currently Critical (Immediate)	Location:	DOOR 73 EXT	
Category:	Repair - Alteration			
Correction:	Install Star 4 Truck Restraint W/ Cantilever Mounting Bracket			
Notes:	Foundation wall to face of rubber bumper 18.75", SOG to bottom of the dock leveler 29", over dock height 46". The dock face below the leveler is adequate. There is an existing red light/green light system. Remove the existing red light/green light and all of its components prior to installing the new system.

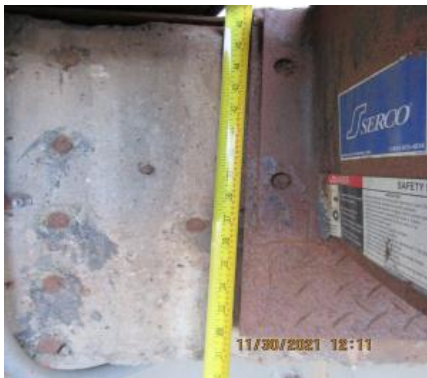
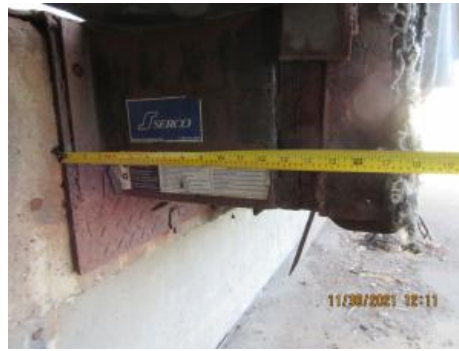
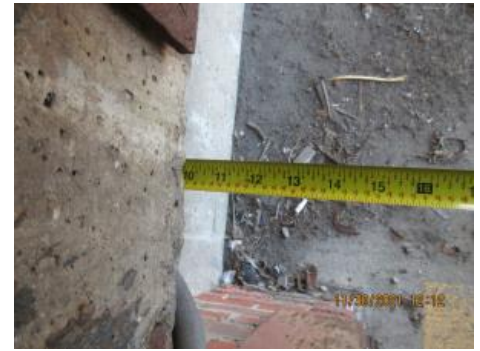
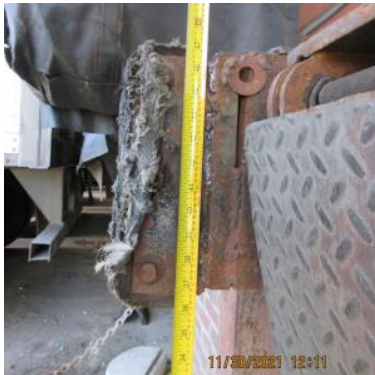
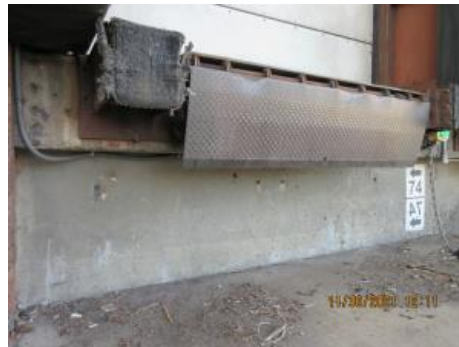
USPS TRSP\Atlantic\Massachusetts\Boston P-DC - 240801-GO6\DOOR 74

Subsystem Code:	E1030310	Surveyor / Update:	Brendan Baranek-Olmstead	11/30/2021
Subsystem Description:	Loading Dock Equipment, EACH	Qty:	1.00	
Material:				
Distress:	Missing	Deficiency Id:	311163	
Priority:	1 - Currently Critical (Immediate)	Location:	DOOR 74 EXT	
Category:	Repair - Alteration			
Correction:	Install Star 4 Truck Restraint W/ Cantilever Mounting Bracket			
Notes:	Foundation wall to face of rubber bumper 18", SOG to bottom of the dock leveler 30", over dock height 46". The dock face below the leveler is (Pick one) inadequate or adequate. There is an existing red light/green light system. Remove the existing red light/green light and all of its components prior to installing the new system.

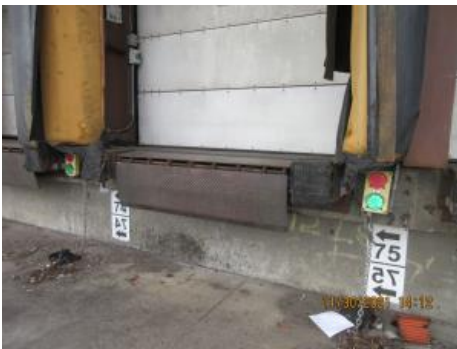
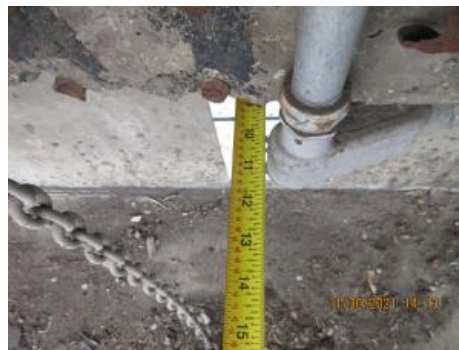
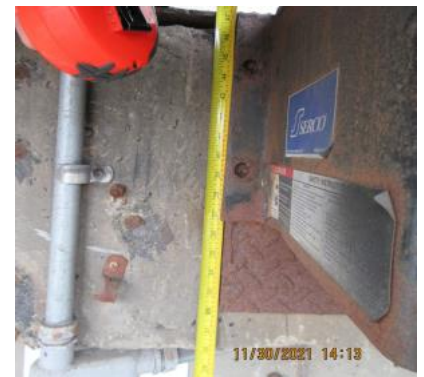
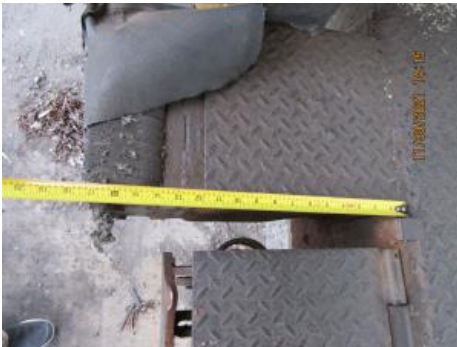
USPS TRSP\Atlantic\Massachusetts\Boston P-DC - 240801-GO6\DOOR 75

Subsystem Code:	E1030310	Surveyor / Update:	Brendan Baranek-Olmstead	11/30/2021
Subsystem Description:	Loading Dock Equipment, EACH	Qty:	1.00	
Material:				
Distress:	Missing	Deficiency Id:	311168	
Priority:	1 - Currently Critical (Immediate)	Location:	DOOR 75 EXT	
Category:	Repair - Alteration			
Correction:	Install Star 4 Truck Restraint W/ Cantilever Mounting Bracket			
Notes:	Foundation wall to face of rubber bumper 18", SOG to bottom of the dock leveler 29", over dock height 47.5". The dock face below the leveler is adequate. There is an existing red light/green light system. Remove the existing red light/green light and all of its components prior to installing the new system.

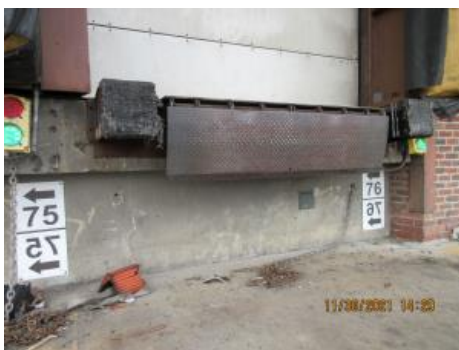
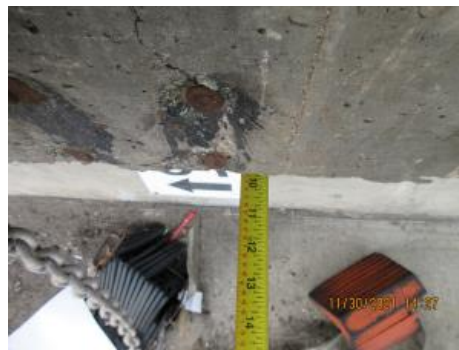
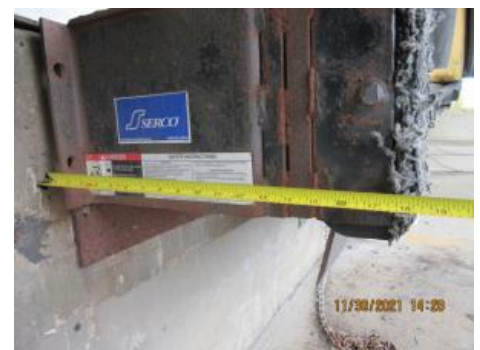
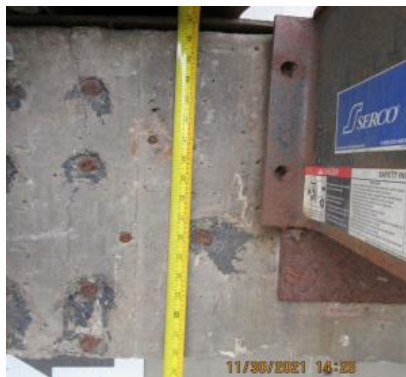
USPS TRSP\Atlantic\Massachusetts\Boston P-DC - 240801-GO6\DOOR 76

Subsystem Code:	E1030310	Surveyor / Update:	Brendan Baranek-Olmstead	11/30/2021
Subsystem Description:	Loading Dock Equipment, EACH	Qty:	1.00	
Material:				
Distress:	Missing	Deficiency Id:	311170	
Priority:	1 - Currently Critical (Immediate)	Location:	DOOR 76 EXT	
Category:	Repair - Alteration			
Correction:	Install Star 4 Truck Restraint W/ Cantilever Mounting Bracket			
Notes:	Foundation wall to face of rubber bumper 18", SOG to bottom of the dock leveler 29.75", over dock height 47". The dock face below the leveler is adequate. There is an existing red light/green light system. Remove the existing red light/green light and all of its components prior to installing the new system.

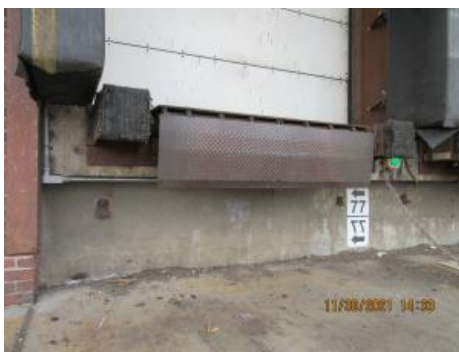
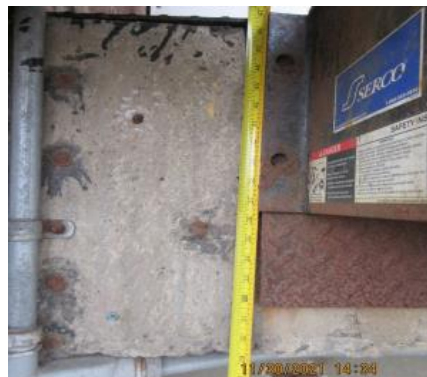
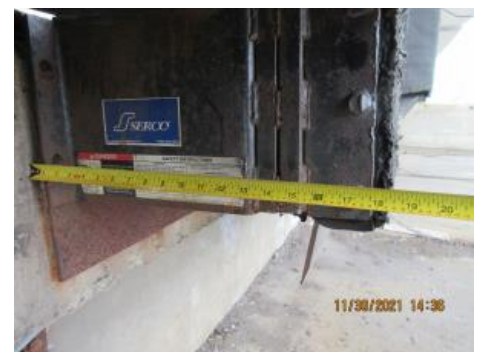
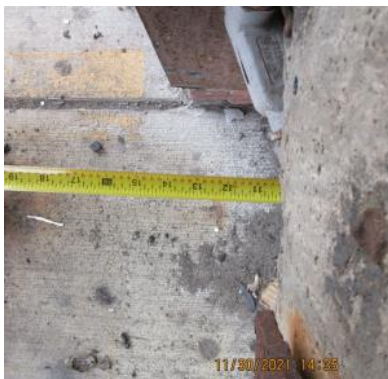
Subsystem Code:	E1030310	Surveyor / Update:	Brendan Baranek-Olmstead	11/30/2021
Subsystem Description:	Loading Dock Equipment, EACH	Qty:	1.00	
Material:				
Distress:	Missing	Deficiency Id:	311171	
Priority:	1 - Currently Critical (Immediate)	Location:	DOOR 77 EXT	
Category:	Repair - Alteration			
Correction:	Install Star 4 Truck Restraint W/ Cantilever Mounting Bracket			
Notes:	Foundation wall to face of rubber bumper 18.25", SOG to bottom of the dock leveler 29", over dock height 47". The dock face below the leveler is adequate. There is an existing red light/green light system. Remove the existing red light/green light and all of its components prior to installing the new system.

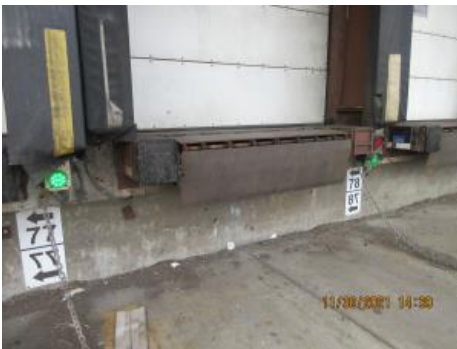
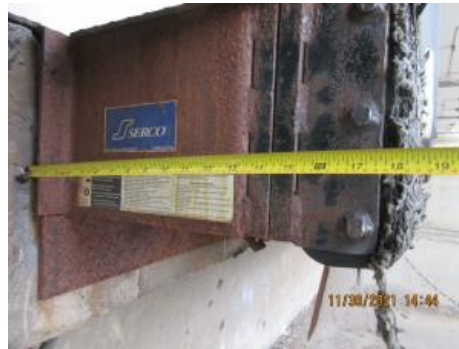
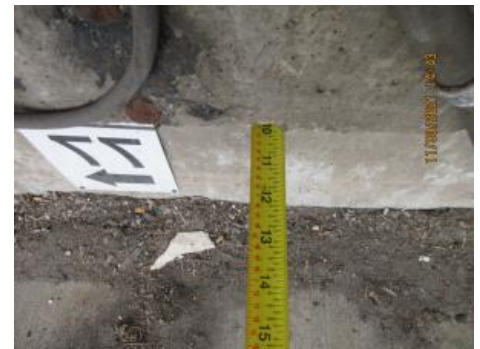
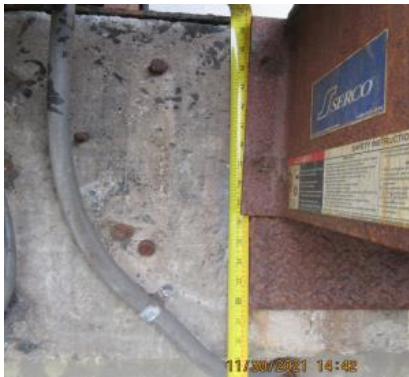
USPS TRSP\Atlantic\Massachusetts\Boston P-DC - 240801-GO6\DOOR 78

Subsystem Code:	E1030310	Surveyor / Update:	Brendan Baranek-Olmstead	11/30/2021
Subsystem Description:	Loading Dock Equipment, EACH	Qty:	1.00	
Material:				
Distress:	Missing	Deficiency Id:	311173	
Priority:	1 - Currently Critical (Immediate)	Location:	DOOR 78 EXT	
Category:	Repair - Alteration			
Correction:	Install Star 4 Truck Restraint W/ Cantilever Mounting Bracket			
Notes:	Foundation wall to face of rubber bumper 18", SOG to bottom of the dock leveler 29", over dock height 46.75". The dock face below the leveler is adequate. There is an existing red light/green light system. Remove the existing red light/green light and all of its components prior to installing the new system.

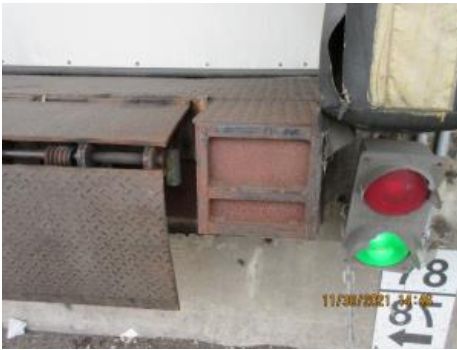
USPS TRSP\Atlantic\Massachusetts\Boston P-DC - 240801-GO6\DOOR 78

Subsystem Code:	E1030310	Surveyor / Update:	Brendan Baranek-Olmstead	11/30/2021
Subsystem Description:	Loading Dock Equipment, EACH	Qty:	1.00	
Material:				
Distress:	Missing	Deficiency Id:	311174	
Priority:	3 - Necessary/Not Yet Critical (Years 2-5)	Location:	DOOR 78 EXT	
Category:	Repair - Alteration			
Correction:	Provide and Replace Rubber Dock Bumper			
Notes:	The rubber bumper is missing on right side of the dock leveler (as facing door).

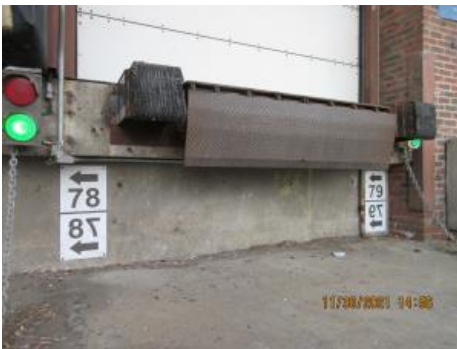
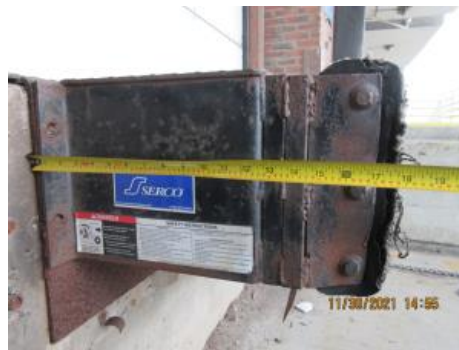
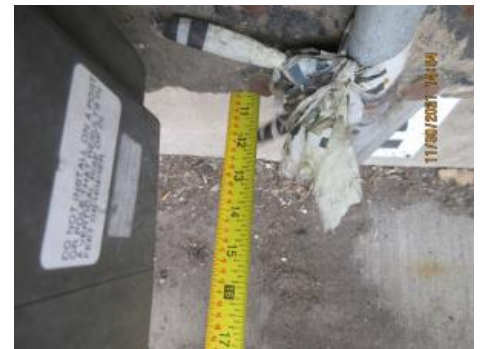
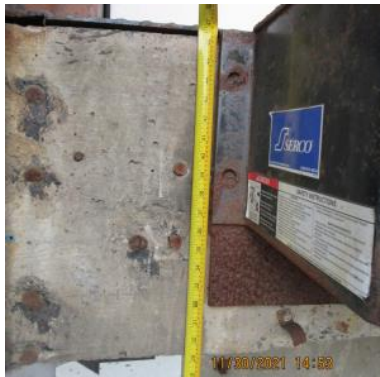
USPS TRSP\Atlantic\Massachusetts\Boston P-DC - 240801-GO6\DOOR 79

Subsystem Code:	E1030310	Surveyor / Update:	Brendan Baranek-Olmstead	11/30/2021
Subsystem Description:	Loading Dock Equipment, EACH	Qty:	1.00	
Material:				
Distress:	Missing	Deficiency Id:	311176	
Priority:	1 - Currently Critical (Immediate)	Location:	DOOR 79 EXT	
Category:	Repair - Alteration			
Correction:	Install Star 4 Truck Restraint W/ Cantilever Mounting Bracket			
Notes:	Foundation wall to face of rubber bumper 18.25", SOG to bottom of the dock leveler 29", over dock height 47". The dock face below the leveler is adequate. There is an existing red light/green light system. Remove the existing red light/green light and all of its components prior to installing the new system.

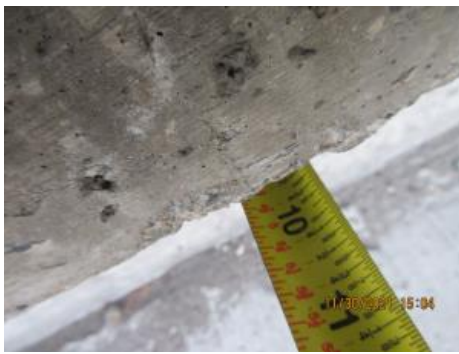
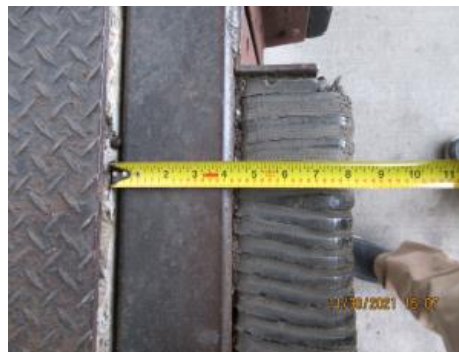
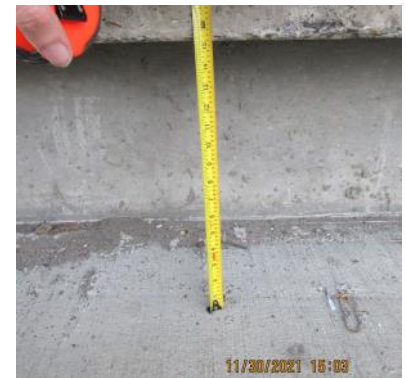
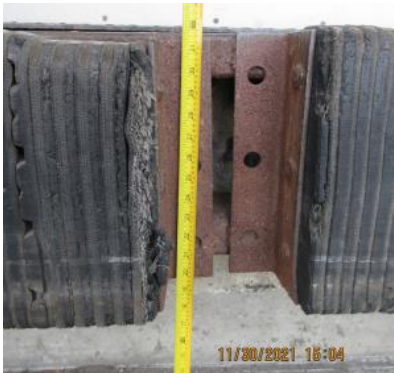
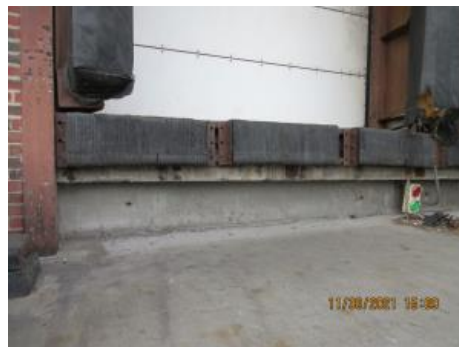
USPS TRSP\Atlantic\Massachusetts\Boston P-DC - 240801-GO6\DOOR 80

Subsystem Code:	E1030310	Surveyor / Update:	Brendan Baranek-Olmstead	11/30/2021
Subsystem Description:	Loading Dock Equipment, EACH	Qty:	1.00	
Material:				
Distress:	Missing	Deficiency Id:	311179	
Priority:	1 - Currently Critical (Immediate)	Location:	DOOR 80 EXT	
Category:	Repair - Alteration			
Correction:	Install Kelley Dock Communication System			
Notes:	The ground to underside of loading dock concrete lip is 15.25 inches. Ground to top of loading dock surface is 32 inches. The loading dock lip sticks out 10 inches. The dock level rubber edge is 8.5 inches from loading dock lip edge. There is no dock leveler present. Due to existing conditions this dock will have received pricing for a communications system and the removal of the existing red light/green light system.

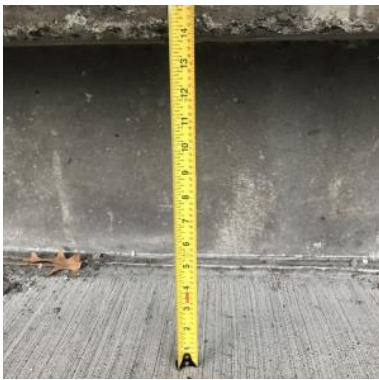
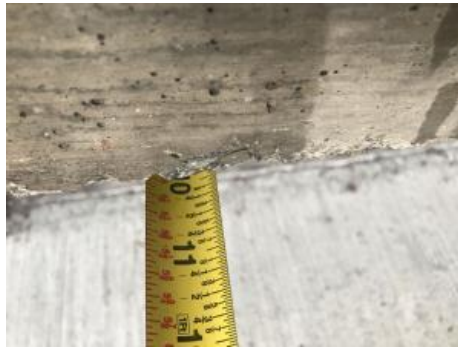
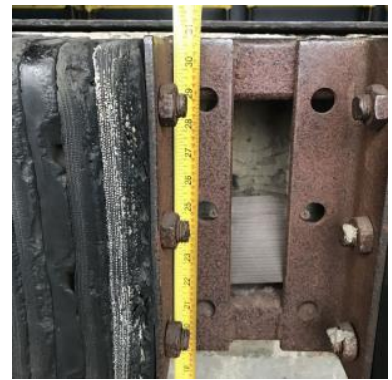
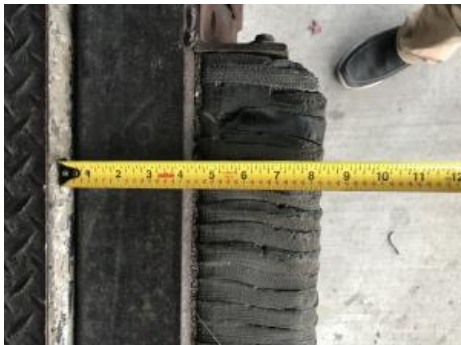
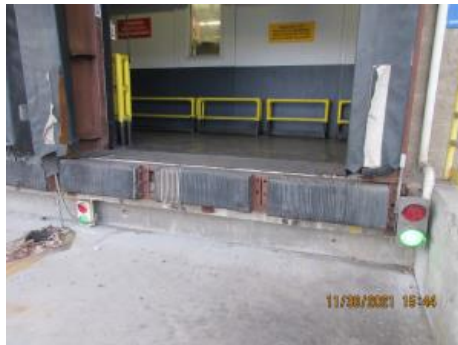
USPS TRSP\Atlantic\Massachusetts\Boston P-DC - 240801-GO6\DOOR 81

Subsystem Code:	E1030310	Surveyor / Update:	Brendan Baranek-Olmstead	11/30/2021
Subsystem Description:	Loading Dock Equipment, EACH	Qty:	1.00	
Material:				
Distress:	Inadequate	Deficiency Id:	311187	
Priority:	1 - Currently Critical (Immediate)	Location:	DOOR 81 EXT	
Category:	Repair - Alteration			
Correction:	Install Kelley Dock Communication System			
Notes:	Foundation wall to face of rubber bumper 8.5", SOG to bottom of the dock leveler 14", over dock height 32". The dock face below the leveler is inadequate. Communications system to be installed only. There is not a dock leveler installed. Due to current conditions a pricing has been provided for a communications system only and removal of the existing red light/green light system.
