Mail Processing Facilities

TRUCK RESTRAINT PROGRAM – USPS P&DC- Boston, MA
25 Dorchester Ave. Boston, MA 02205-9761

SCOPE OF WORK PACKAGE (RFP 743672-31678P) Date 08/05/2022

General Findings and Condition Report (eCOMET Enhanced Deficiency Sheet Report)

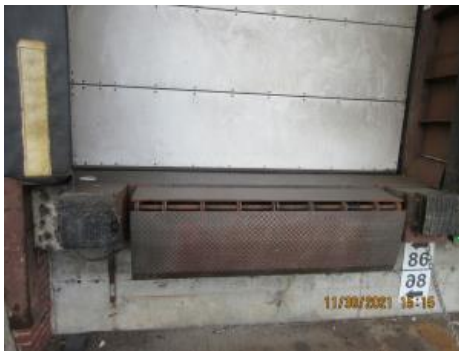
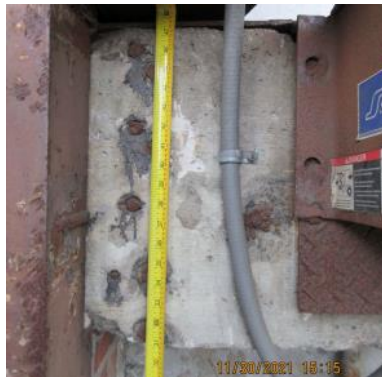
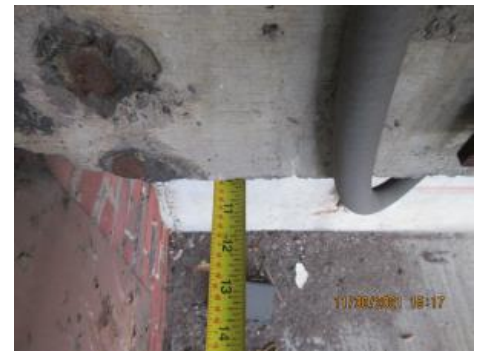
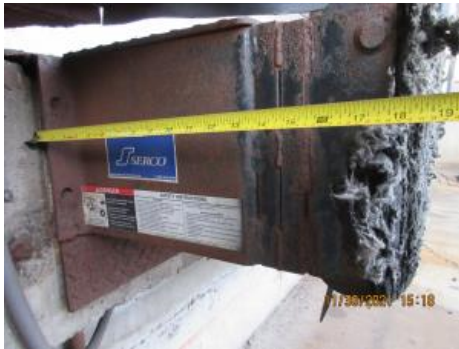
USPS TRSP\Atlantic\Massachusetts\Boston P-DC - 240801-GO6\DOOR 86

Subsystem Code:	E1030310	Surveyor / Update:	Brendan Baranek-Olmstead	11/30/2021
Subsystem Description:	Loading Dock Equipment, EACH	Qty:	1.00	
Material:				
Distress:	Missing	Deficiency Id:	311181	
Priority:	1 - Currently Critical (Immediate)	Location:	DOOR 86 EXT	
Category:	Repair - Alteration			
Correction:	Install Star 4 Truck Restraint W/ Cantilever Mounting Bracket			
Notes:	Foundation wall to face of rubber bumper 30.5", SOG to bottom of the dock leveler 30.5", over dock height 47.5". The dock face below the leveler is adequate. There is an existing red light/green light system. Remove the existing red light/green light and all of its components prior to installing the new system.

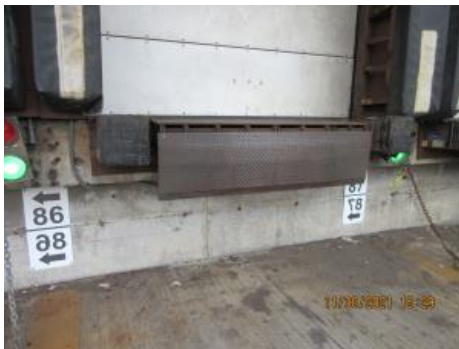
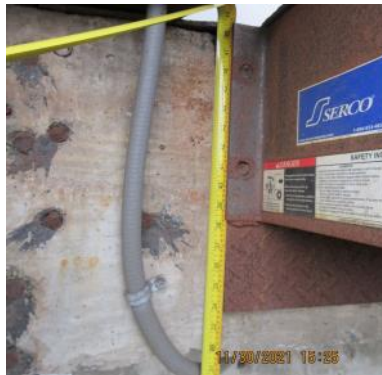
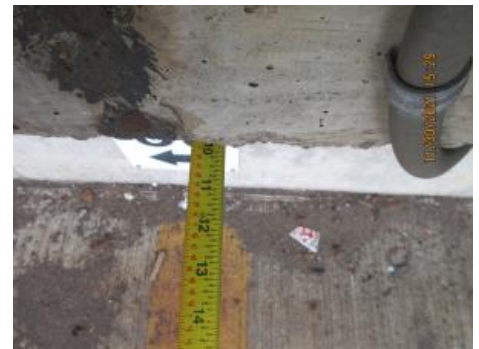
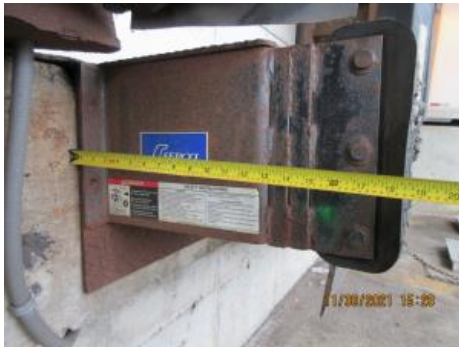
USPS TRSP\Atlantic\Massachusetts\Boston P-DC - 240801-GO6\DOOR 87

Subsystem Code:	E1030310	Surveyor / Update:	Brendan Baranek-Olmstead	11/30/2021
Subsystem Description:	Loading Dock Equipment, EACH	Qty:	1.00	
Material:				
Distress:	Missing	Deficiency Id:	311184	
Priority:	1 - Currently Critical (Immediate)	Location:	DOOR 87 EXT	
Category:	Repair - Alteration			
Correction:	Install Star 4 Truck Restraint W/ Cantilever Mounting Bracket			
Notes:	Foundation wall to face of rubber bumper 18.75", SOG to bottom of the dock leveler 31.25", over dock height 48.75". The dock face below the leveler adequate. There is an existing red light/green light system. Remove the existing red light/green light and all of its components prior to installing the new system.

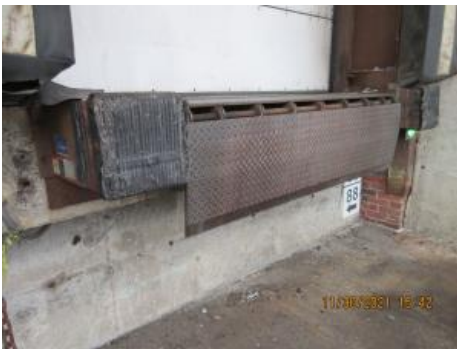
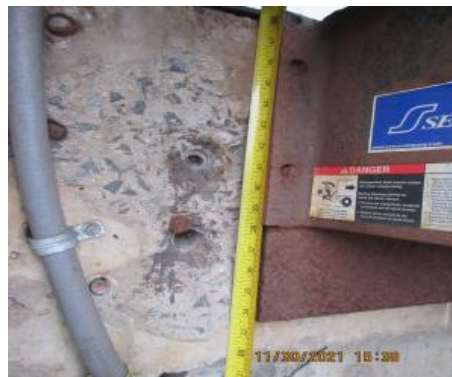
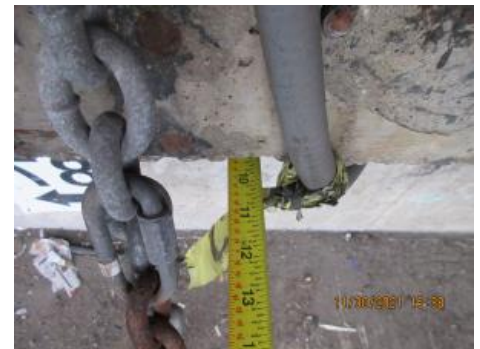
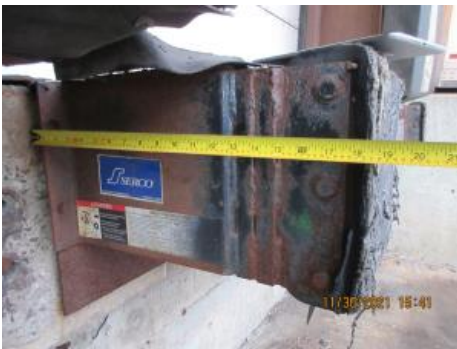
USPS TRSP\Atlantic\Massachusetts\Boston P-DC - 240801-GO6\DOOR 88

Subsystem Code:	E1030310	Surveyor / Update:	Brendan Baranek-Olmstead	11/30/2021
Subsystem Description:	Loading Dock Equipment, EACH	Qty:	1.00	
Material:				
Distress:	Missing	Deficiency Id:	311186	
Priority:	1 - Currently Critical (Immediate)	Location:	DOOR 88 EXT	
Category:	Repair - Alteration			
Correction:	Install Star 4 Truck Restraint W/ Cantilever Mounting Bracket			
Notes:	Foundation wall to face of rubber bumper 18.5", SOG to bottom of the dock leveler 31.25", over dock height 48.75". The dock face below the leveler is adequate. There is an existing red light/green light system. Remove the existing red light/green light and all of its components prior to installing the new system.

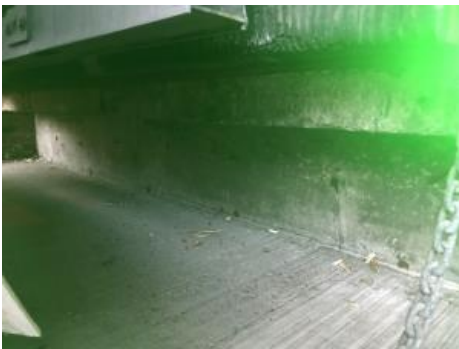
USPS TRSP\Atlantic\Massachusetts\Boston P-DC - 240801-GO6\DOOR 89

Subsystem Code:	E1030310	Surveyor / Update:	Todd Murphy	12/17/2021
Subsystem Description:	Loading Dock Equipment, EACH	Qty:	1.00	
Material:				
Distress:	Missing	Deficiency Id:	313093	
Priority:	1 - Currently Critical (Immediate)	Location:	DOOR 89 EXT	
Category:	Repair - Alteration			
Correction:	Install Kelley Dock Communication System			
Notes:	There is an existing red light/green light system. Remove the existing red light/green light and all of its components prior to installing the new system. Install communications system only, to include manual truck chocks.

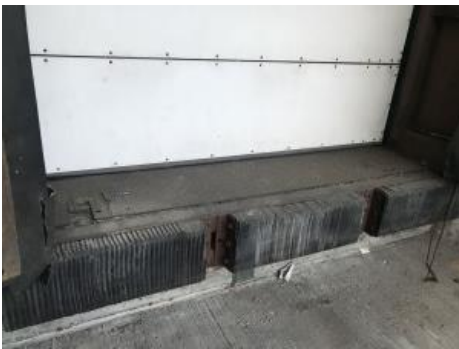
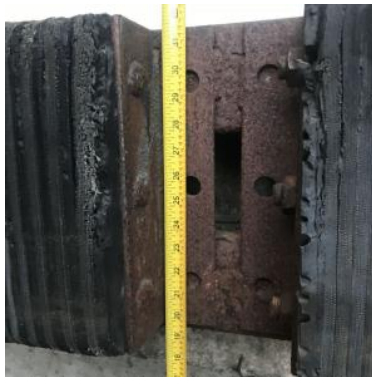
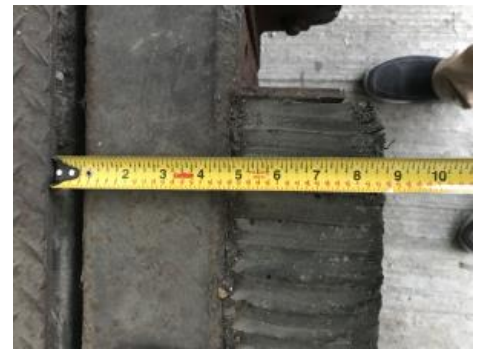
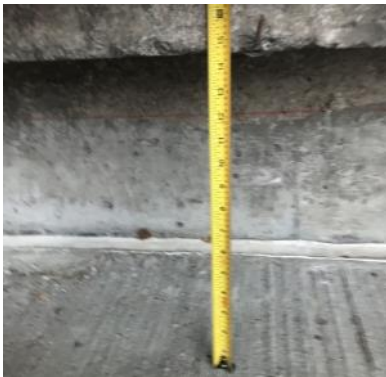
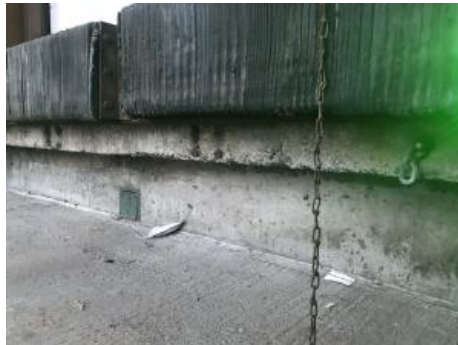
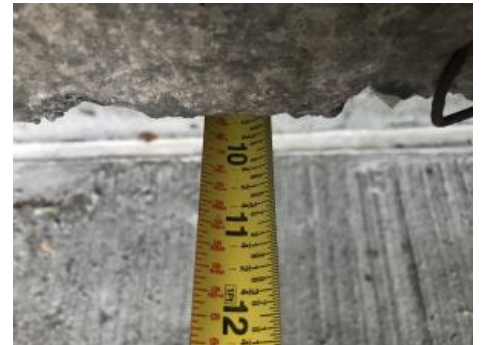
Subsystem Code:	E1030310	Surveyor / Update:	Brendan Baranek-Olmstead	11/30/2021
Subsystem Description:	Loading Dock Equipment, EACH	Qty:	1.00	
Material:				
Distress:	Missing	Deficiency Id:	311192	
Priority:	1 - Currently Critical (Immediate)	Location:	DOOR 90 EXT	
Category:	Repair - Alteration			
Correction:	Install Kelley Dock Communication System			
Notes:	Foundation wall to face of rubber bumper 8.5", SOG to bottom of the dock leveler 14.5", over dock height 32". The dock face below the leveler is inadequate. There is an existing red light/green light system. Remove the existing red light/green light and all of its components prior to installing the new system.

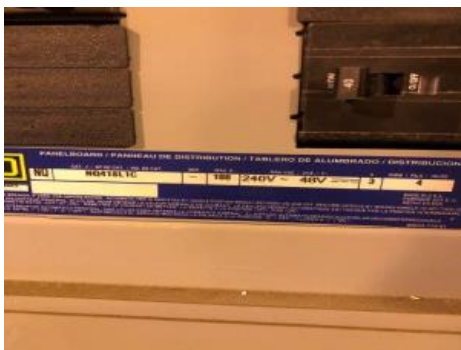
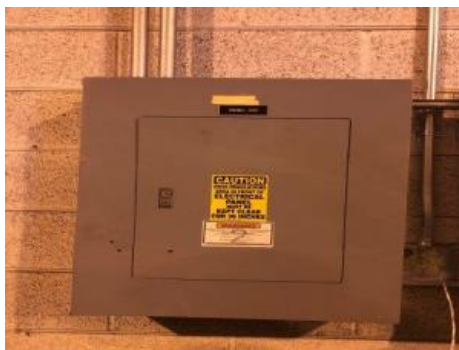
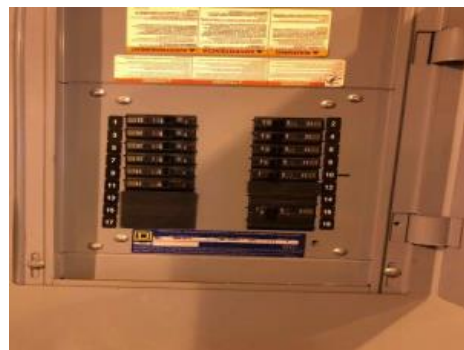
Subsystem Code:	D5010250	Surveyor / Update:	Stephen Butler	12/21/2021
Subsystem Description:	Panelboard	Qty:	3.00	
Material:				
Distress:	Inadequate	Deficiency Id:	313218	
Priority:	3 - Necessary/Not Yet Critical (Years 2-5)	Location:	OLD DOORS 1-12	
Category:	Repair - Alteration			
Correction:	Add New 1 Pole 20A Circuit Breaker (1 for every 4 Doors)			
Notes:	Old doors 1 - 12, add 20A, single-pole circuit breakers in existing panel C1X1

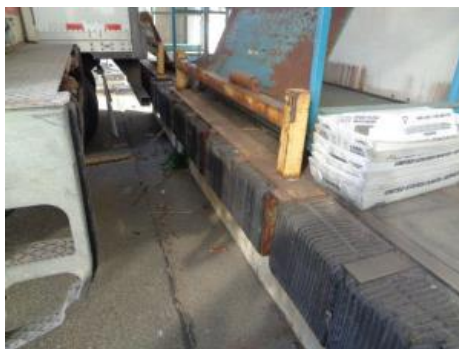
USPS TRSP\Atlantic\Massachusetts\Boston P-DC - 240801-GO6\OLD DOOR 01

Subsystem Code:	E1030310	Surveyor / Update:	Dustin Hollenbeck	12/03/2021
Subsystem Description:	Loading Dock Equipment, EACH	Qty:	1.00	
Material:				
Distress:	Missing	Deficiency Id:	311424	
Priority:	1 - Currently Critical (Immediate)	Location:	OLD DOOR 01 EXT	
Category:	Repair - Alteration			
Correction:	Install Kelley Dock Communication System			
Notes:	This dock is for small and medium delivery vehicles. It has no dock leveler or room for a truck restraint system.

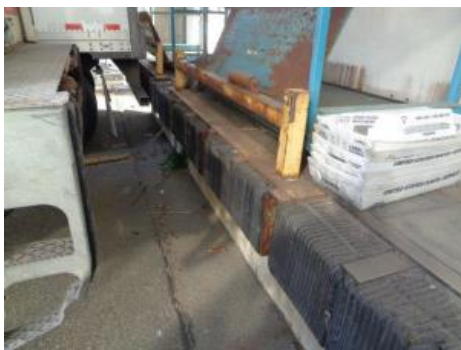
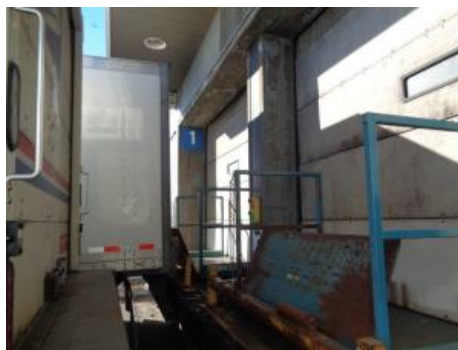
USPS TRSP\Atlantic\Massachusetts\Boston P-DC - 240801-GO6\OLD DOOR 02

Subsystem Code:	E1030310	Surveyor / Update:	Dustin Hollenbeck	12/03/2021
Subsystem Description:	Loading Dock Equipment, EACH	Qty:	1.00	
Material:				
Distress:	Missing	Deficiency Id:	311423	
Priority:	1 - Currently Critical (Immediate)	Location:	OLD DOOR 02 EXT	
Category:	Repair - Alteration			
Correction:	Install Kelley Dock Communication System			
Notes:	This dock is for small and medium delivery vehicles. It has no dock leveler or room for a truck restraint system.

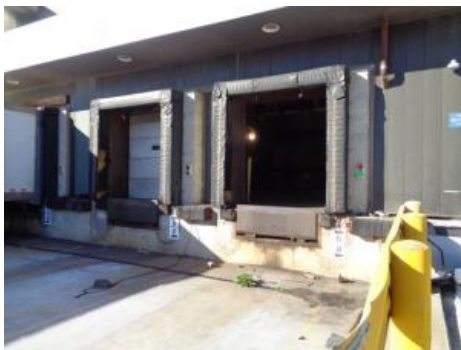
USPS TRSP\Atlantic\Massachusetts\Boston P-DC - 240801-GO6\OLD DOOR 03

Subsystem Code:	E1030310	Surveyor / Update:	Dustin Hollenbeck	12/03/2021
Subsystem Description:	Loading Dock Equipment, EACH	Qty:	1.00	
Material:				
Distress:	Missing	Deficiency Id:	311422	
Priority:	1 - Currently Critical (Immediate)	Location:	OLD DOOR 03 EXT	
Category:	Repair - Alteration			
Correction:	Install Star 4 Truck Restraint			
Notes:	Dock leveler frame is flush mounted to foundation wall. Bottom of frame is only 21" above grade. Restraint bracket will need to be cut down. There is an existing red light/green light system. Remove the existing red light/green light and all of its components prior to installing the new system.

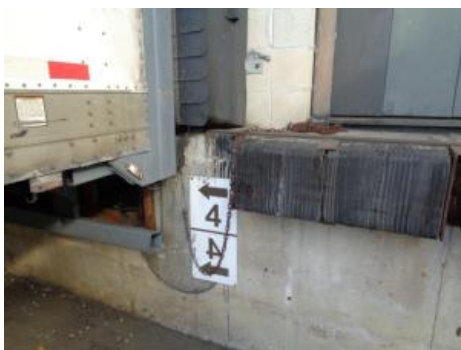
USPS TRSP\Atlantic\Massachusetts\Boston P-DC - 240801-GO6\OLD DOOR 04

Subsystem Code:	E1030310	Surveyor / Update:	Dustin Hollenbeck	12/03/2021
Subsystem Description:	Loading Dock Equipment, EACH	Qty:	1.00	
Material:				
Distress:	Missing	Deficiency Id:	311421	
Priority:	1 - Currently Critical (Immediate)	Location:	OLD DOOR 04 EXT	
Category:	Repair - Alteration			
Correction:	Install Star 4 Truck Restraint			
Notes:	Dock leveler frame is flush mounted to foundation wall. Bottom of frame is only 21" above grade. Restraint bracket will need to be cut down. There is an existing red light/green light system. Remove the existing red light/green light and all of its components prior to installing the new system.

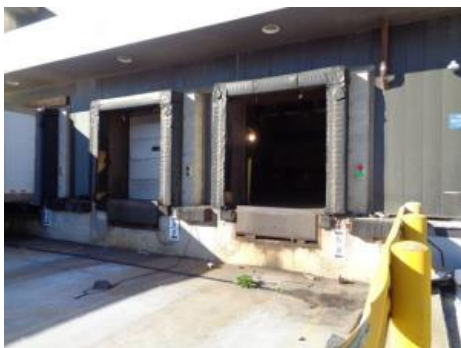
USPS TRSP\Atlantic\Massachusetts\Boston P-DC - 240801-GO6\OLD DOOR 05

Subsystem Code:	E1030310	Surveyor / Update:	Dustin Hollenbeck	12/03/2021
Subsystem Description:	Loading Dock Equipment, EACH	Qty:	1.00	
Material:				
Distress:	Missing	Deficiency Id:	311420	
Priority:	1 - Currently Critical (Immediate)	Location:	OLD DOOR 05 EXT	
Category:	Repair - Alteration			
Correction:	Install Star 4 Truck Restraint			
Notes:	Dock leveler frame is flush mounted to foundation wall. Bottom of frame is only 21" above grade. Restraint bracket will need to be cut down. There is an existing red light/green light system. Remove the existing red light/green light and all of its components prior to installing the new system.

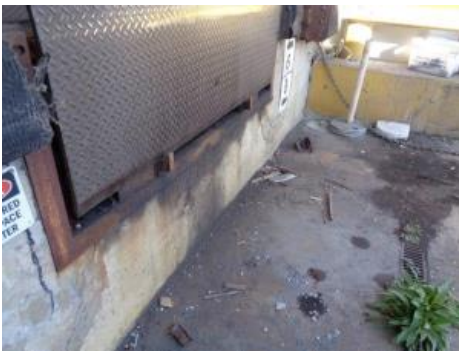
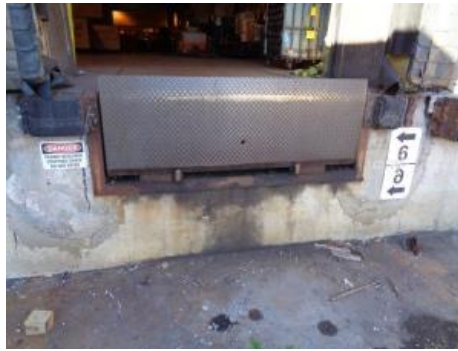
USPS TRSP\Atlantic\Massachusetts\Boston P-DC - 240801-GO6\OLD DOOR 06

Subsystem Code:	E1030310	Surveyor / Update:	Dustin Hollenbeck	12/03/2021
Subsystem Description:	Loading Dock Equipment, EACH	Qty:	1.00	
Material:				
Distress:	Missing	Deficiency Id:	311419	
Priority:	1 - Currently Critical (Immediate)	Location:	OLD DOOR 06 EXT	
Category:	Repair - Alteration			
Correction:	Install Star 4 Truck Restraint			
Notes:	Dock leveler frame is flush mounted to foundation wall. Bottom of frame is only 21" above grade. Restraint bracket will need to be cut down. There is an existing red light/green light system. Remove the existing red light/green light and all of its components prior to installing the new system.

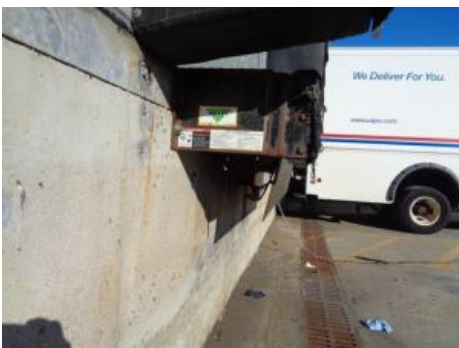
USPS TRSP\Atlantic\Massachusetts\Boston P-DC - 240801-GO6\OLD DOOR 07

Subsystem Code:	E1030310	Surveyor / Update:	Dustin Hollenbeck	12/03/2021
Subsystem Description:	Loading Dock Equipment, EACH	Qty:	1.00	
Material:				
Distress:	Missing	Deficiency Id:	311418	
Priority:	1 - Currently Critical (Immediate)	Location:	OLD DOOR 07 EXT	
Category:	Repair - Alteration			
Correction:	Install Star 4 Truck Restraint W/ Cantilever Mounting Bracket			
Notes:	Docks have Kelley dock levelers and Kelley lights with control box installed. Replace existing communication unit with new unit. Reuse existing 120VAC circuit. Foundation wall to face of rubber bumper 18", install truck restraint system.

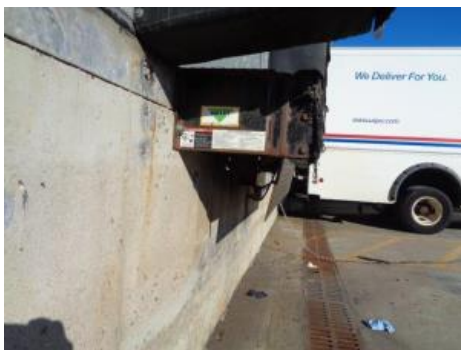
USPS TRSP\Atlantic\Massachusetts\Boston P-DC - 240801-GO6\OLD DOOR 08

Subsystem Code:	E1030310	Surveyor / Update:	Dustin Hollenbeck	12/03/2021
Subsystem Description:	Loading Dock Equipment, EACH	Qty:	1.00	
Material:				
Distress:	Missing	Deficiency Id:	311417	
Priority:	1 - Currently Critical (Immediate)	Location:	OLD DOOR 08 EXT	
Category:	Repair - Alteration			
Correction:	Install Star 4 Truck Restraint W/ Cantilever Mounting Bracket			
Notes:	This dock is for small and medium delivery vehicles. It has no dock leveler. Foundation wall to face of rubber bumper 18", install truck restraint system.

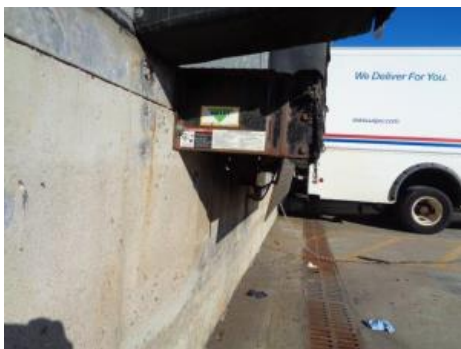
USPS TRSP\Atlantic\Massachusetts\Boston P-DC - 240801-GO6\OLD DOOR 09

Subsystem Code:	E1030310	Surveyor / Update:	Dustin Hollenbeck	12/03/2021
Subsystem Description:	Loading Dock Equipment, EACH	Qty:	1.00	
Material:				
Distress:	Missing	Deficiency Id:	311416	
Priority:	1 - Currently Critical (Immediate)	Location:	OLD DOOR 09 EXT	
Category:	Repair - Alteration			
Correction:	Install Star 4 Truck Restraint W/ Cantilever Mounting Bracket			
Notes:	This dock is for small and medium delivery vehicles. It has no dock leveler. Foundation wall to face of rubber bumper 18", install truck restraint system.

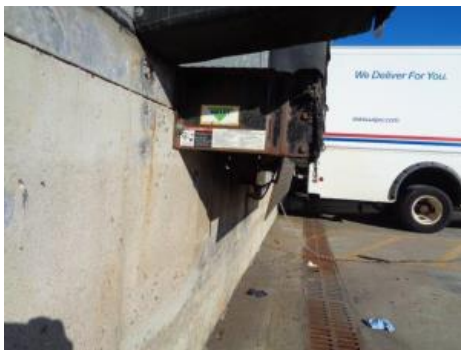
Subsystem Code:	E1030310	Surveyor / Update:	Dustin Hollenbeck	12/03/2021
Subsystem Description:	Loading Dock Equipment, EACH	Qty:	1.00	
Material:				
Distress:	Missing	Deficiency Id:	311414	
Priority:	1 - Currently Critical (Immediate)	Location:	OLD DOOR 11 EXT	
Category:	Repair - Alteration			
Correction:	Install Star 4 Truck Restraint W/ Cantilever Mounting Bracket			
Notes:	Docks have Kelley dock levelers and Kelley lights with control box installed. Replace existing communication unit with new unit. Reuse existing 120VAC circuit. Foundation wall to face of rubber bumper 18", install truck restraint system.

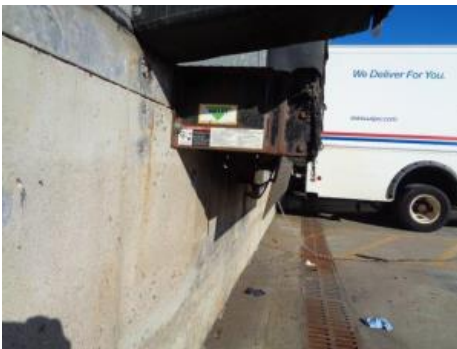
USPS TRSP\Atlantic\Massachusetts\Boston P-DC - 240801-GO6\OLD DOOR 12

Subsystem Code:	E1030310	Surveyor / Update:	Dustin Hollenbeck	12/03/2021
Subsystem Description:	Loading Dock Equipment, EACH	Qty:	1.00	
Material:				
Distress:	Missing	Deficiency Id:	311413	
Priority:	1 - Currently Critical (Immediate)	Location:	OLD DOOR 12 EXT	
Category:	Repair - Alteration			
Correction:	Install Star 4 Truck Restraint W/ Cantilever Mounting Bracket			
Notes:	Docks have Kelley dock levelers and Kelley lights with control box installed. Replace existing communication unit with new unit. Reuse existing 120VAC circuit. Foundation wall to face of rubber bumper 18", install truck restraint system.

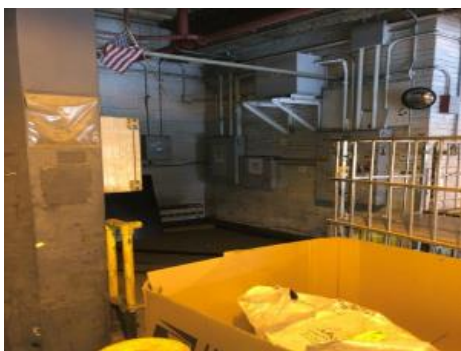
Subsystem Code:	D5010250	Surveyor / Update:	Stephen Butler	12/21/2021
Subsystem Description:	Panelboard	Qty:	1.00	
Material:				
Distress:	Inadequate	Deficiency Id:	313217	
Priority:	3 - Necessary/Not Yet Critical (Years 2-5)	Location:	OLD DOORS 13-21	
Category:	Repair - Alteration			
Correction:	Replace Existing Power Panel w/New 225A, 3Phase 208Y/120VAC			
Notes:	For old doors 13 - 21, replace existing power Panel 4 with a new 225A, 3-phase, 208Y/120VAC panel. Reconnect all existing loads to new circuit breakers of the same size. Add new 20A, single-pole circuit breakers to support TRS.

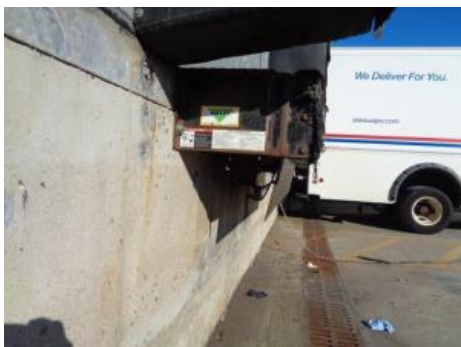
USPS TRSP\Atlantic\Massachusetts\Boston P-DC - 240801-GO6\OLD DOOR 13

Subsystem Code:	E1030310	Surveyor / Update:	Dustin Hollenbeck	12/03/2021
Subsystem Description:	Loading Dock Equipment, EACH	Qty:	1.00	
Material:				
Distress:	Missing	Deficiency Id:	311412	
Priority:	1 - Currently Critical (Immediate)	Location:	OLD DOOR 13 EXT	
Category:	Repair - Alteration			
Correction:	Install Star 4 Truck Restraint W/ Cantilever Mounting Bracket			
Notes:	Docks have Kelley dock levelers and Kelley lights with control box installed. Replace existing communication unit with new unit. Reuse existing 120VAC circuit. Foundation wall to face of rubber bumper 18", install truck restraint system.

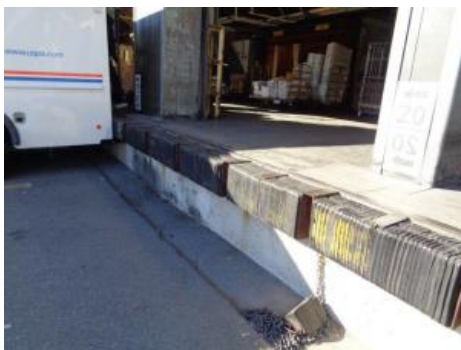
USPS TRSP\Atlantic\Massachusetts\Boston P-DC - 240801-GO6\OLD DOOR 14

Subsystem Code:	E1030310	Surveyor / Update:	Dustin Hollenbeck	12/03/2021
Subsystem Description:	Loading Dock Equipment, EACH	Qty:	1.00	
Material:				
Distress:	Missing	Deficiency Id:	311409	
Priority:	1 - Currently Critical (Immediate)	Location:	OLD DOOR 14 EXT	
Category:	Repair - Alteration			
Correction:	Install Kelley Dock Communication System			
Notes:	This dock is for small and medium delivery vehicles. It has no dock leveler or room for a truck restraint system.

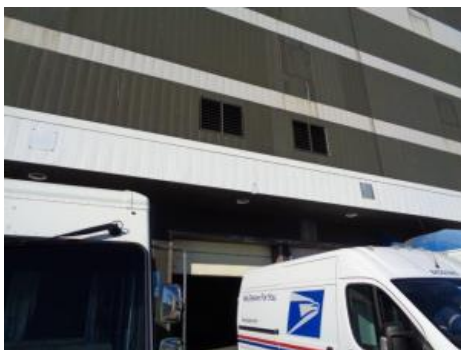
USPS TRSP\Atlantic\Massachusetts\Boston P-DC - 240801-GO6\OLD DOOR 15

Subsystem Code:	E1030310	Surveyor / Update:	Dustin Hollenbeck	12/14/2021
Subsystem Description:	Loading Dock Equipment, EACH	Qty:	1.00	
Material:				
Distress:	Missing	Deficiency Id:	312711	
Priority:	1 - Currently Critical (Immediate)	Location:	OLD DOOR 15 EXT	
Category:	Repair - Alteration			
Correction:	Install Kelley Dock Communication System			
Notes:	This dock is for small and medium delivery vehicles. It has no dock leveler or room a for truck restraint system. The ground to top of loading dock surface is 34 inches. The loading dock wall has a recessed section from 12 to 19 inches AGS that is 10.75 inches deep. The dock level rubber edge is 4 inches from loading dock lip edge.

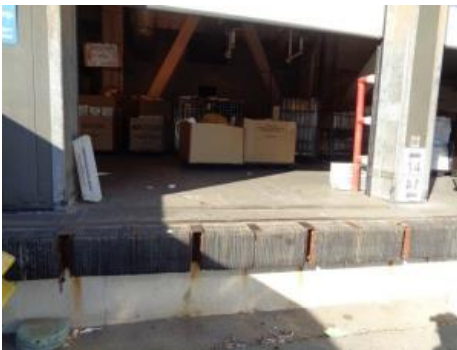
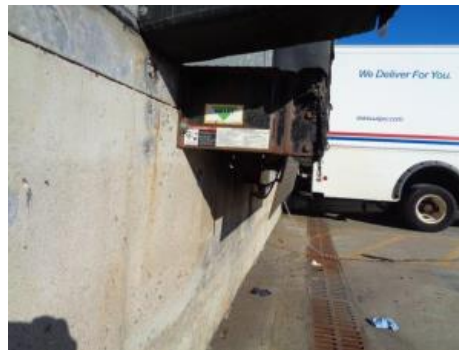
USPS TRSP\Atlantic\Massachusetts\Boston P-DC - 240801-GO6\OLD DOOR 16

Subsystem Code:	E1030310	Surveyor / Update:	Dustin Hollenbeck	12/03/2021
Subsystem Description:	Loading Dock Equipment, EACH	Qty:	1.00	
Material:				
Distress:	Missing	Deficiency Id:	311401	
Priority:	1 - Currently Critical (Immediate)	Location:	OLD DOOR 16 EXT	
Category:	Repair - Alteration			
Correction:	Install Kelley Dock Communication System			
Notes:	This dock is for small and medium delivery vehicles. It has no dock leveler or room for a truck restraint system.

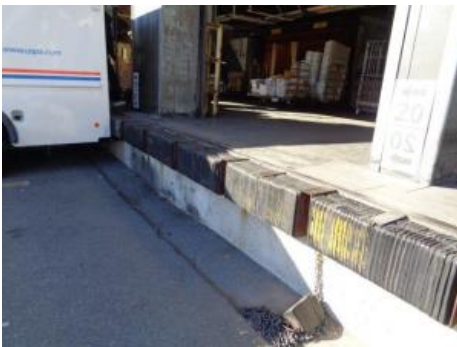
USPS TRSP\Atlantic\Massachusetts\Boston P-DC - 240801-GO6\OLD DOOR 17

Subsystem Code:	E1030310	Surveyor / Update:	Dustin Hollenbeck	12/03/2021
Subsystem Description:	Loading Dock Equipment, EACH	Qty:	1.00	
Material:				
Distress:	Missing	Deficiency Id:	311402	
Priority:	1 - Currently Critical (Immediate)	Location:	OLD DOOR 17 EXT	
Category:	Repair - Alteration			
Correction:	Install Kelley Dock Communication System			
Notes:	This dock is for small and medium delivery vehicles. It has no dock leveler or room for a truck restraint system.

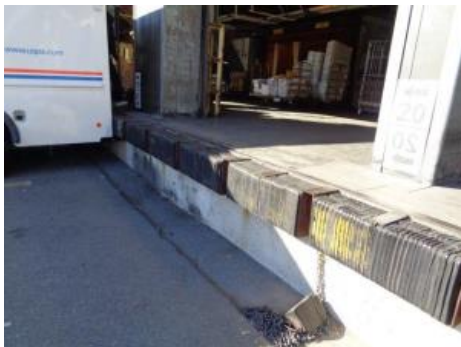
Subsystem Code:	E1030310	Surveyor / Update:	Dustin Hollenbeck	12/03/2021
Subsystem Description:	Loading Dock Equipment, EACH	Qty:	1.00	
Material:				
Distress:	Missing	Deficiency Id:	311404	
Priority:	1 - Currently Critical (Immediate)	Location:	OLD DOOR 19 EXT	
Category:	Repair - Alteration			
Correction:	Install Kelley Dock Communication System			
Notes:	This dock is for small and medium delivery vehicles. It has no dock leveler or room for a truck restraint system.

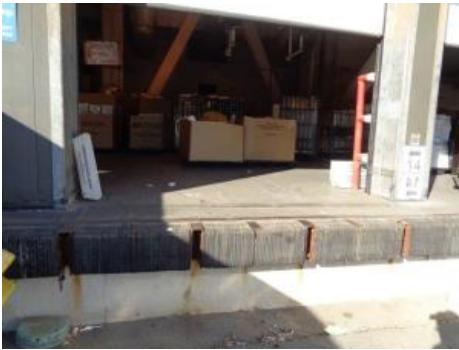
USPS TRSP\Atlantic\Massachusetts\Boston P-DC - 240801-GO6\OLD DOOR 20

Subsystem Code:	E1030310	Surveyor / Update:	Dustin Hollenbeck	12/03/2021
Subsystem Description:	Loading Dock Equipment, EACH	Qty:	1.00	
Material:				
Distress:	Missing	Deficiency Id:	311405	
Priority:	1 - Currently Critical (Immediate)	Location:	OLD DOOR 20 EXT	
Category:	Repair - Alteration			
Correction:	Install Kelley Dock Communication System			
Notes:	This dock is for small and medium delivery vehicles. It has no dock leveler or room for a truck restraint system.

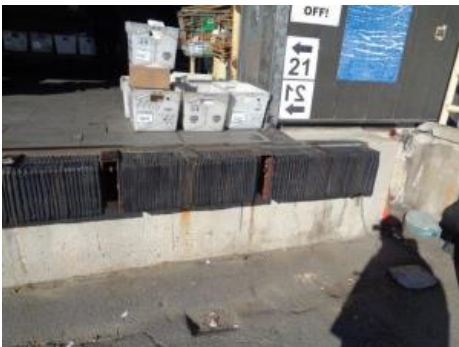
USPS TRSP\Atlantic\Massachusetts\Boston P-DC - 240801-GO6\OLD DOOR 21

Subsystem Code:	E1030310	Surveyor / Update:	Stephen Butler	11/29/2021
Subsystem Description:	Loading Dock Equipment, EACH	Qty:	1.00	
Material:				
Distress:	Missing	Deficiency Id:	311080	
Priority:	1 - Currently Critical (Immediate)	Location:	OLD DOOR 21 EXT	
Category:	Repair - Alteration			
Correction:	Install Kelley Dock Communication System			
Notes:	This dock is for small and medium delivery vehicles. It has no dock leveler or room for a truck restraint system.
