TRUCK RESTRAINT PROGRAM – USPS P&DC- Hartford, CT
141 Weston ST, Hartford, CT 06101-9612

SCOPE OF WORK PACKAGE (RFP 743672-31678P) Date 08/5/2022

General Findings and Condition Report (eCOMET Enhanced Deficiency Sheet Report)

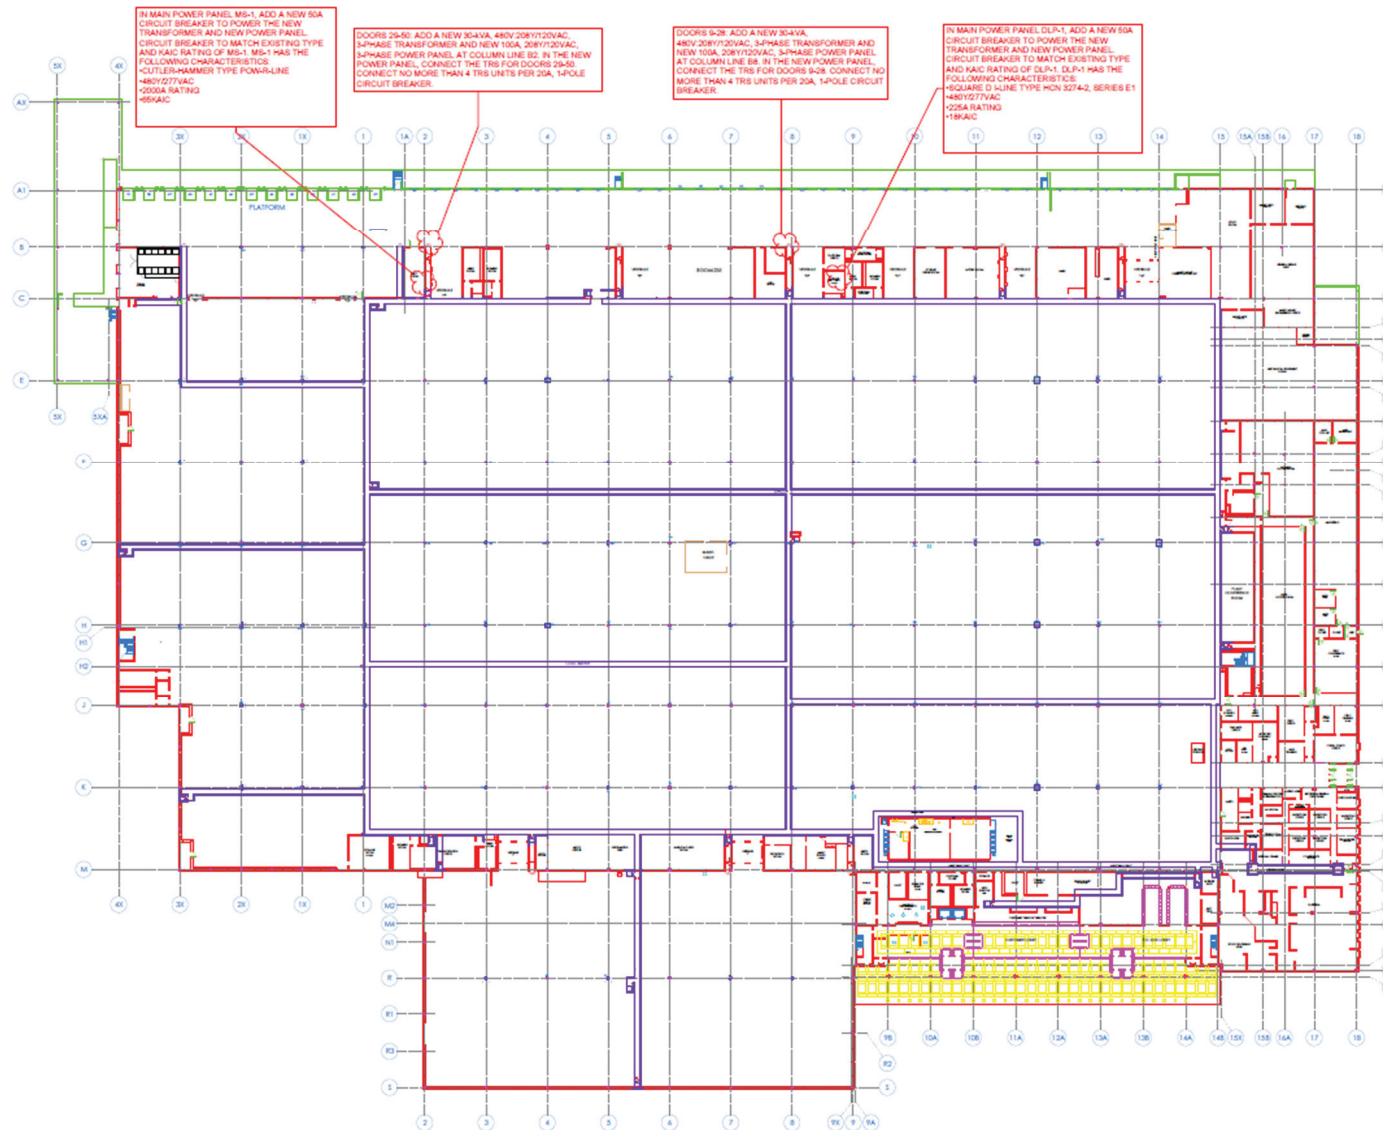
Figure 1: Hartford CT P&DC Doors 1-49

- Doors 1-28: Add a new 30-kVA, 480V:208Y/120VAC, 3-phase transformer and new 100A, 208Y/120VAC, 3-phase power panel at column line B8. In power panel DLP1, add a new 50A circuit breaker to power the new transformer and new power panel. Circuit breaker to match existing type and KAIC rating of DLP1. In the new power panel at column line B8, connect the TRS for Doors 1-28 connecting no more than 4 TRS per 20A, 1-pole circuit breaker.
- Doors 29-49: Add a new 30-kVA, 480V:208Y/120VAC, 3-phase transformer and new 100A, 208Y/120VAC, 3-phase power panel at column line B2. In main power panel MS-1, add a new 50A circuit breaker to power the new transformer and new power panel. Circuit breaker to match existing type and KAIC rating of MS-1. In the new power panel at column line B2, connect the TRS for Doors 29-50 connecting no more than 4 TRS per 20A, 1-pole circuit breaker.

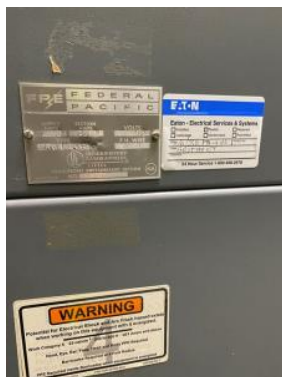
Subsystem Code:	D5010	Surveyor / Update:	Stephen Butler	04/04/2022
Subsystem Description:	Electrical Service/Distribution	Qty:	1.00	
Material:				
Distress:	Inadequate	Deficiency Id:	317362	
Priority:	3 - Necessary/Not Yet Critical (Years 2-5)	Location:	B8 (DOORS 1-28)	
Category:	Repair - Alteration			
Correction:	Provide New 30-kVA Step-down Transformer w/new 3P Circuit Breaker			
Notes:	For doors 1 - 28, the existing power panels in the area of these doors are Federal Pacific brand, they are obsolete and not usable. Provide a new 30-kVA, 480-208Y/120VAC step-down transformer to feed a new 3-phase, 208Y120VAC power panel at column B8 to support the truck restraint system loads. The maximum distance from the new panel to farthest door is 225'. In power panel DLP1 in the electrical room located at column line C9, add a new 50A, 3-pole, circuit breaker in one of the open spaces. Install a circuit breaker to match existing type and kAIC rating. The maximum feeder distance from power panel DLP1 is 75'.

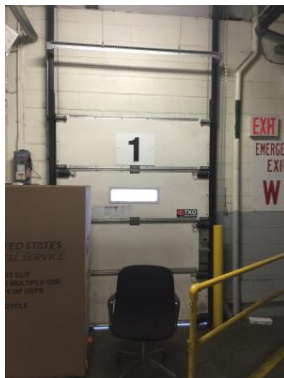
USPS TRSP\Atlantic\Connecticut \Hartford P - DC 083367-G04\DOOR 01

Subsystem Code:	E1030310	Surveyor / Update:	Brendan Baranek-Olmstead	03/16/2022
Subsystem Description:	Loading Dock Equipment, EACH	Qty:	1.00	
Material:				
Distress:	Missing	Deficiency Id:	315914	
Priority:	1 - Currently Critical (Immediate)	Location:	DOOR 01	
Category:	Repair - Alteration			
Correction:	Install Kelley Dock Communication System			
Notes:	No deficiencies observed. The BMU area, not expected to receive trucks. The foundation wall to the face of the rubber bumper is 16", SOG to the bottom of the dock leveler 11", over all dock height 31". The dock face below the leveler is inadequate. Docks for DOORS 01-03 are similar design. Install a new communications system only, including manual truck chocks.

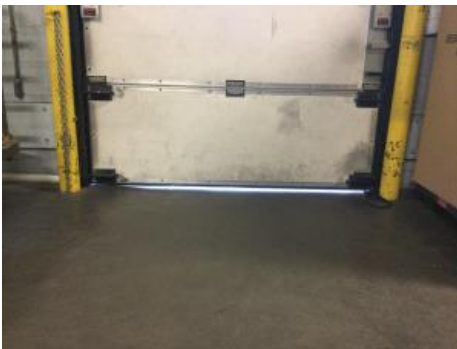
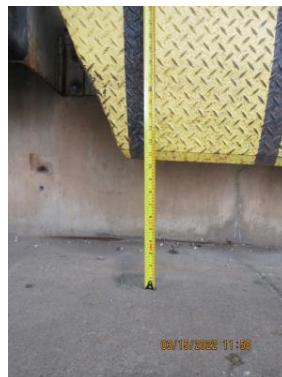
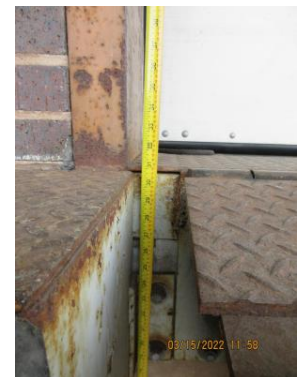
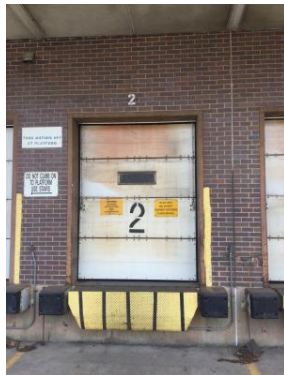
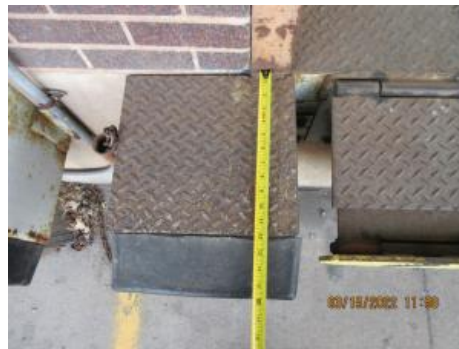
USPS TRSP\Atlantic\Connecticut \Hartford P - DC 083367-G04\DOOR 02

Subsystem Code:	E1030310	Surveyor / Update:	Brendan Baranek-Olmstead	03/23/2022
Subsystem Description:	Loading Dock Equipment, EACH	Qty:	1.00	
Material:				
Distress:	Missing	Deficiency Id:	316191	
Priority:	1 - Currently Critical (Immediate)	Location:	DOOR 02	
Category:	Repair - Alteration			
Correction:	Install Kelley Dock Communication System			
Notes:	The foundation wall to the face of the rubber bumper is 16", SOG to the bottom of the dock leveler 10.5", over all dock height 31". The dock face below the leveler is inadequate. Docks for DOORS 01-03 are similar design. Install a new communications system only, including manual truck chocks.

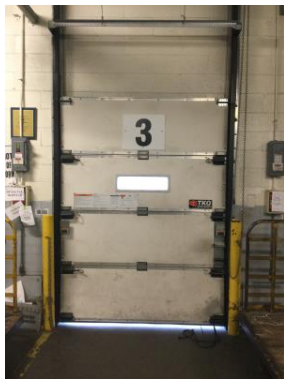
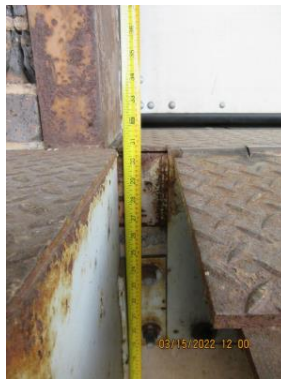
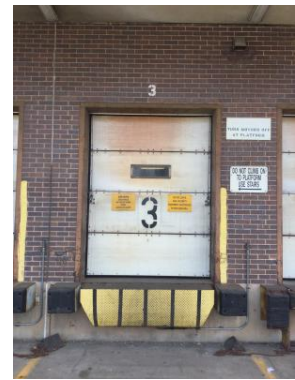
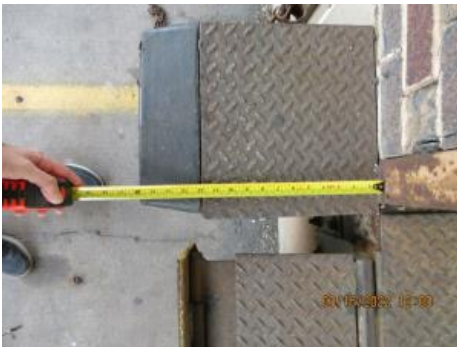
USPS TRSP\Atlantic\Connecticut \Hartford P - DC 083367-G04\DOOR 03

Subsystem Code:	E1030310	Surveyor / Update:	Brendan Baranek-Olmstead	03/23/2022
Subsystem Description:	Loading Dock Equipment, EACH	Qty:	1.00	
Material:				
Distress:	Missing	Deficiency Id:	316192	
Priority:	1 - Currently Critical (Immediate)	Location:	DOOR 03	
Category:	Repair - Alteration			
Correction:	Install Kelley Dock Communication System			
Notes:	No deficiencies observed. BMU area, not expected to receive trucks. The foundation wall to the face of the rubber bumper is 16", SOG to the bottom of the dock leveler 10.5", over all dock height 31". The dock face below the leveler is inadequate. Docks for DOORS 01-03 are similar design. Install a new communications system only, including manual truck chocks.

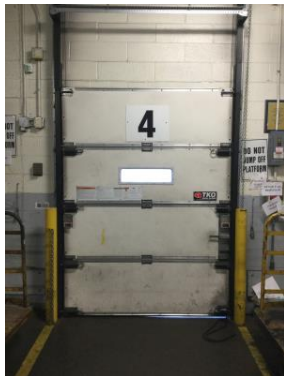
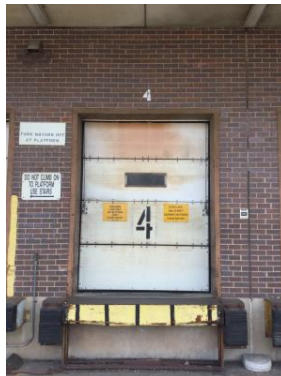
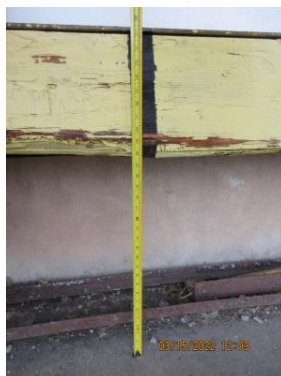
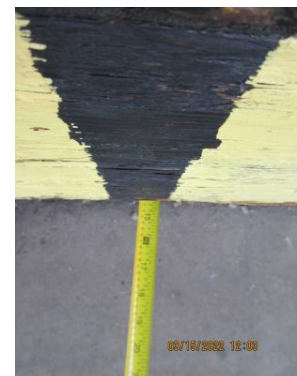
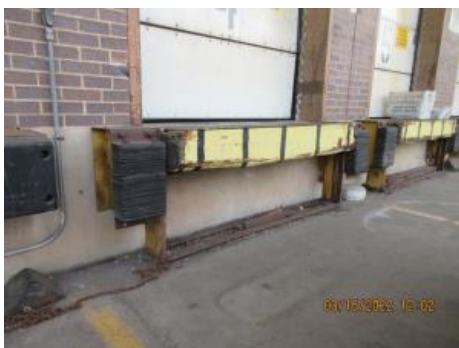
USPS TRSP\Atlantic\Connecticut \Hartford P - DC 083367-G04\DOOR 04

Subsystem Code:	E1030310	Surveyor / Update:	Brendan Baranek-Olmstead	03/23/2022
Subsystem Description:	Loading Dock Equipment, EACH	Qty:	1.00	
Material:				
Distress:	Missing	Deficiency Id:	316194	
Priority:	1 - Currently Critical (Immediate)	Location:	DOOR 04	
Category:	Repair - Alteration			
Correction:	Install Kelley Dock Communication System			
Notes:	No deficiencies observed. BMU area, not expected to receive trucks. The foundation wall to the face of the rubber bumper is 13", SOG to the bottom of the dock leveler 21.75", over all dock height 31". Dock extends 14.25" from foundation wall. The dock face below the leveler is adequate. BMU area, not expected to receive trucks. Docks for DOORS 04-07 are similar design. Install a new communications system only, including manual truck chocks.

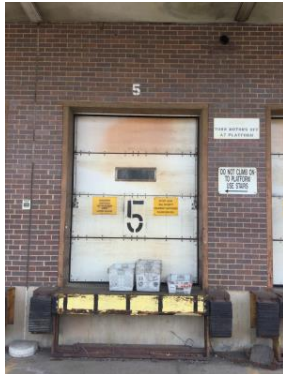
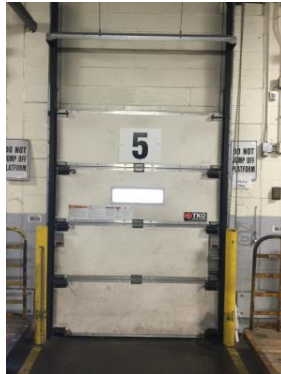
USPS TRSP\Atlantic\Connecticut \Hartford P - DC 083367-G04\DOOR 05

Subsystem Code:	E1030310	Surveyor / Update:	Brendan Baranek-Olmstead	03/23/2022
Subsystem Description:	Loading Dock Equipment, EACH	Qty:	1.00	
Material:				
Distress:	Missing	Deficiency Id:	316195	
Priority:	1 - Currently Critical (Immediate)	Location:	DOOR 05	
Category:	Repair - Alteration			
Correction:	Install Kelley Dock Communication System			
Notes:	No deficiencies observed. BMU area, not expected to receive trucks. The foundation wall to the face of the rubber bumper is 13", SOG to the bottom of the dock leveler 21.75", over all dock height 31". Dock extends 14.25" from foundation wall. The dock face below the leveler is adequate. BMU area, not expected to receive trucks. Docks for DOORS 04-07 are similar design. Install a new communications system only, including manual truck chocks.

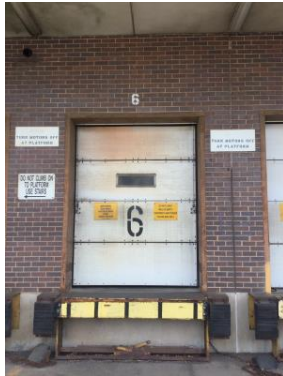
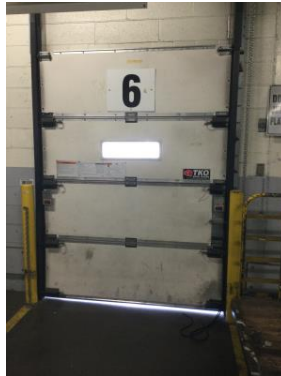
USPS TRSP\Atlantic\Connecticut \Hartford P - DC 083367-G04\DOOR 06

Subsystem Code:	E1030310	Surveyor / Update:	Brendan Baranek-Olmstead	03/23/2022
Subsystem Description:	Loading Dock Equipment, EACH	Qty:	1.00	
Material:				
Distress:	Missing	Deficiency Id:	316196	
Priority:	1 - Currently Critical (Immediate)	Location:	DOOR 06	
Category:	Repair - Alteration			
Correction:	Install Kelley Dock Communication System			
Notes:	No deficiencies observed. BMU area, not expected to receive trucks. The foundation wall to the face of the rubber bumper is 13", SOG to the bottom of the dock leveler 21.75", over all dock height 31". Dock extends 14.25" from foundation wall. The dock face below the leveler is adequate. BMU area, not expected to receive trucks. Docks for DOORS 04-07 are similar design. Install a new communications system only, including manual truck chocks.

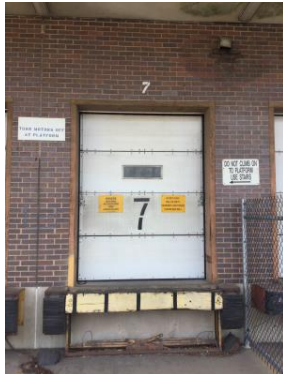
USPS TRSP\Atlantic\Connecticut \Hartford P - DC 083367-G04\DOOR 07

Subsystem Code:	E1030310	Surveyor / Update:	Brendan Baranek-Olmstead	03/23/2022
Subsystem Description:	Loading Dock Equipment, EACH	Qty:	1.00	
Material:				
Distress:	Missing	Deficiency Id:	316197	
Priority:	1 - Currently Critical (Immediate)	Location:	DOOR 07	
Category:	Repair - Alteration			
Correction:	Install Kelley Dock Communication System			
Notes:	No deficiencies observed. BMU area, not expected to receive trucks. The foundation wall to the face of the rubber bumper is 13", SOG to the bottom of the dock leveler 21.75", over all dock height 31". Dock extends 14.25" from foundation wall. The dock face below the leveler is adequate. BMU area, not expected to receive trucks. Docks for DOORS 04-07 are similar design. Install a new communications system only, including manual truck chocks. Left side, facing door, wall section abuts a security screen.

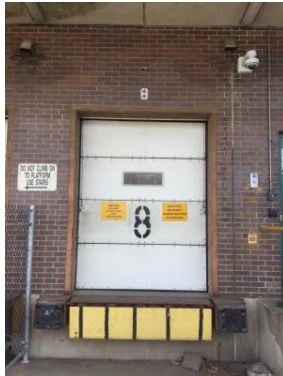
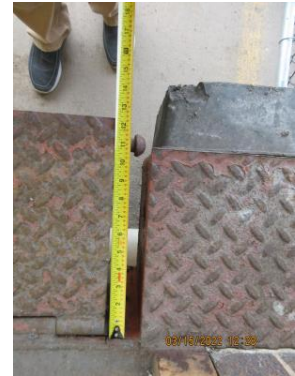
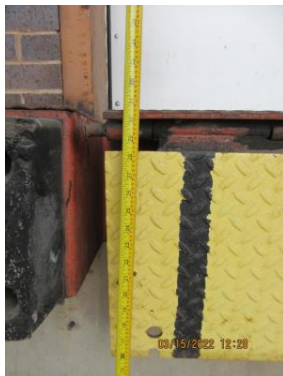
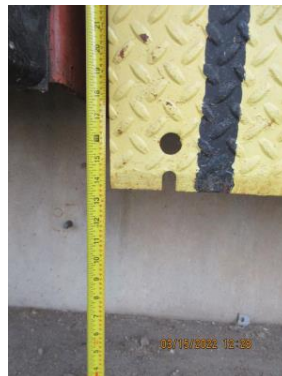
USPS TRSP\Atlantic\Connecticut \Hartford P - DC 083367-G04\DOOR 08

Subsystem Code:	E1030310	Surveyor / Update:	Brendan Baranek-Olmstead	03/23/2022
Subsystem Description:	Loading Dock Equipment, EACH	Qty:	1.00	
Material:				
Distress:	Missing	Deficiency Id:	316198	
Priority:	1 - Currently Critical (Immediate)	Location:	DOOR 08	
Category:	Repair - Alteration			
Correction:	Install Kelley Dock Communication System			
Notes:	No deficiencies observed. BMU area, not expected to receive trucks. The foundation wall to the face of the rubber bumper is 15.25", SOG to the bottom of the dock leveler 13.5", over all dock height 30.5". Dock extends 12.5" from foundation wall. The dock face below the leveler is inadequate. BMU area, not expected to receive trucks. Install a new communications system only, including manual truck chocks. The left side, facing the door, wall sections only available space due to security screen on right side.

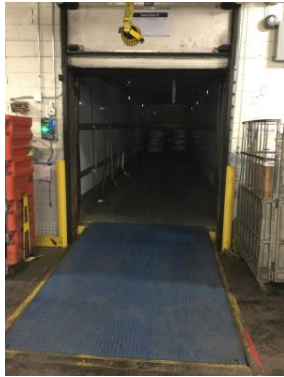
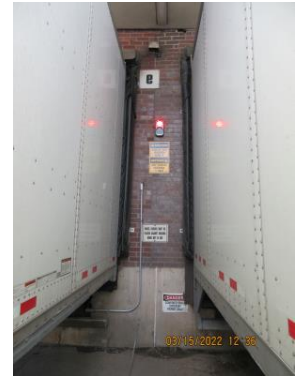
USPS TRSP\Atlantic\Connecticut \Hartford P - DC 083367-G04\DOOR 09

Subsystem Code:	E1030310	Surveyor / Update:	Brendan Baranek-Olmstead	03/23/2022
Subsystem Description:	Loading Dock Equipment, EACH	Qty:	1.00	
Material:				
Distress:	Inadequate	Deficiency Id:	316207	
Priority:	1 - Currently Critical (Immediate)	Location:	DOOR 09	
Category:	Repair - Alteration			
Correction:	Install Kelley Dock Communication System			
Notes:	The foundation wall to the face of the rubber bumper is 7", SOG to the bottom of the dock leveler 20.5", SOG to the bottom of the dock leveler metal frame 15", over all dock height 42". The dock face below the leveler is inadequate. There is an existing Red/Green light and signage mounted to exterior wall, and comm. box mounted on the interior side. Install a new communications system only, including manual truck chocks. Remove the existing Red/Green light and signage mounted to exterior wall, and remove the communication box mounted to the interior side. The dock was partially obstructed from view, the full condition of all dock components could not be verified. The assumption of partial condition is based on the condition of adjacent docks.

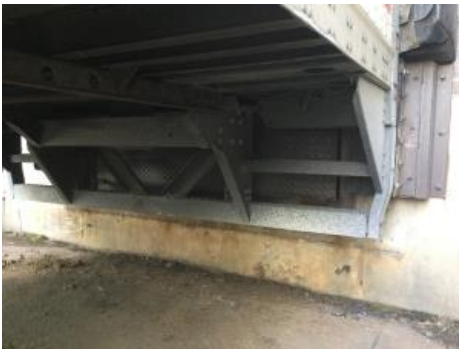
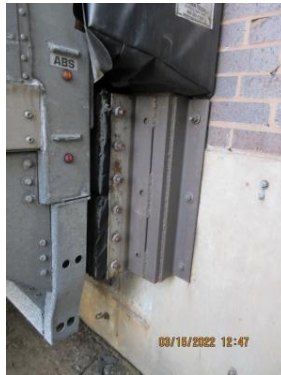
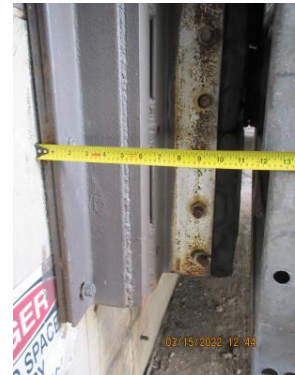
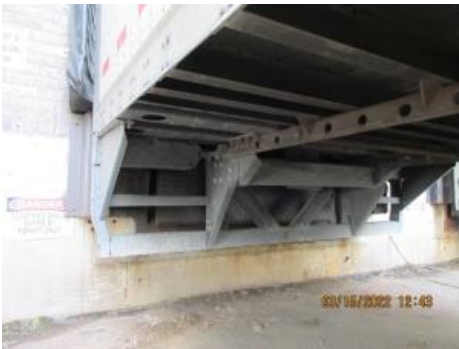
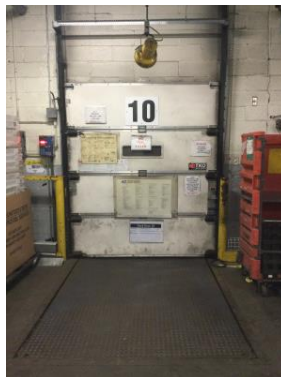
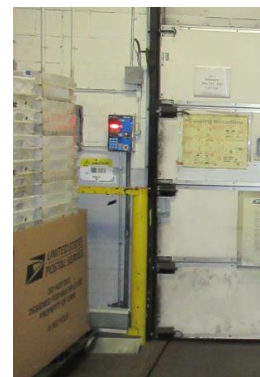
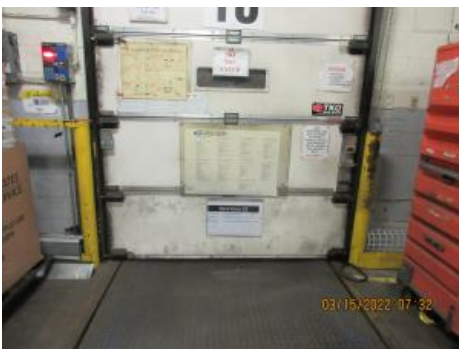
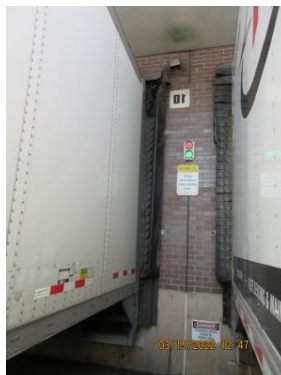
USPS TRSP\Atlantic\Connecticut \Hartford P - DC 083367-G04\DOOR 10

Subsystem Code:	E1030310	Surveyor / Update:	Brendan Baranek-Olmstead	03/23/2022
Subsystem Description:	Loading Dock Equipment, EACH	Qty:	1.00	
Material:				
Distress:	Inadequate	Deficiency Id:	316209	
Priority:	1 - Currently Critical (Immediate)	Location:	DOOR 10	
Category:	Repair - Alteration			
Correction:	Install Kelley Dock Communication System			
Notes:	The foundation wall to the face of the rubber bumper is 11", SOG to the bottom of the dock leveler 20.5", SOG to the bottom of the dock leveler metal frame 15", over all dock height 42". The dock face below the leveler is inadequate. There is an existing Red/Green light and signage mounted to exterior wall, and a comm. box mounted on the interior side. Install a new communications system only, including manual truck chocks. Remove the existing Red/Green light and signage mounted to exterior wall, and a comm. box mounted on the interior side. The dock was partially obstructed from view, the full condition of all dock components could not be verified. The assumption of partial condition is based on the condition of adjacent docks.

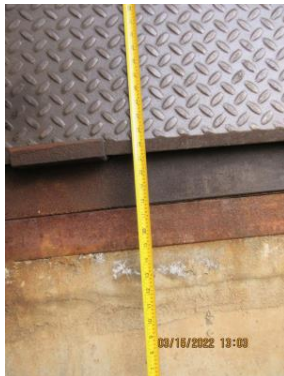
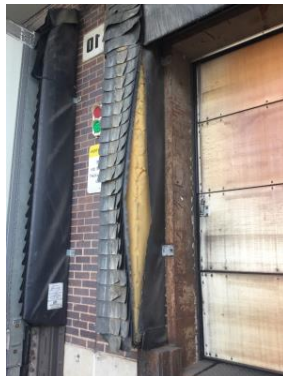
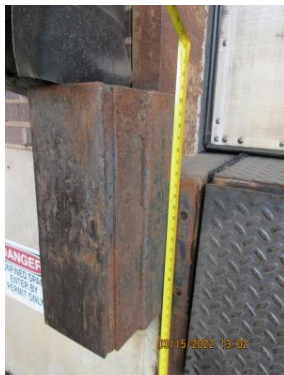
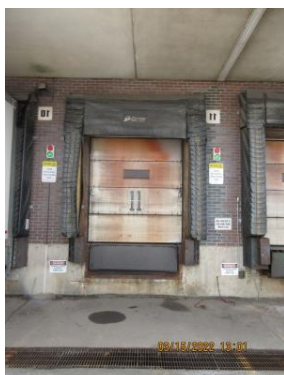
USPS TRSP\Atlantic\Connecticut \Hartford P - DC 083367-G04\DOOR 11

Subsystem Code:	E1030310	Surveyor / Update:	Brendan Baranek-Olmstead	03/23/2022
Subsystem Description:	Loading Dock Equipment, EACH	Qty:	1.00	
Material:				
Distress:	Inadequate	Deficiency Id:	316210	
Priority:	1 - Currently Critical (Immediate)	Location:	DOOR 11	
Category:	Repair - Alteration			
Correction:	Install Kelley Dock Communication System			
Notes:	The foundation wall to the face of the rubber bumper is 8", SOG to the bottom of the dock leveler 21", SOG to the bottom of the dock leveler metal frame 15", over all dock height 42". The dock face below the leveler is inadequate. There is an existing Red/Green light and signage mounted to exterior wall, and comm. box mounted interior side. Install a new communications system only, including manual truck chocks. Remove the existing Red/Green light and signage mounted to exterior wall, and comm. box mounted interior side.

Comm box mounted on right wall

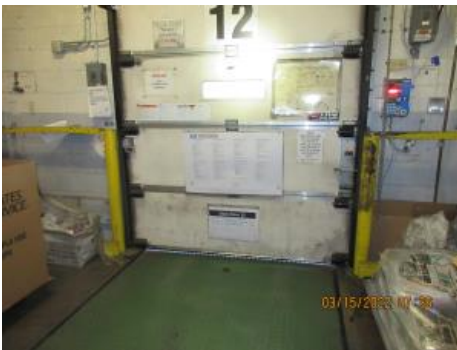
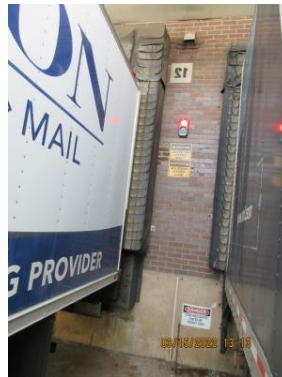
Subsystem Code:	E1030310	Surveyor / Update:	Brendan Baranek-Olmstead	03/24/2022
Subsystem Description:	Loading Dock Equipment, EACH	Qty:	1.00	
Material:				
Distress:	Inadequate	Deficiency Id:	316211	
Priority:	1 - Currently Critical (Immediate)	Location:	DOOR 12	
Category:	Repair - Alteration			
Correction:	Install Star 4 Truck Restraint W/ Cantilever Mounting Bracket			
Notes:	The foundation wall to the face of the rubber bumper is 17", SOG to the bottom of the dock leveler 19.75", over all dock height 42". Folded dock leveler edge extends 13" from foundation wall. The dock face below the leveler is adequate. There is an existing Red/Green light and signage mounted to exterior wall, and comm. box mounted on the interior side. Install a new Kelley truck restraint system. Remove the existing Red/Green light and signage mounted to exterior wall, and comm. box mounted interior side. The dock was partially obstructed from view, the full condition of all dock components could not be verified. The assumption of partial condition is based on the condition of adjacent docks.

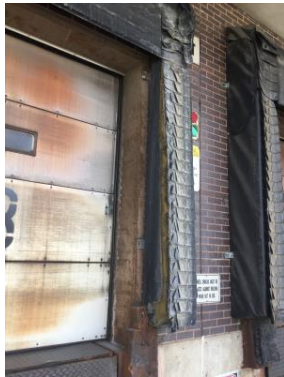
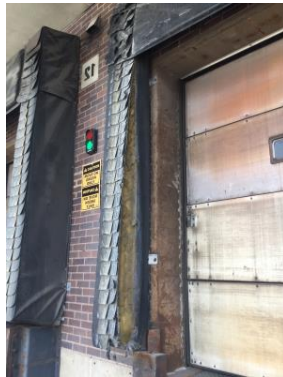
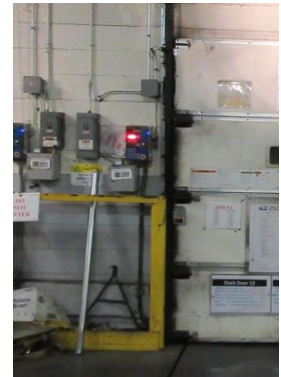
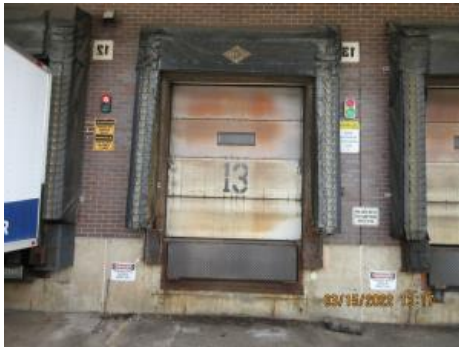
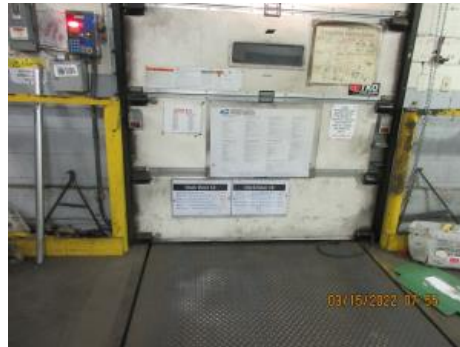
Subsystem Code:	E1030310	Surveyor / Update:	Brendan Baranek-Olmstead	03/24/2022
Subsystem Description:	Loading Dock Equipment, EACH	Qty:	1.00	
Material:				
Distress:	Missing	Deficiency Id:	316212	
Priority:	1 - Currently Critical (Immediate)	Location:	DOOR 13	
Category:	Repair - Alteration			
Correction:	Install Kelley Dock Communication System			
Notes:	The foundation wall to the face of the rubber bumper is 4.5", SOG to the bottom of the dock leveler 21.5", SOG to the bottom of the dock leveler metal frame 15", over all dock height 42". The dock face below the leveler is inadequate. There is an existing Red/Green light and signage mounted to exterior wall, and comm. box mounted on the interior side. Install a new communications system only, including manual truck chocks. 2 hours of labor have been added to remove the existing Red/Green light and signage mounted to exterior wall, and comm. box mounted on the interior side.

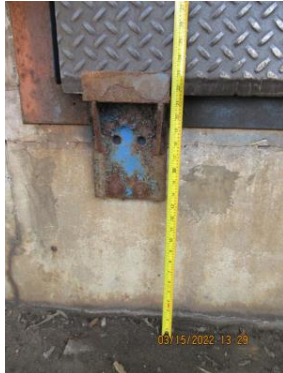
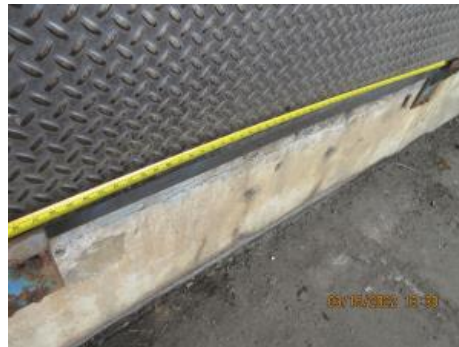
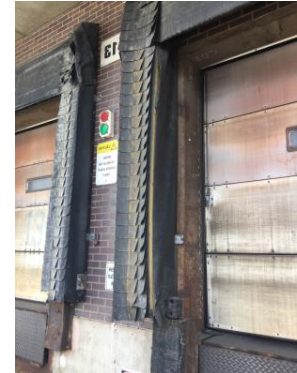
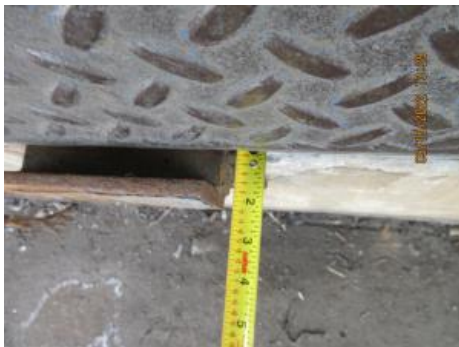
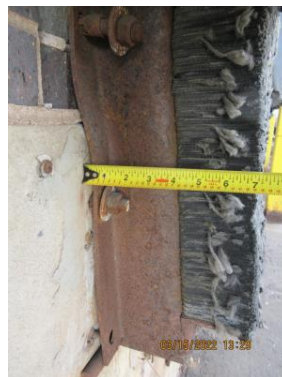
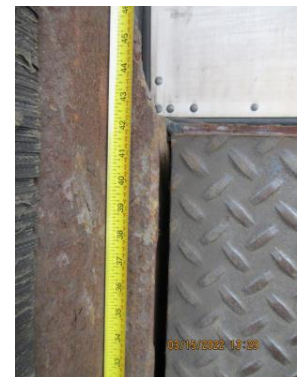
USPS TRSP\Atlantic\Connecticut \Hartford P - DC 083367-G04\DOOR 14

Subsystem Code:	E1030310	Surveyor / Update:	Brendan Baranek-Olmstead	03/24/2022
Subsystem Description:	Loading Dock Equipment, EACH	Qty:	1.00	
Material:				
Distress:	Missing	Deficiency Id:	316213	
Priority:	1 - Currently Critical (Immediate)	Location:	DOOR 14	
Category:	Repair - Alteration			
Correction:	Install Kelley Dock Communication System			
Notes:

The foundation wall to the face of the rubber bumper is 7.5" Left and 9.5" right, SOG to the bottom of the dock leveler 21.5", SOG to the bottom of the dock leveler metal frame 19", over all dock height 42". Dock leveler has support braces attached to foundation wall with 13" clearance SOG to bottom of brace. The inner edge of the braces are 56.75" apart centered on the loading doc. The dock face below the leveler is inadequate. There is an existing Red/Green light mounted to exterior wall, and comm. box mounted on the interior side. Install a new communications system only, including manual truck chocks. Remove the existing Red/Green light mounted to exterior wall, and comm. box mounted on the interior side.

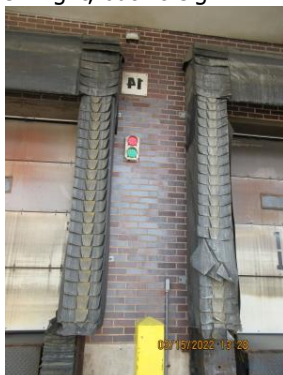
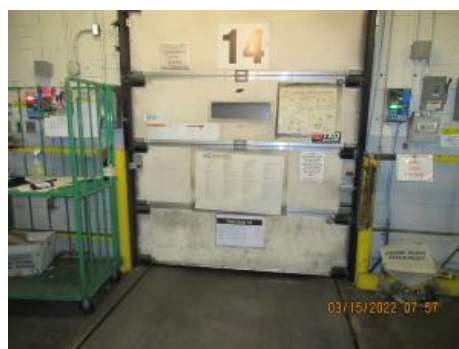
Red/Green Light, but no sign

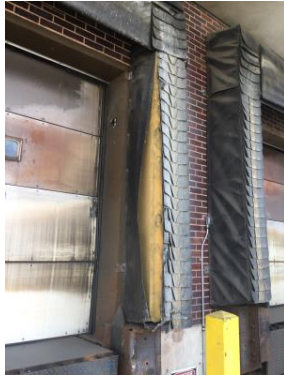
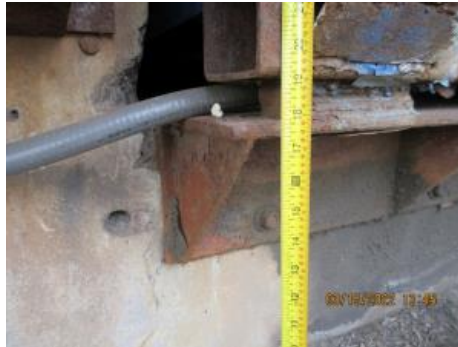
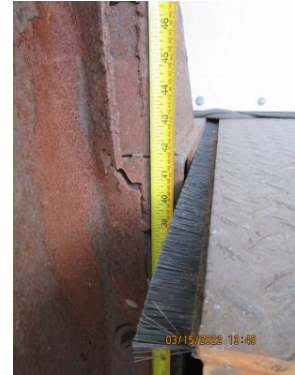
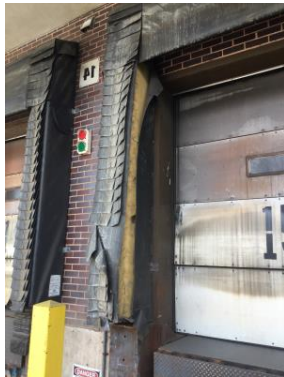
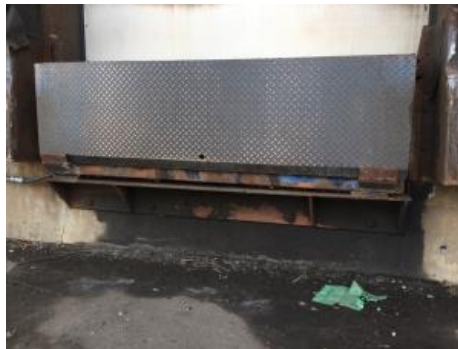
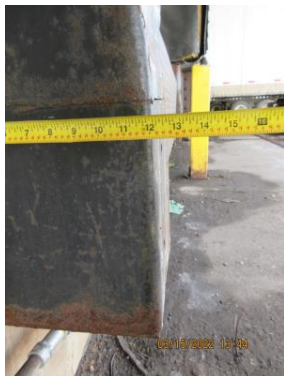
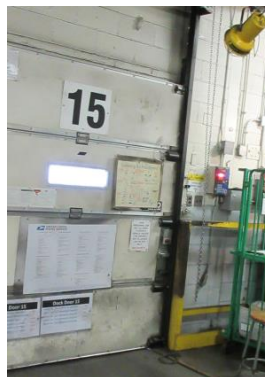
USPS TRSP\Atlantic\Connecticut \Hartford P - DC 083367-G04\DOOR 15

Distress:	Inadequate	Deficiency Id:	316214
Priority:	1 - Currently Critical (Immediate)	Location:	DOOR 15
Category:	Repair - Alteration		
Correction:	Install Kelley Dock Communication System		
Notes:	The foundation wall to the face of the rubber bumper is 12", SOG to the bottom of the dock leveler 17.25", SOG to the bottom of the dock leveler angled braces 13", over all dock height 42". Folded dock leveler extends 10" from foundation wall by angled braces. The dock face below the leveler is inadequate. There is an existing Red/Green light mounted to exterior wall, and comm. box mounted on the interior side. Install a new communications system only, including manual truck chocks. Remove the existing Red/Green light mounted to exterior wall, and comm. box mounted on the interior side.

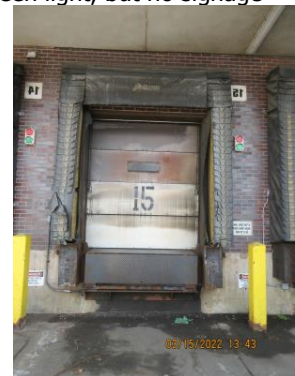
Red/Green light, but no signage

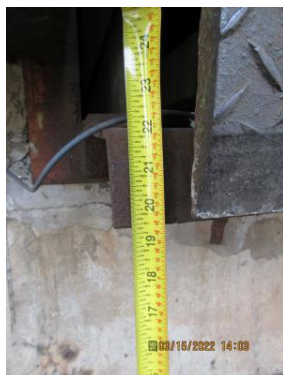
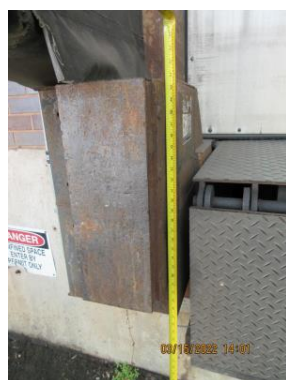
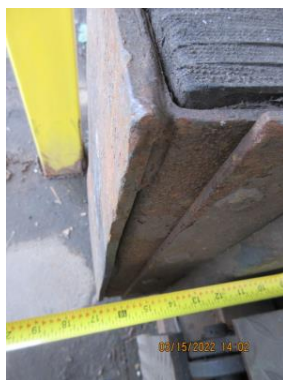
USPS TRSP\Atlantic\Connecticut \Hartford P - DC 083367-G04\DOOR 16

Subsystem Code:	E1030310	Surveyor / Update:	Brendan Baranek-Olmstead	03/24/2022
Subsystem Description:	Loading Dock Equipment, EACH	Qty:	1.00	
Material:				
Distress:	Inadequate	Deficiency Id:	316215	
Priority:	3 - Necessary/Not Yet Critical (Years 2-5)	Location:	DOOR 16	
Category:	Repair - Alteration			
Correction:	Install Kelley Dock Communication System			
Notes:	The foundation wall to the face of the rubber bumper is 12", SOG to the bottom of the dock leveler 19.5", over all dock height 42". Folded dock leveler extends 13" from foundation wall. The dock face below the leveler is inadequate. There is an existing Red/Green light and signage mounted to exterior wall, and comm. box mounted on the interior side. Install a new communications system only, including manual truck chocks. Remove the existing Red/Green light and signage mounted to exterior wall, and comm. box mounted on the interior side.

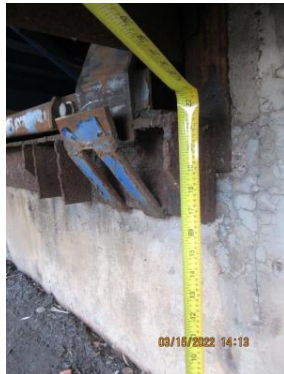
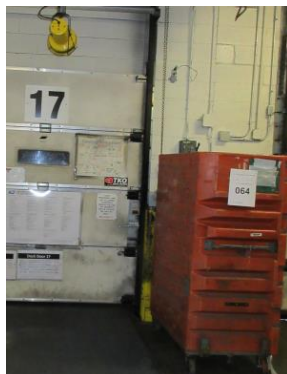
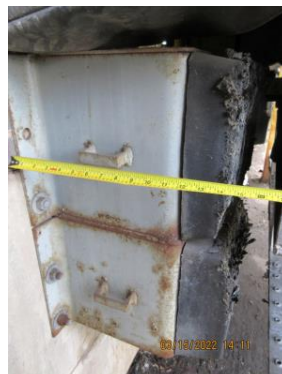
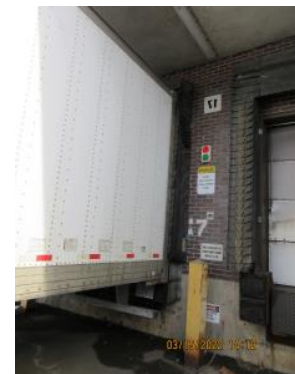
USPS TRSP\Atlantic\Connecticut \Hartford P - DC 083367-G04\DOOR 17

Subsystem Code:	E1030310	Surveyor / Update:	Brendan Baranek-Olmstead	03/24/2022
Subsystem Description:	Loading Dock Equipment, EACH	Qty:	1.00	
Material:				
Distress:	Inadequate	Deficiency Id:	316216	
Priority:	1 - Currently Critical (Immediate)	Location:	DOOR 17	
Category:	Repair - Alteration			
Correction:	Install Kelley Dock Communication System			
Notes:

The foundation wall to the face of the rubber bumper is 15", SOG to the bottom of the dock leveler 16", over all dock height 42". The dock face below the leveler is inadequate. The folded dock leveler had 4" depth off foundation wall, distance between braces unknown. There is an existing Red/Green light and signage mounted to exterior wall, and comm. box mounted to the interior side. Install a new communications system only, including manual truck chocks. Remove the existing Red/Green light and signage mounted to exterior wall, and comm. box mounted to the interior side. The dock was partially obstructed from view, the full condition of all dock components could not be verified. The assumption of partial condition is based on the condition of adjacent docks.

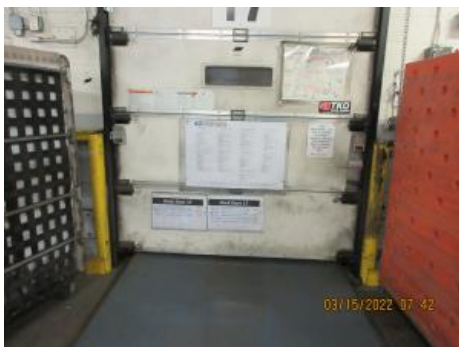
Right side of door, on wall

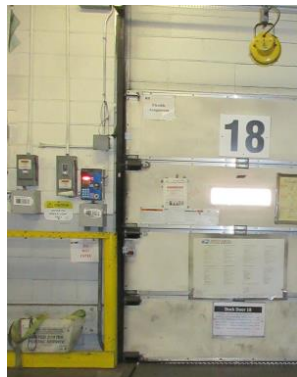
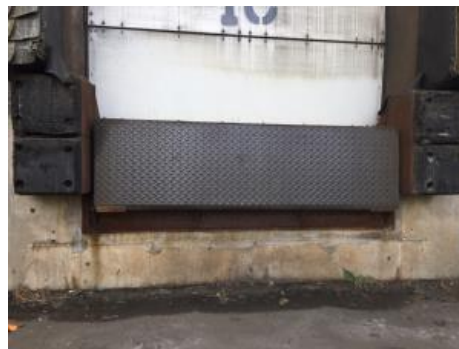
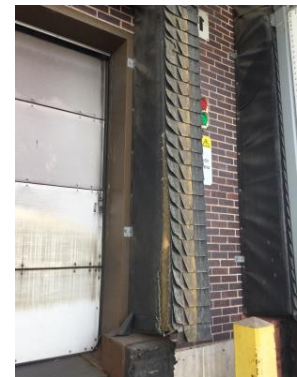
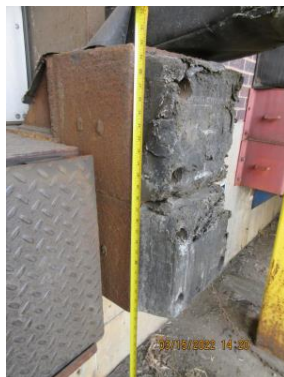
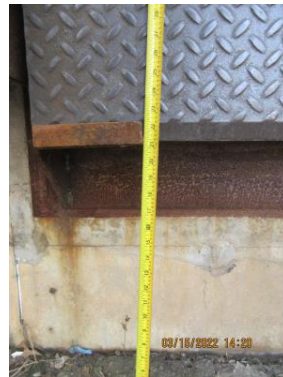
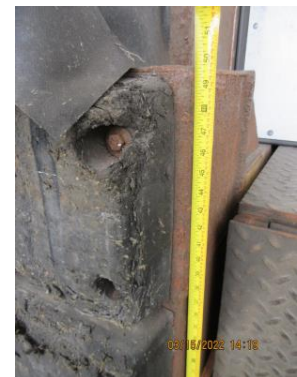
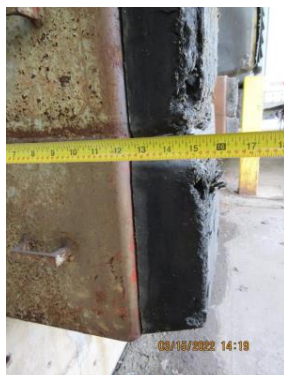
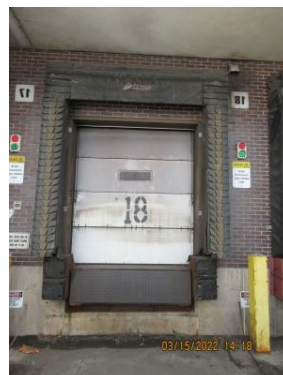
USPS TRSP\Atlantic\Connecticut \Hartford P - DC 083367-G04\DOOR 18

Subsystem Code:	E1030310	Surveyor / Update:	Brendan Baranek-Olmstead	03/24/2022
Subsystem Description:	Loading Dock Equipment, EACH	Qty:	1.00	
Material:				
Distress:	Inadequate	Deficiency Id:	316217	
Priority:	1 - Currently Critical (Immediate)	Location:	DOOR 18	
Category:	Repair - Alteration			
Correction:	Install Kelley Dock Communication System			
Notes:	The foundation wall to the face of the rubber bumper is 14.5", SOG to the bottom of the dock leveler 20.5", SOG to the bottom of the dock leveler angled braces 13", over all dock height 42". Folded dock leveler extends 10" from foundation wall by angled braces. The dock face below the leveler is inadequate. There is an existing Red/Green light and signage mounted to the exterior wall, and a comm. box mounted to the interior side. Install a new communications system only, including manual truck chocks. Remove the existing Red/Green light and signage mounted to the exterior wall, and a comm. box mounted to the interior side.

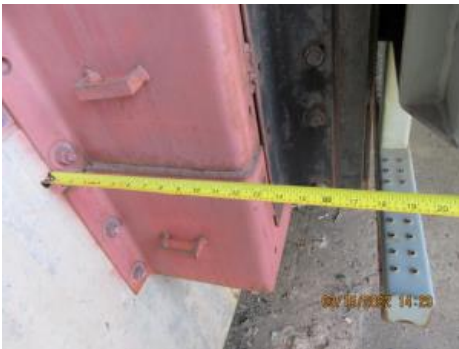
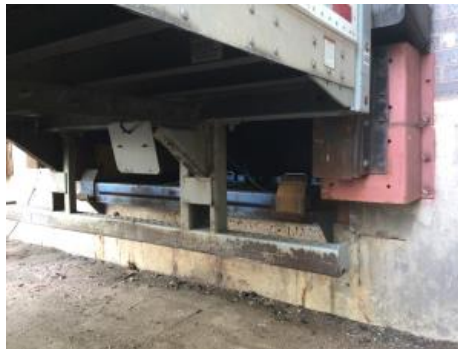
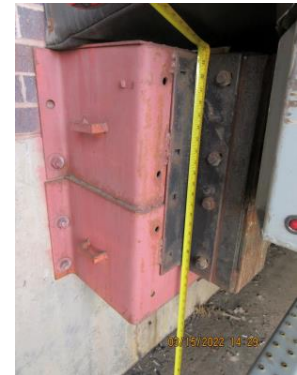
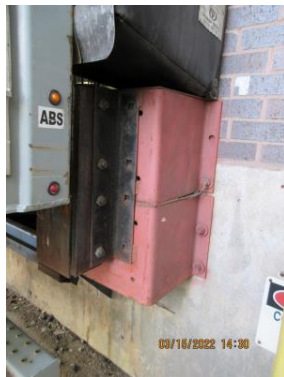
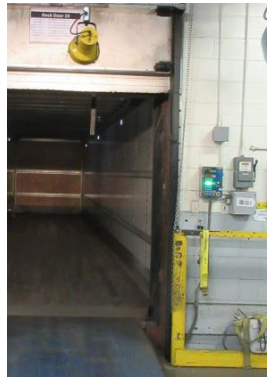
Subsystem Code:	E1030310	Surveyor / Update:	Brendan Baranek-Olmstead	03/24/2022
Subsystem Description:	Loading Dock Equipment, EACH	Qty:	1.00	
Material:				
Distress:	Inadequate	Deficiency Id:	316218	
Priority:	1 - Currently Critical (Immediate)	Location:	DOOR 19	
Category:	Repair - Alteration			
Correction:	Install Kelley Dock Communication System			
Notes:	The foundation wall to the face of the rubber bumper is 17.5", SOG to the bottom of the dock leveler 20.5", SOG to the bottom of the dock leveler angled braces 13", over all dock height 42". Folded dock leveler extends 8" from foundation wall by angled braces. The dock face below the leveler is inadequate. There is an existing Red/Green light and signage mounted to the exterior wall, and a comm. box mounted to the interior side. Install a new communications system only, including manual truck chocks. Removal of the existing Red/Green light and signage mounted to the exterior wall, and a comm. box mounted to the interior side. The dock was partially obstructed from view, the full condition of all dock components could not be verified. The assumption of partial condition is based on the condition of adjacent docks.

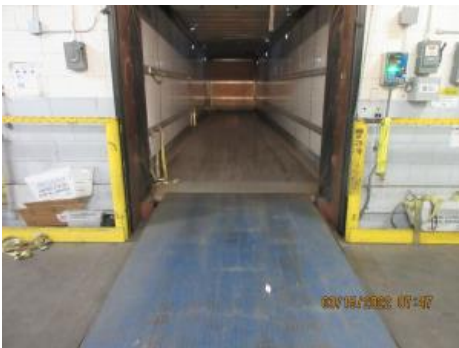
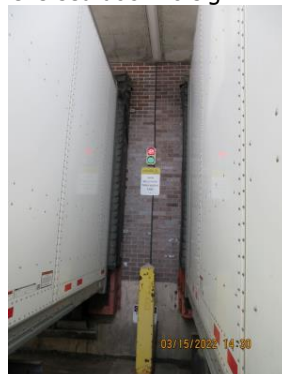
USPS TRSP\Atlantic\Connecticut \Hartford P - DC 083367-G04\DOOR 20

Missing reversed dock no sigh

Subsystem Code:	E1030310	Surveyor / Update:	Brendan Baranek-Olmstead	03/24/2022
Subsystem Description:	Loading Dock Equipment, EACH	Qty:	1.00	
Material:				
Distress:	Inadequate	Deficiency Id:	316219	
Priority:	3 - Necessary/Not Yet Critical (Years 2-5)	Location:	DOOR 20	
Category:	Repair - Alteration			
Correction:	Install Kelley Dock Communication System			
Notes:

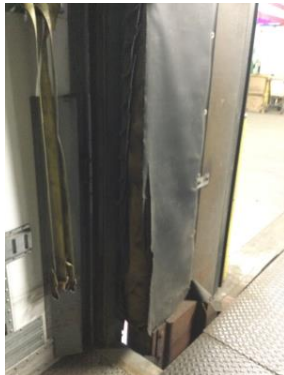
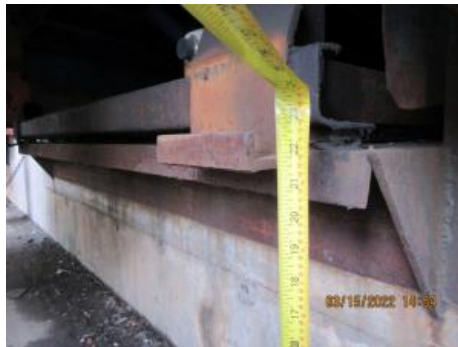
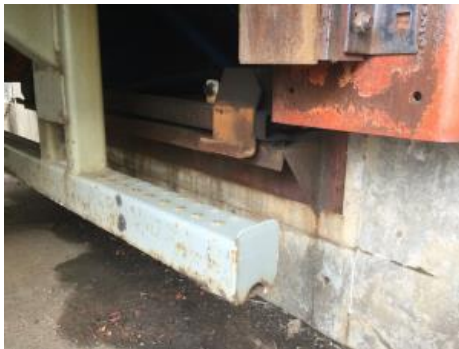
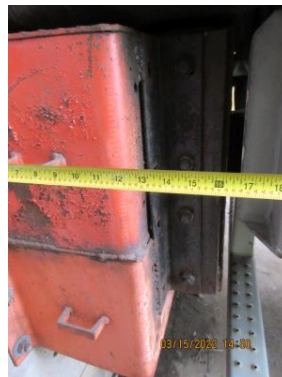
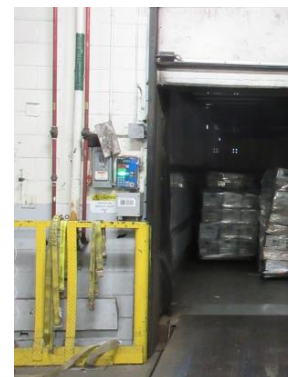
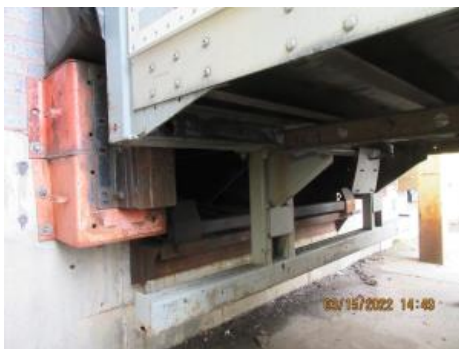
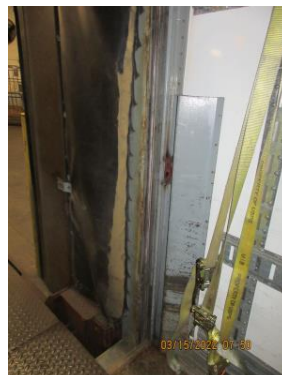
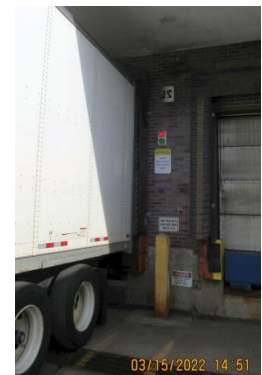
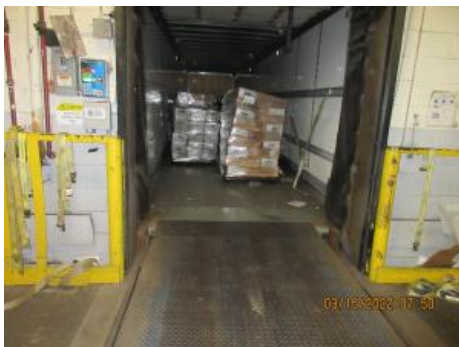
USPS TRSP\Atlantic\Connecticut \Hartford P - DC 083367-G04\DOOR 21

The foundation wall to the face of the rubber bumper is 16", SOG to the bottom of the dock leveler 20", SOG to the bottom of the dock leveler angled braces 14", over all dock height 42". Folded dock leveler extends 10" from foundation wall by angled braces. The dock face below the leveler is inadequate. There is an existing Red/Green light and signage mounted to the exterior wall, and a comm. box mounted to the interior side. Install a new communications system only, including manual truck chocks. Remove the existing Red/Green light and signage mounted to the exterior wall, and a comm. box mounted to the interior side. The dock was partially obstructed from view, the full condition of all dock components could not be verified. The assumption of partial condition is based on the condition of adjacent docks.

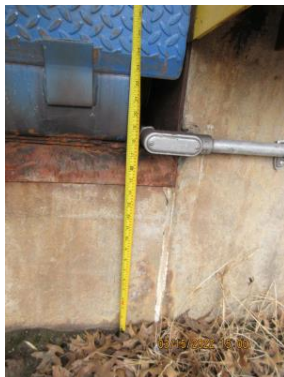
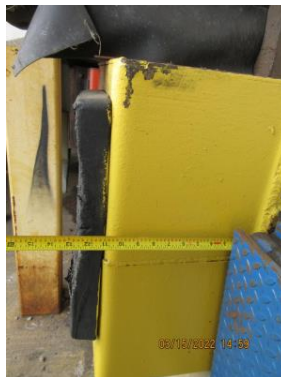
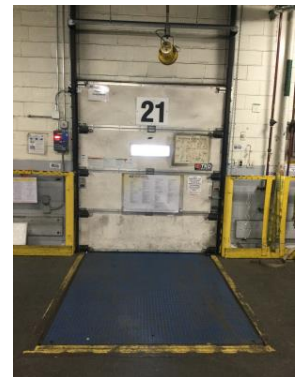
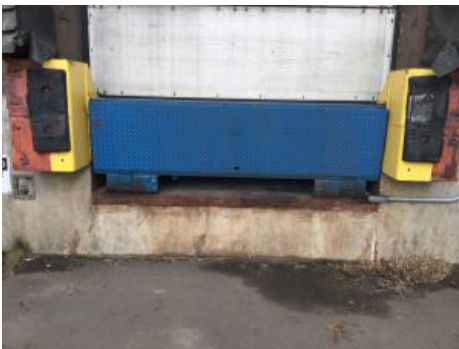
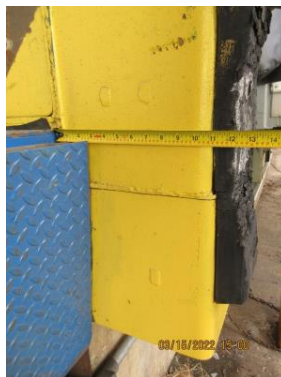
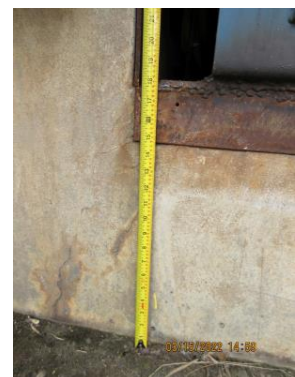
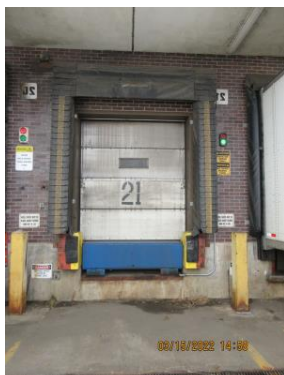
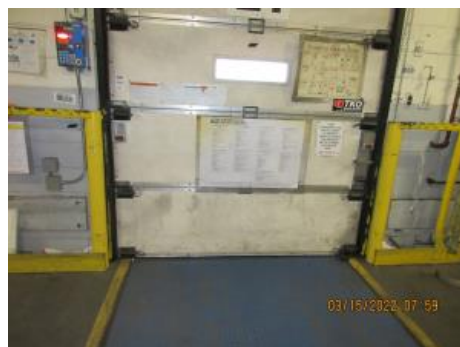
Subsystem Code:	E1030310	Surveyor / Update:	Brendan Baranek-Olmstead	03/24/2022
Subsystem Description:	Loading Dock Equipment, EACH	Qty:	1.00	
Material:				
Distress:	Inadequate	Deficiency Id:	316221	
Priority:	1 - Currently Critical (Immediate)	Location:	DOOR 21	
Category:	Repair - Alteration			
Correction:	Install Kelley Dock Communication System			
Notes:	The foundation wall to the face of the rubber bumper is 12", SOG to the bottom of the dock leveler 28.5", SOG to the bottom of the dock leveler metal frame 14.75", over all dock height 42". The dock face below the leveler is inadequate. There is an existing Red/Green light and signage mounted to the exterior wall, and a comm. box mounted to the interior side. Install a new communications system only, including manual truck chocks. Remove the existing Red/Green light and signage mounted to the exterior wall, and a comm. box mounted to the interior side.

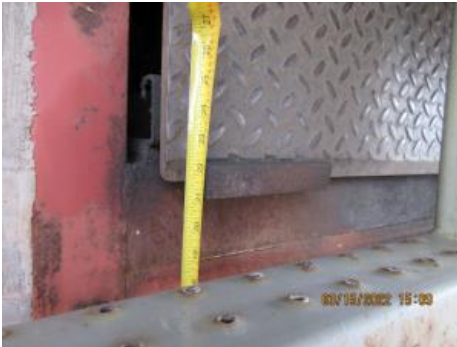
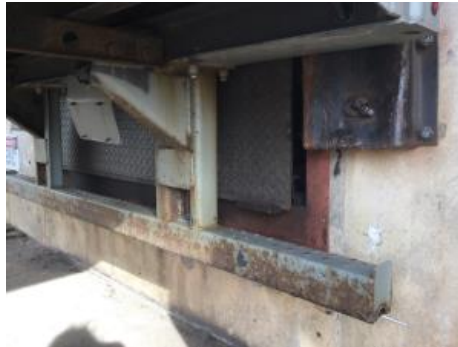
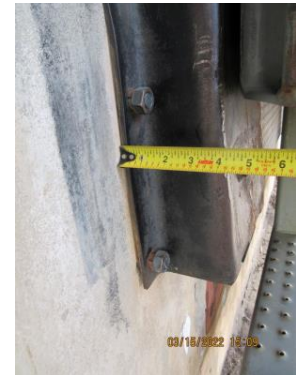
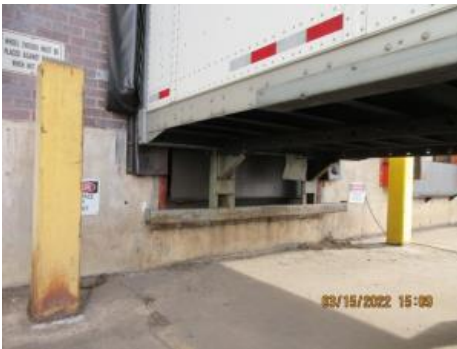
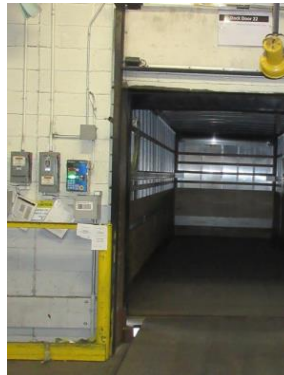
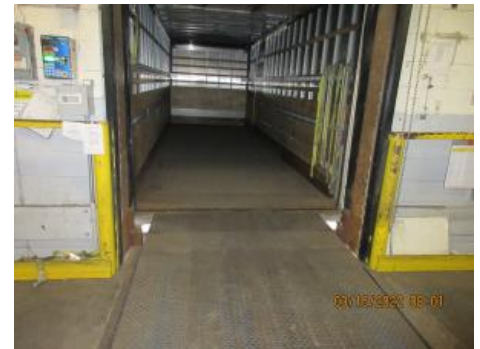
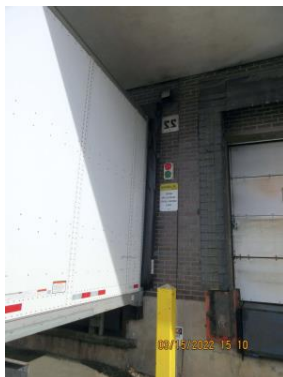
USPS TRSP\Atlantic\Connecticut \Hartford P - DC 083367-G04\DOOR 23

Subsystem Code:	E1030310	Surveyor / Update:	Brendan Baranek-Olmstead	03/24/2022
Subsystem Description:	Loading Dock Equipment, EACH	Qty:	1.00	
Material:				
Distress:	Inadequate	Deficiency Id:	316222	
Priority:	1 - Currently Critical (Immediate)	Location:	DOOR 22	
Category:	Repair - Alteration			
Correction:	Install Kelley Dock Communication System			
Notes:	The foundation wall to the face of the rubber bumper is 4", SOG to the bottom of the dock leveler 20.5", SOG to the bottom of the dock leveler metal frame 15", over all dock height 42". The dock face below the leveler is inadequate. There is an existing Red/Green light and signage mounted to the exterior wall, and a comm. box mounted to the interior side. Install a new communications system only, including manual truck chocks. Remove the existing Red/Green light and signage mounted to the exterior wall, and a comm. box mounted to the interior side. The dock was partially obstructed from view, the full condition of all dock components could not be verified. The assumption of partial condition is based on the condition of adjacent docks.

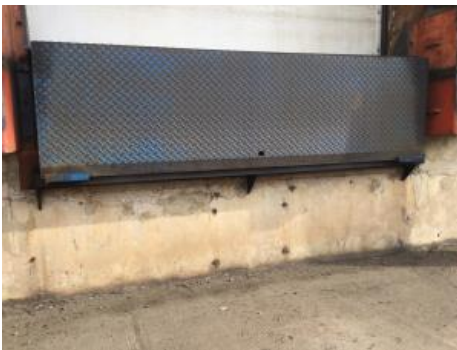
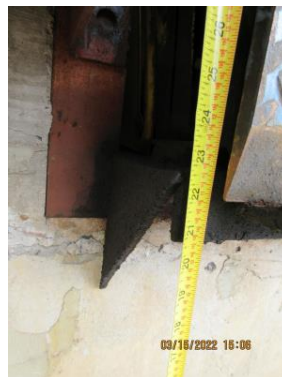
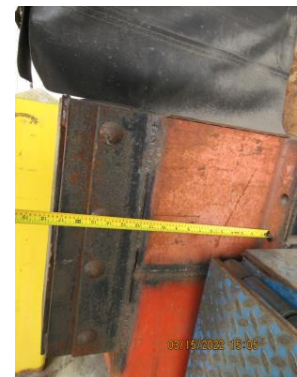
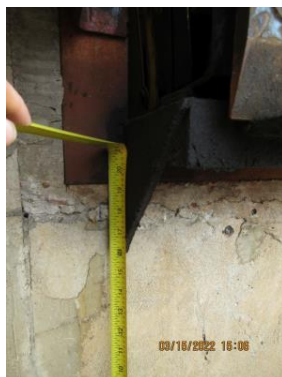
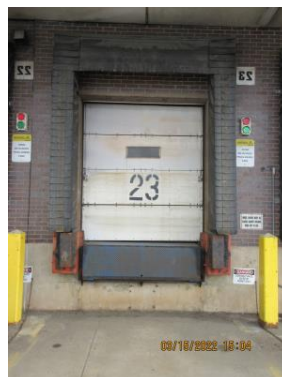
Subsystem Code:	E1030310	Surveyor / Update:	Brendan Baranek-Olmstead	03/24/2022
Subsystem Description:	Loading Dock Equipment, EACH	Qty:	1.00	
Material:				
Distress:	Inadequate	Deficiency Id:	316223	
Priority:	1 - Currently Critical (Immediate)	Location:	DOOR 23	
Category:	Repair - Alteration			
Correction:	Install Kelley Dock Communication System			
Notes:	The foundation wall to the face of the rubber bumper is 17.5", SOG to the bottom of the dock leveler 20", SOG to the bottom of the dock leveler angled braces 16", over all dock height 42". Folded dock leveler extends 8" from foundation wall by angled braces. The dock face below the leveler is inadequate. There is an existing Red/Green light and signage mounted to the exterior wall, and a comm. box mounted to the interior side. Install a new communications system only, including manual truck chocks. Removal of the existing Red/Green light and signage mounted to the exterior wall, and a comm. box mounted to the interior side.
