TRUCK RESTRAINT PROGRAM – USPS P&DC- Hartford, CT
141 Weston ST, Hartford, CT 06101-9612

SCOPE OF WORK PACKAGE (RFP 743672-31678P) Date 08/5/2022

General Findings and Condition Report (eCOMET Enhanced Deficiency Sheet Report)

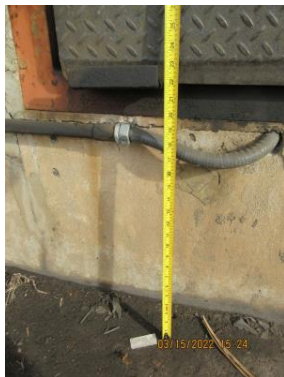
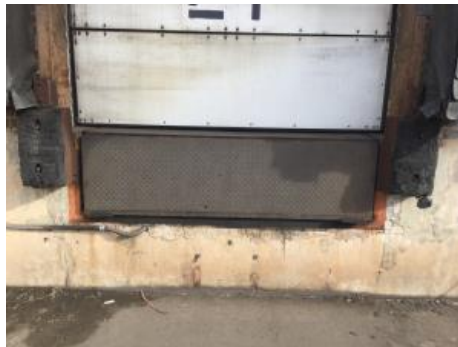
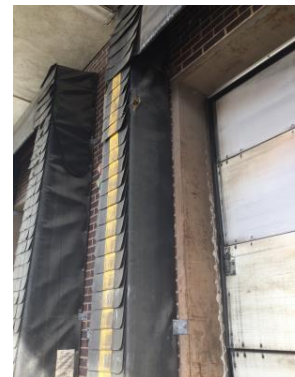
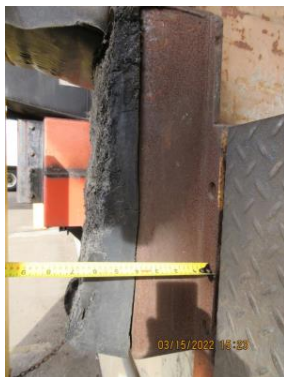
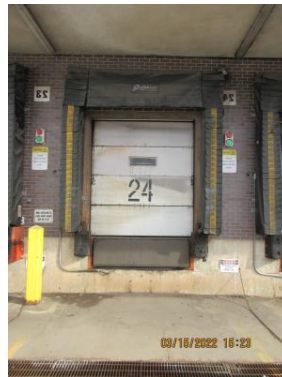
Subsystem Code:	E1030310	Surveyor / Update:	Brendan Baranek-Olmstead	03/24/2022
Subsystem Description:	Loading Dock Equipment, EACH	Qty:	1.00	
Material:				
Distress:	Inadequate	Deficiency Id:	316224	
Priority:	1 - Currently Critical (Immediate)	Location:	DOOR 24	
Category:	Repair - Alteration			
Correction:	Install Kelley Dock Communication System			
Notes:	The foundation wall to the face of the rubber bumper is 7", SOG to the bottom of the dock leveler 21.5", SOG to the bottom of the dock leveler metal frame 20", over all dock height 42". The dock face below the leveler is inadequate. Left side of dock has conduit to leveler. There is an existing Red/Green light and signage mounted to the exterior wall, and a comm. box mounted to the interior side. Install a new communications system only, including manual truck chocks. Removal of the existing Red/Green light and signage mounted to the exterior wall, and a comm. box mounted to the interior side.

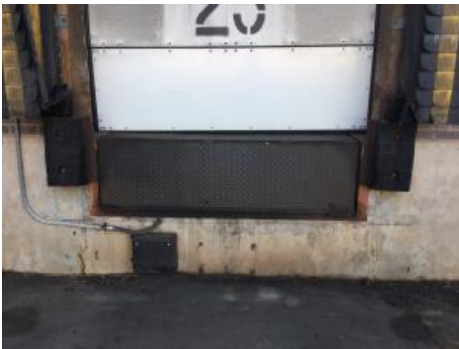
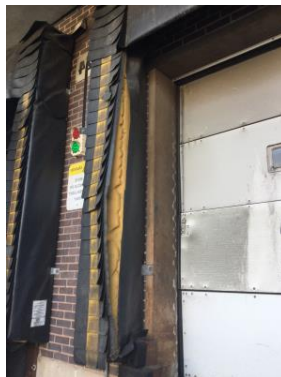
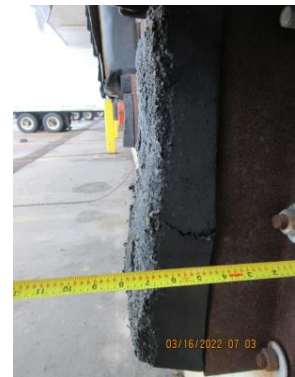
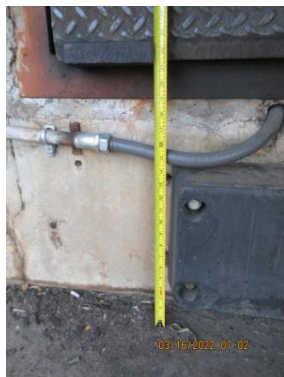
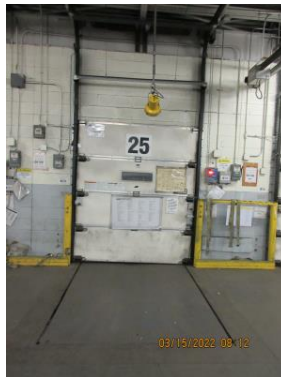
Subsystem Code:	E1030310	Surveyor / Update:	Brendan Baranek-Olmstead	03/28/2022
Subsystem Description:	Loading Dock Equipment, EACH	Qty:	1.00	
Material:				
Distress:	Inadequate	Deficiency Id:	316358	
Priority:	1 - Currently Critical (Immediate)	Location:	DOOR 25	
Category:	Repair - Alteration			
Correction:	Install Kelley Dock Communication System			
Notes:	The foundation wall to the face of the rubber bumper is 7", SOG to the bottom of the dock leveler 21", over all dock height 42". The dock face below the leveler is inadequate. Left side of dock has conduit to leveler. There is an existing Red/Green light and signage mounted to the exterior wall, and a comm. box mounted to the interior side. Install a new communications system only, including manual truck chocks. Removal of the existing Red/Green light and signage mounted to the exterior wall, and a comm. box mounted to the interior side.

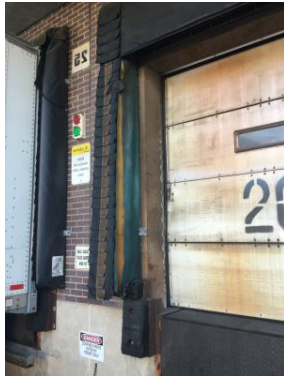
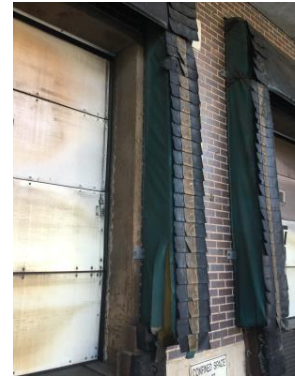
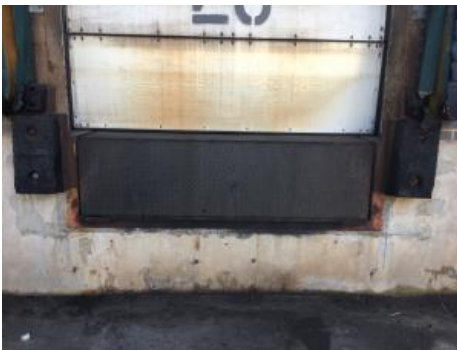
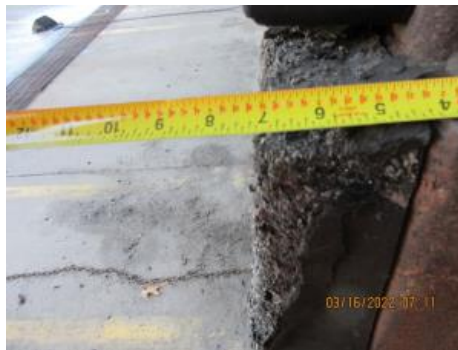
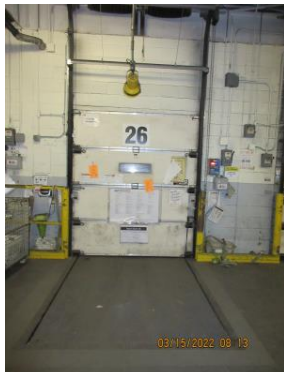
Subsystem Code:	E1030310	Surveyor / Update:	Brendan Baranek-Olmstead	03/28/2022
Subsystem Description:	Loading Dock Equipment, EACH	Qty:	1.00	
Material:				
Distress:	Inadequate	Deficiency Id:	316359	
Priority:	1 - Currently Critical (Immediate)	Location:	DOOR 26	
Category:	Repair - Alteration			
Correction:	Install Kelley Dock Communication System			
Notes:	The foundation wall to the face of the rubber bumper is 7", SOG to the bottom of the dock leveler 21", over all dock height 42". The dock face below the leveler is inadequate. There is an existing Red/Green light and signage mounted to the exterior wall, and a comm. box mounted interior side. Install a new communications system only, including manual truck chocks. Removal of the existing Red/Green light and signage mounted to the exterior wall, and a comm. box mounted interior side.

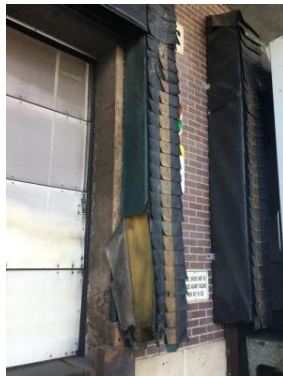
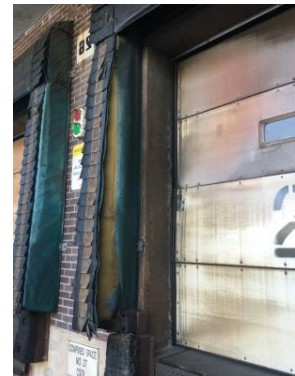
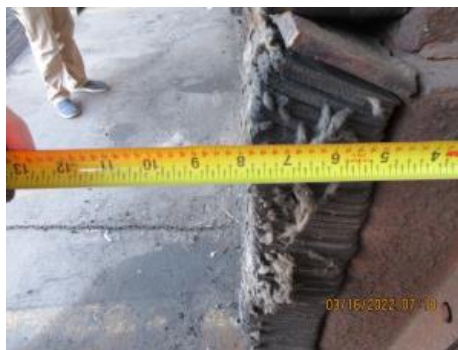
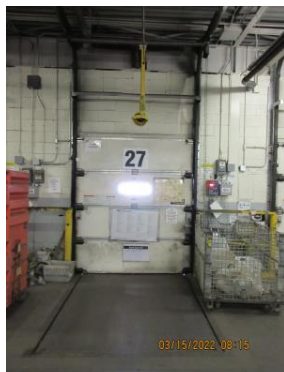
Subsystem Code:	E1030310	Surveyor / Update:	Brendan Baranek-Olmstead	03/28/2022
Subsystem Description:	Loading Dock Equipment, EACH	Qty:	1.00	
Material:				
Distress:	Inadequate	Deficiency Id:	316362	
Priority:	1 - Currently Critical (Immediate)	Location:	DOOR 27	
Category:	Repair - Alteration			
Correction:	Install Kelley Dock Communication System			
Notes:	The foundation wall to the face of the rubber bumper is 7", SOG to the bottom of the dock leveler 21", over all dock height 42". The dock face below the leveler is inadequate. There is an existing Red/Green light and signage mounted to the exterior wall, and a comm. box mounted to the interior side. Install a new communications system only, including manual truck chocks. Removal of the existing Red/Green light and signage mounted to the exterior wall, and a comm. box mounted to the interior side.

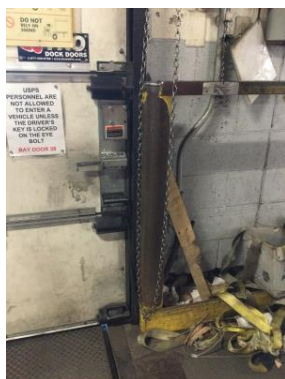
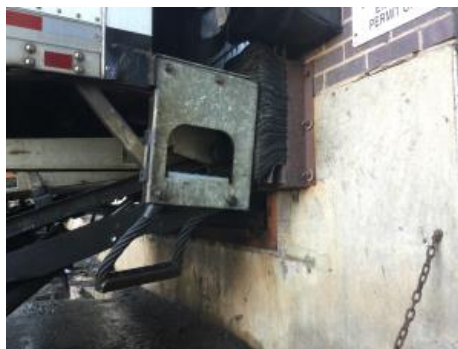
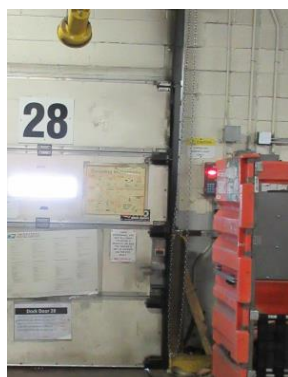
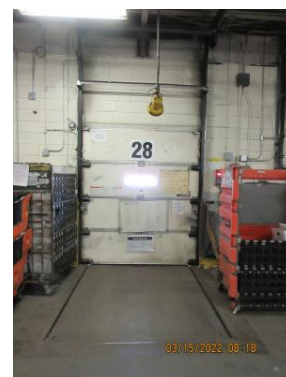
Subsystem Code:	E1030310	Surveyor / Update:	Brendan Baranek-Olmstead	03/28/2022
Subsystem Description:	Loading Dock Equipment, EACH	Qty:	1.00	
Material:				
Distress:	Inadequate	Deficiency Id:	316364	
Priority:	1 - Currently Critical (Immediate)	Location:	DOOR 28	
Category:	Repair - Alteration			
Correction:	Install Kelley Dock Communication System			
Notes:	The foundation wall to the face of the rubber bumper is 10", SOG to the bottom of the dock leveler 21", over all dock height 42". The dock face below the leveler is inadequate. There is an existing Red/Green light and signage mounted to the exterior wall, and a comm. box mounted to the interior side. Install a new communications system only, including manual truck chocks. Removal of the existing Red/Green light and signage mounted to the exterior wall, and a comm. box mounted to the interior side. The dock was partially obstructed from view, the full condition of all dock components could not be verified. The assumption of partial condition is based on the condition of adjacent docks.

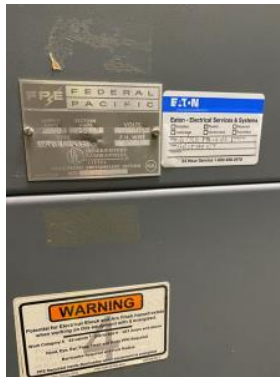
Subsystem Code:	D5010	Surveyor / Update:	Stephen Butler	04/04/2022
Subsystem Description:	Electrical Service/Distribution	Qty:	1.00	
Material:				
Distress:	Inadequate	Deficiency Id:	317369	
Priority:	3 - Necessary/Not Yet Critical (Years 2-5)	Location:	B2 (DOORS 29-49)	
Category:	Repair - Alteration			
Correction:	Provide New 30-kVA Step-down Transformer w/new 3P Circuit Breaker			
Notes:	For doors 29 - 50, the existing power panels in the area of these doors are Federal Pacific brand, they are obsolete and not usable. Provide a new 30-kVA, 480-208Y/120VAC step-down transformer to feed a new 3-phase, 208Y120VAC power panel at column B2 to support the truck restraint system loads. Maximum distance from the new panel to farthest door is 225'. The main power panel MS-1 in the electrical room located at column line C2, add a new 50A, 3-pole, circuit breaker in one of the open spaces. Install a circuit breaker to match the existing type and KAIC rating. The maximum feeder distance from power panel DLP1 is 50'.

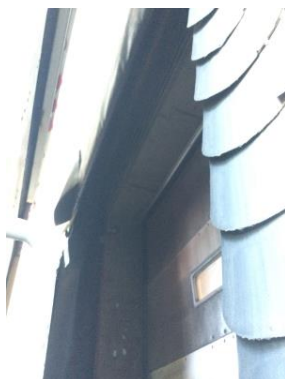
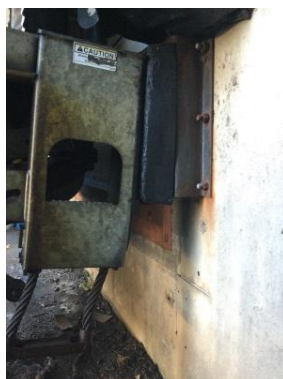
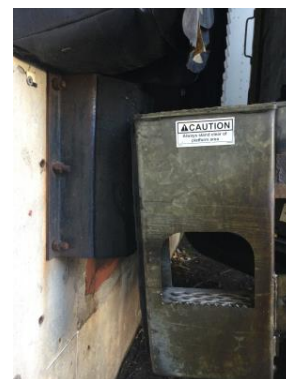
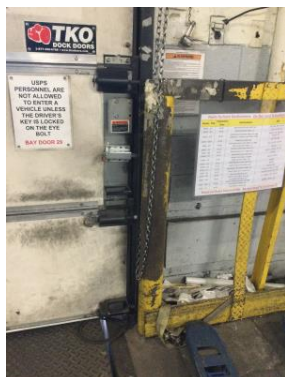
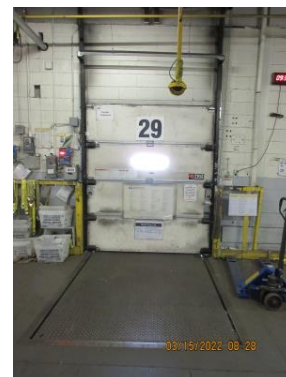
Subsystem Code:	E1030310	Surveyor / Update:	Brendan Baranek-Olmstead	03/28/2022
Subsystem Description:	Loading Dock Equipment, EACH	Qty:	1.00	
Material:				
Distress:	Inadequate	Deficiency Id:	316366	
Priority:	1 - Currently Critical (Immediate)	Location:	DOOR 29	
Category:	Repair - Alteration			
Correction:	Install Kelley Dock Communication System			
Notes:	The foundation wall to the face of the rubber bumper is 8", SOG to the bottom of the dock leveler 29", over all dock height 51". The dock face below the leveler is inadequate. There is an existing Red/Green light and signage mounted to the exterior wall, and a comm. box mounted to the interior side. Install a new communications system only, including manual truck chocks. Removal of the existing Red/Green light and signage mounted to the exterior wall, and a comm. box mounted to the interior side. The dock was partially obstructed from view, the full condition of all dock components could not be verified. The assumption of partial condition is based on the condition of adjacent docks.

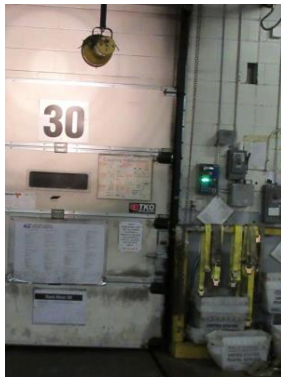
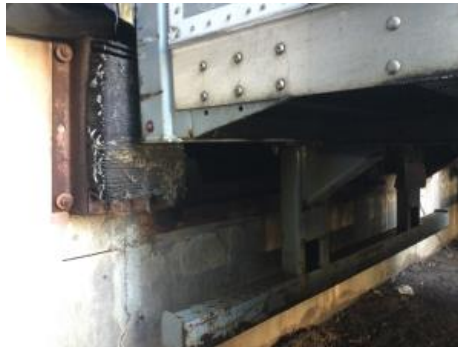
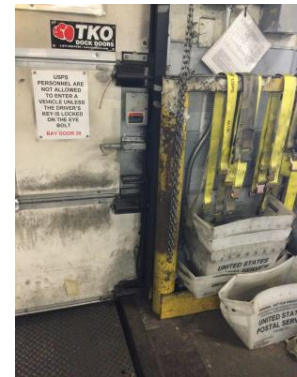
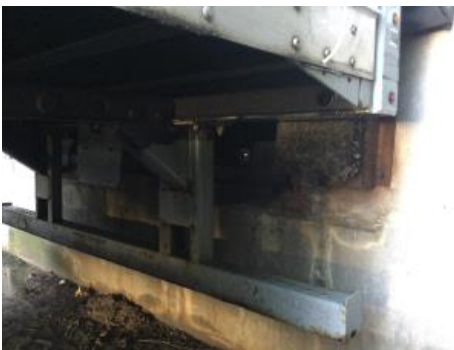
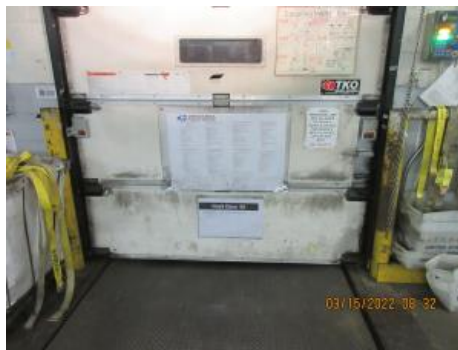
Subsystem Code:	E1030310	Surveyor / Update:	Brendan Baranek-Olmstead	03/28/2022
Subsystem Description:	Loading Dock Equipment, EACH	Qty:	1.00	
Material:				
Distress:	Inadequate	Deficiency Id:	316367	
Priority:	1 - Currently Critical (Immediate)	Location:	DOOR 30	
Category:	Repair - Alteration			
Correction:	Install Kelley Dock Communication System			
Notes:	The foundation wall to the face of the rubber bumper is 8", SOG to the bottom of the dock leveler 29", over all dock height 51". The dock face below the leveler is inadequate. There is an existing Red/Green light and signage mounted to the exterior wall, and a comm. box mounted to the interior side. Install a new communications system only, including manual truck chocks. Removal of the existing Red/Green light and signage mounted to the exterior wall, and a comm. box mounted to the interior side. The dock was partially obstructed from view, the full condition of all dock components could not be verified. The assumption of partial condition is based on the condition of adjacent docks.

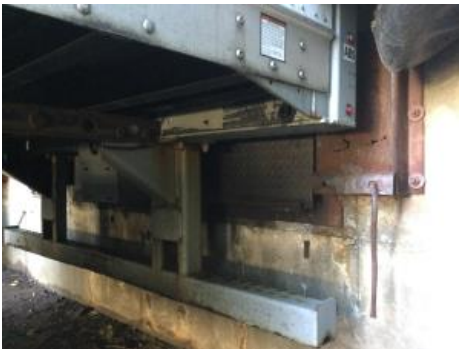
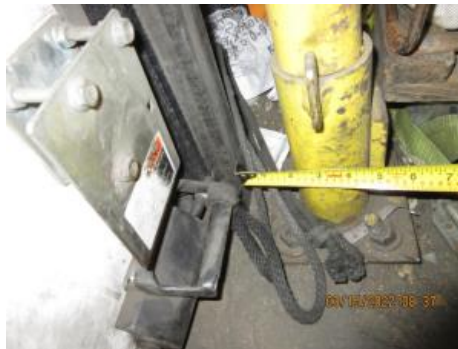
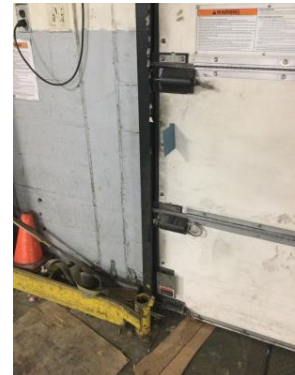
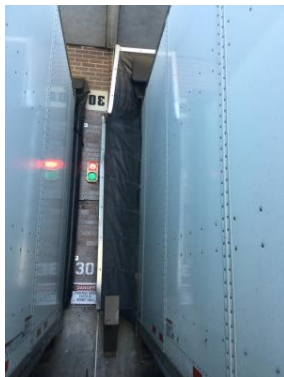
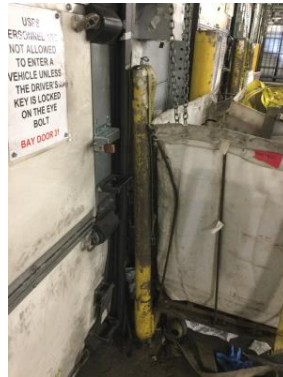
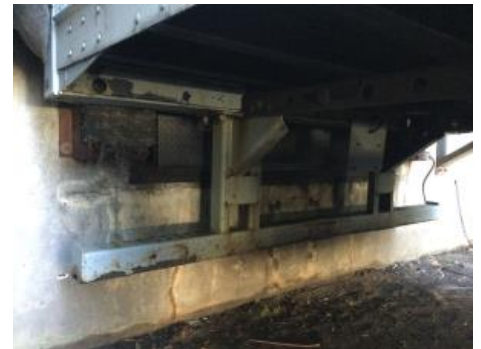
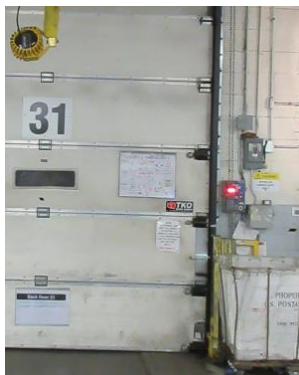
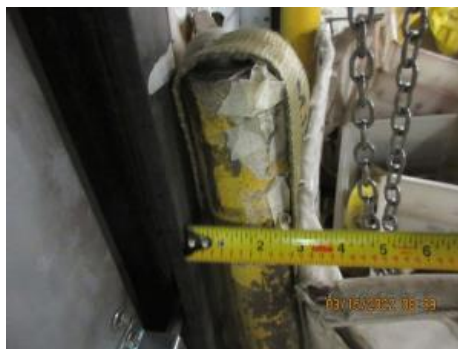
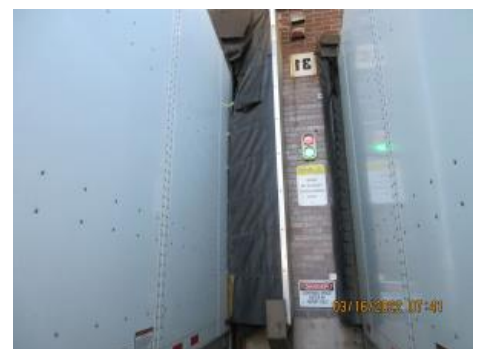
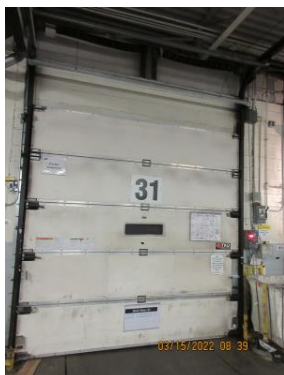
USPS TRSP\Atlantic\Connecticut \Hartford P - DC 083367-G04\DOOR 32

The foundation wall to the face of the metal bumper is 4", SOG to the bottom of the dock leveler 29", over all dock height 51". The dock face below the leveler is inadequate. There is an existing Red/Green light and signage mounted to the exterior wall, and a comm. box mounted to the interior side. Install a new communications system only, including manual truck chocks. Removal of the existing Red/Green light and signage mounted to the exterior wall, and a comm. box mounted to the interior side. The dock was partially obstructed from view, the full condition of all dock components could not be verified. The assumption of partial condition is based on the condition of adjacent docks.

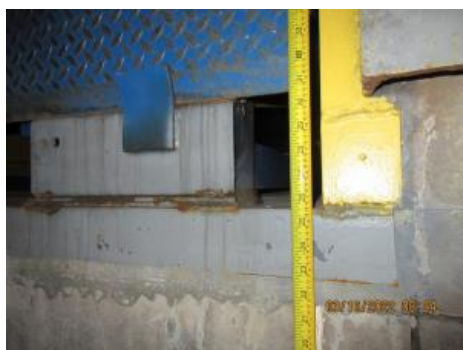
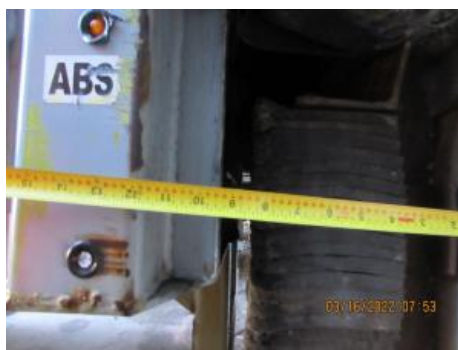
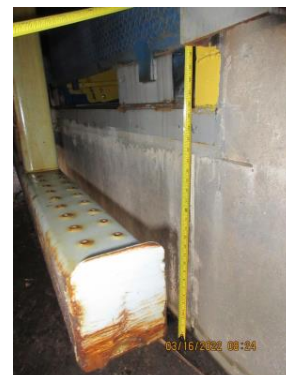
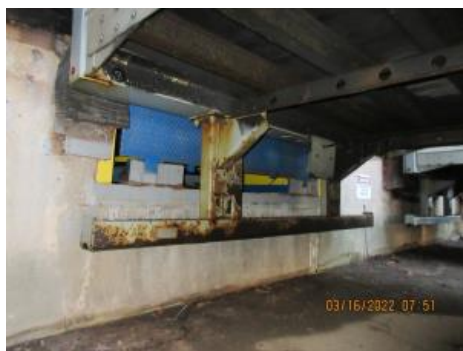
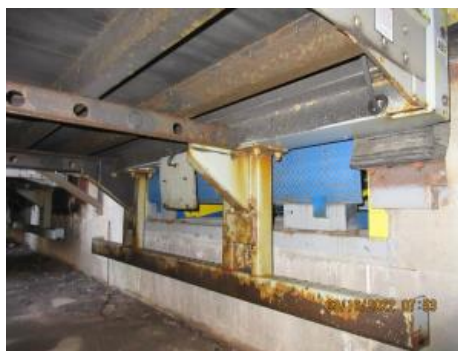
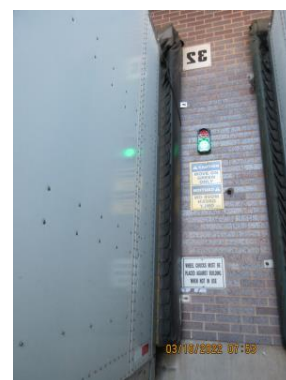
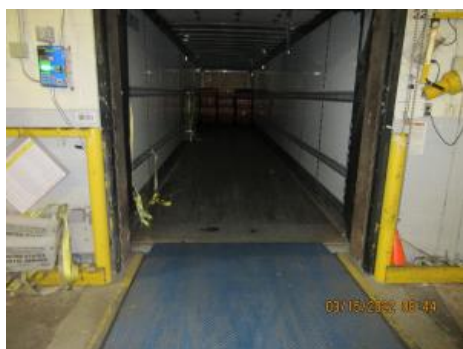
USPS TRSP\Atlantic\Connecticut \Hartford P - DC 083367-G04\DOOR 33

Subsystem Code:	E1030310	Surveyor / Update:	Brendan Baranek-Olmstead	03/28/2022
Subsystem Description:	Loading Dock Equipment, EACH	Qty:	1.00	
Material:				
Distress:	Inadequate	Deficiency Id:	316372	
Priority:	1 - Currently Critical (Immediate)	Location:	DOOR 32	
Category:	Repair - Alteration			
Correction:	Install Kelley Dock Communication System			
Notes:	The foundation wall to the face of the rubber bumper is 8", SOG to the bottom of the dock leveler 30", over all dock height 51". The dock face below the leveler is adequate. There is an existing Red/Green light and signage mounted to the exterior wall, and a comm. box mounted the interior side. Install a new communications system only, including manual truck chocks. Removal of the existing Red/Green light and signage mounted to the exterior wall, and a comm. box mounted the interior side. The dock was partially obstructed from view, the full condition of all dock components could not be verified. The assumption of partial condition is based on the condition of adjacent docks.

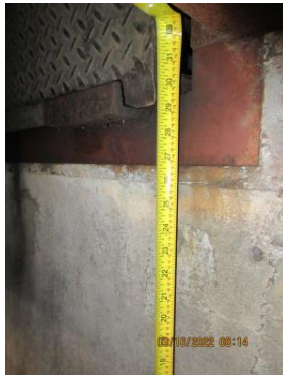
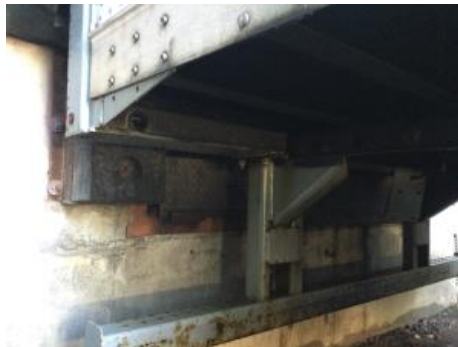
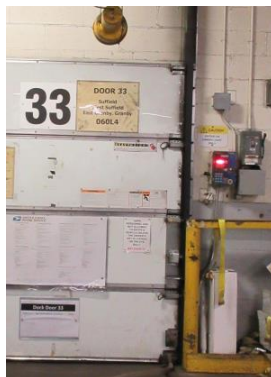
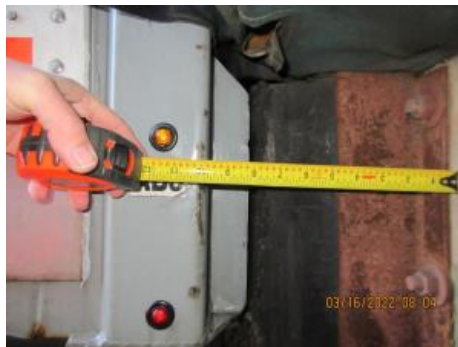
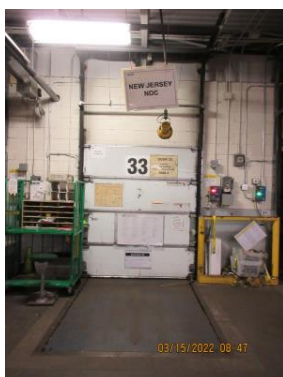
USPS TRSP\Atlantic\Connecticut \Hartford P - DC 083367-G04\DOOR 34

The foundation wall to the face of the rubber bumper is 7.5", SOG to the bottom of the dock leveler 29", over all dock height 51". The dock face below the leveler is inadequate. There is an existing Red/Green light and signage mounted to the exterior wall, and a comm. box mounted to the interior side. Install a new communications system only, including manual truck chocks. Removal of the existing Red/Green light and signage mounted to the exterior wall, and a comm. box mounted to the interior side. The dock was partially obstructed from view, the full condition of all dock components could not be verified. The assumption of partial condition is based on the condition of adjacent docks.

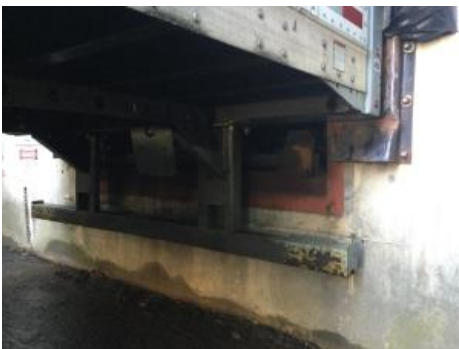
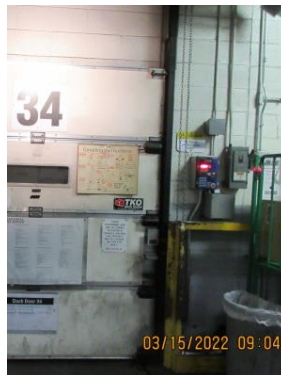
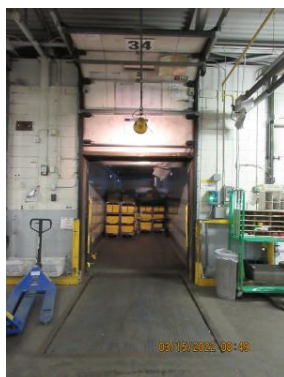
USPS TRSP\Atlantic\Connecticut \Hartford P - DC 083367-G04\DOOR 35

Distress:	Inadequate	Deficiency Id:	316386
Priority:	1 - Currently Critical (Immediate)	Location:	DOOR 34
Category:	Repair - Alteration		
Correction:	Install Kelley Dock Communication System		
Notes:	The foundation wall to the face of the metal bumper is 4.5", SOG to the bottom of the dock leveler 30", over all dock height 51". The dock face below the leveler is inadequate. There is an existing Red/Green light and signage mounted to the exterior wall, and a comm. box mounted to the interior side. Install a new communications system only, including manual truck chocks. Removal of the existing Red/Green light and signage mounted to the exterior wall, and a comm. box mounted to the interior side. The dock was partially obstructed from view, the full condition of all dock components could not be verified. The assumption of partial condition is based on the condition of adjacent docks.

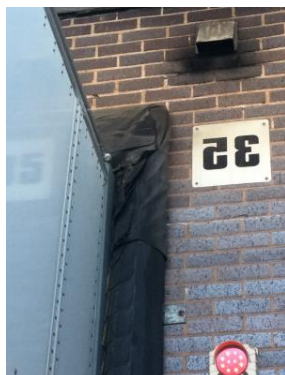
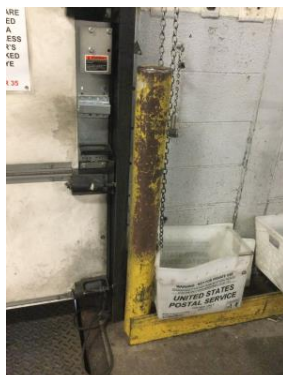
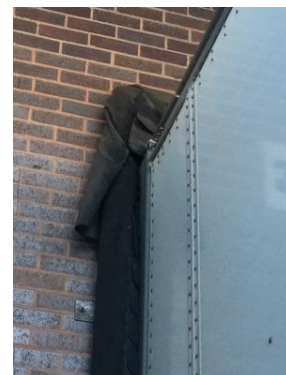
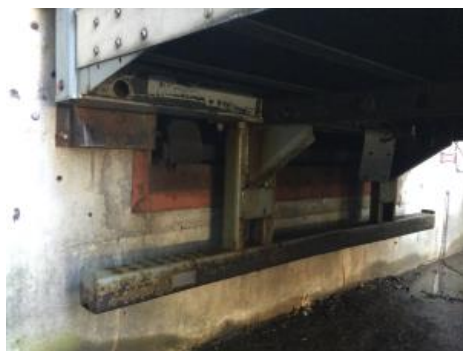
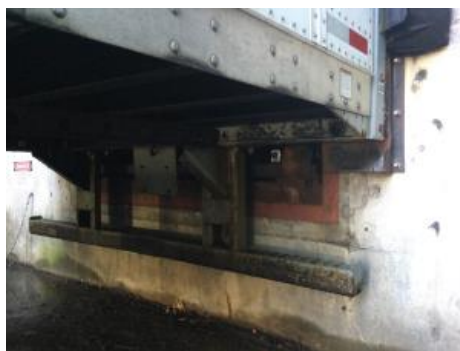
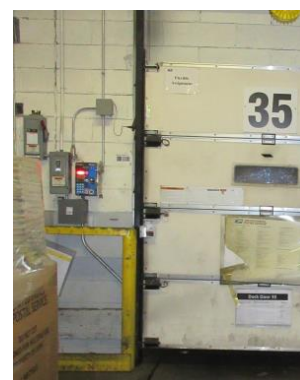
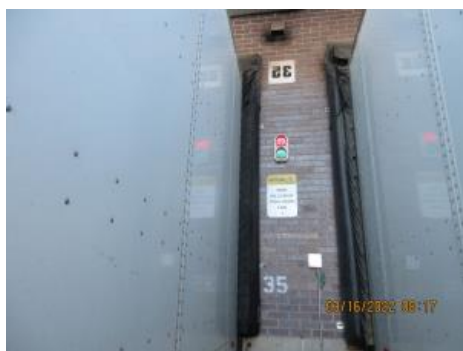
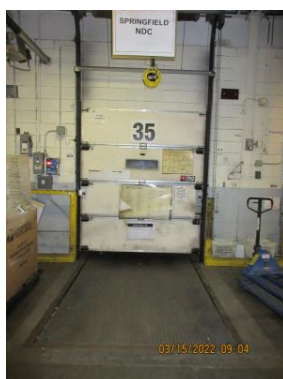
USPS TRSP\Atlantic\Connecticut \Hartford P - DC 083367-G04\DOOR 36

Subsystem Code:	E1030310	Surveyor / Update:	Brendan Baranek-Olmstead	03/28/2022
Subsystem Description:	Loading Dock Equipment, EACH	Qty:	1.00	
Material:				
Distress:	Inadequate	Deficiency Id:	316387	
Priority:	1 - Currently Critical (Immediate)	Location:	DOOR 35	
Category:	Repair - Alteration			
Correction:	Install Kelley Dock Communication System			
Notes:	The foundation wall to the face of the metal bumper is 4.5", SOG to the bottom of the dock leveler 30", over all dock height 51". The dock face below the leveler is inadequate. There is an existing Red/Green light and signage mounted to the exterior wall, and a comm. box mounted to the interior side. Install a new communications system only, including manual truck chocks. Removal of the existing Red/Green light and signage mounted to the exterior wall, and a comm. box mounted to the interior side. The dock was partially obstructed from view, the full condition of all dock components could not be verified. The assumption of partial condition is based on the condition of adjacent docks.

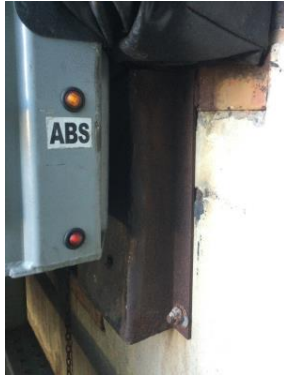
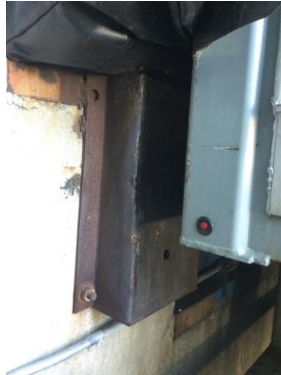
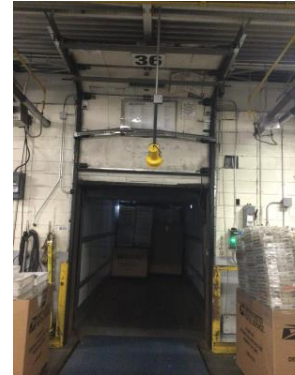
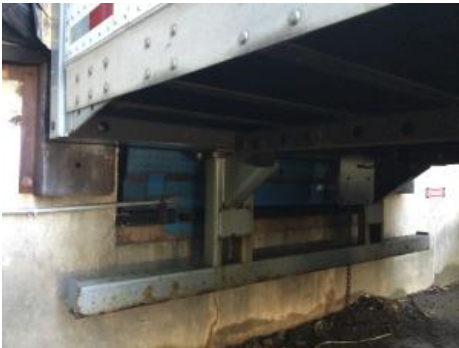
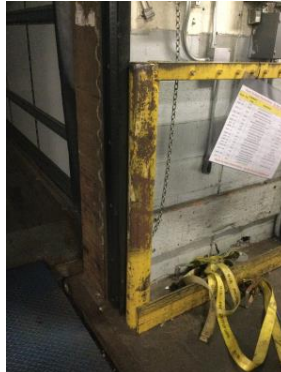
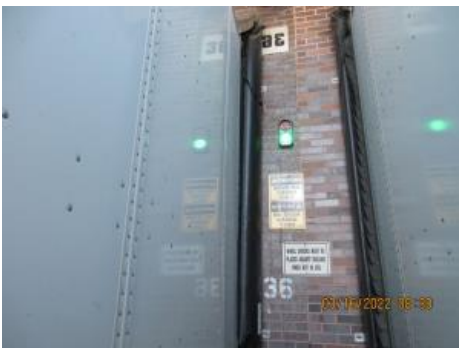
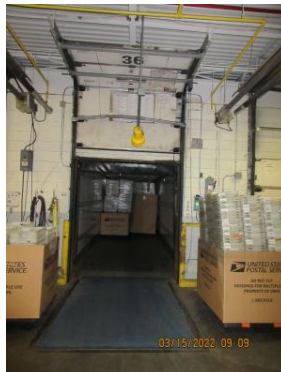
USPS TRSP\Atlantic\Connecticut \Hartford P - DC 083367-G04\DOOR 37

The foundation wall to the face of the metal bumper is 4.5", SOG to the bottom of the dock leveler 30", over all dock height 51". The dock face below the leveler is inadequate. There is an existing Red/Green light and signage mounted to the exterior wall, and a comm. box mounted to the interior side. Install a new communications system only, including manual truck chocks Removal of the . existing Red/Green light and signage mounted to the exterior wall, and a comm. box mounted to the interior side. The dock was partially obstructed from view, the full condition of all dock components could not be verified. The assumption of partial condition is based on the condition of adjacent docks.

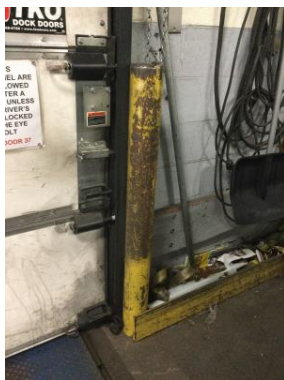
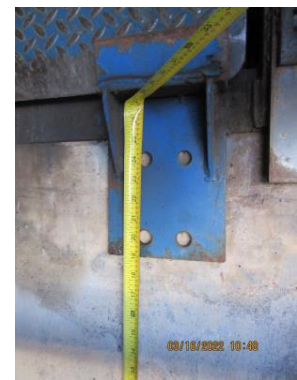
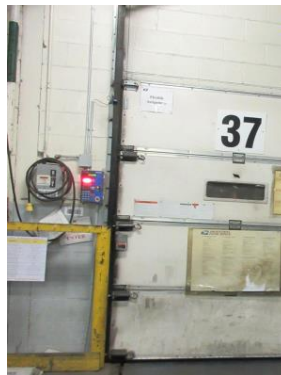
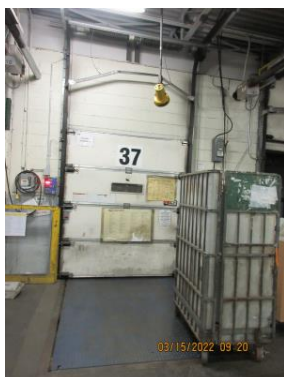
Distress:	Inadequate	Deficiency Id:	316401
Priority:	1 - Currently Critical (Immediate)	Location:	DOOR 37
Category:	Repair - Alteration		
Correction:	Install Kelley Dock Communication System		
Notes:	The foundation wall to the face of the metal bumper is 4.5", SOG to the bottom of the dock leveler 27.5", over all dock height 51". The dock face below the leveler is inadequate. There is an existing Red/Green light and signage mounted to the exterior wall, and a comm. box mounted to the interior side. Install a new communications system only, including manual truck chocks. Removal of the existing Red/Green light and signage mounted to the exterior wall, and a comm. box mounted to the interior side. The dock was partially obstructed from view, the full condition of all dock components could not be verified. The assumption of partial condition is based on the condition of adjacent docks.

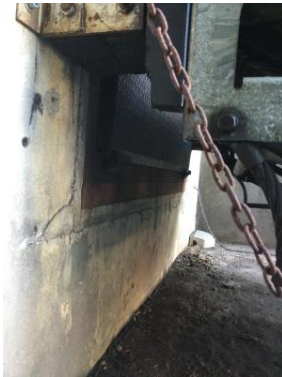
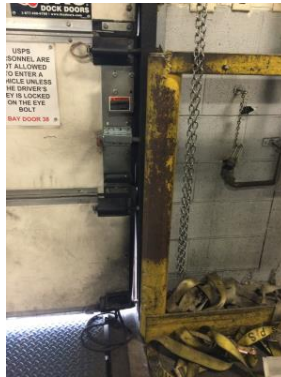
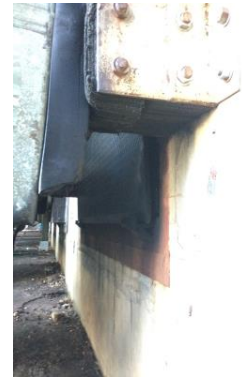
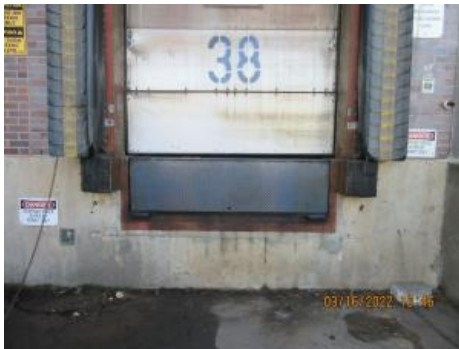
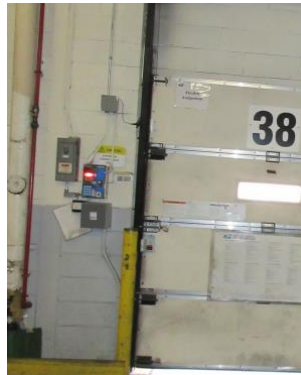
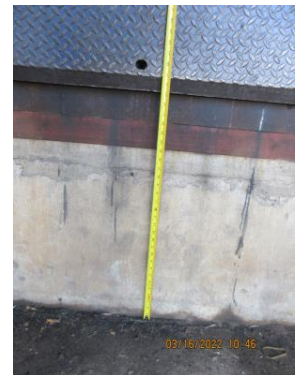
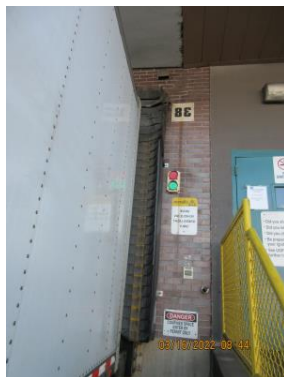
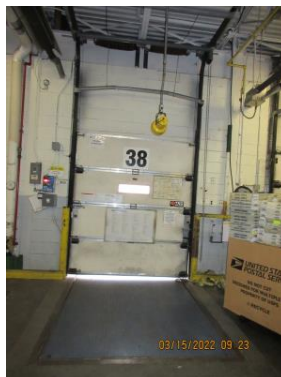
USPS TRSP\Atlantic\Connecticut \Hartford P - DC 083367-G04\DOOR 38

Subsystem Code:	E1030310	Surveyor / Update:	Brendan Baranek-Olmstead	03/28/2022
Subsystem Description:	Loading Dock Equipment, EACH	Qty:	1.00	
Material:				
Distress:	Inadequate	Deficiency Id:	316405	
Priority:	1 - Currently Critical (Immediate)	Location:	DOOR 38	
Category:	Repair - Alteration			
Correction:	Install Kelley Dock Communication System			
Notes:	The foundation wall to the face of the rubber bumper is 10", SOG to the bottom of the dock leveler 29", over all dock height 51". The dock face below the leveler is inadequate. There is an existing Red/Green light and signage mounted to the exterior wall, and a comm. box mounted to the interior side. Install a new communications system only, including manual truck chocks. Removal of the existing Red/Green light and signage mounted to the exterior wall, and a comm. box mounted to the interior side. The dock was partially obstructed from view, the full condition of all dock components could not be verified. The assumption of partial condition is based on the condition of adjacent docks.

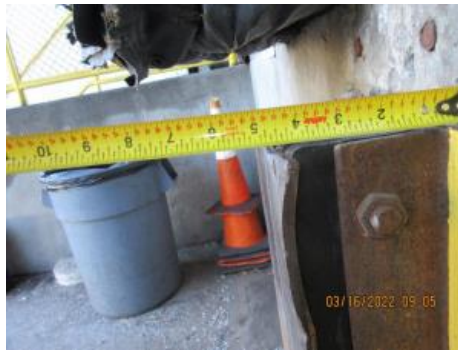
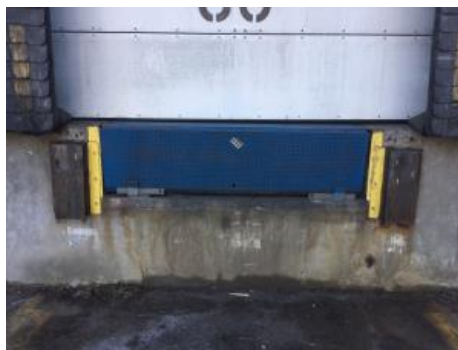
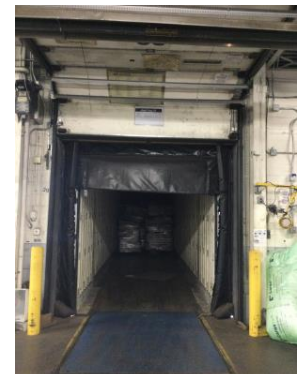
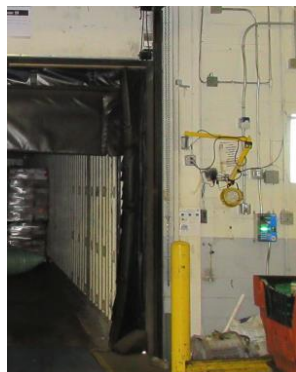
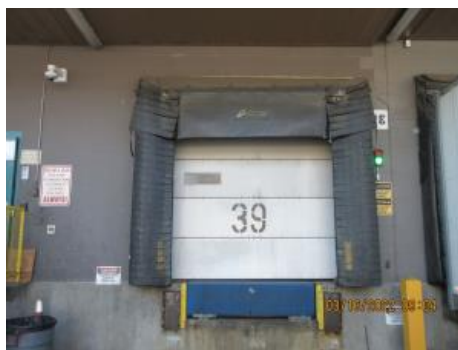
USPS TRSP\Atlantic\Connecticut \Hartford P - DC 083367-G04\DOOR 39

Subsystem Code:	E1030310	Surveyor / Update:	Brendan Baranek-Olmstead	03/28/2022
Subsystem Description:	Loading Dock Equipment, EACH	Qty:	1.00	
Material:				
Distress:	Inadequate	Deficiency Id:	316407	
Priority:	1 - Currently Critical (Immediate)	Location:	DOOR 39	
Category:	Repair - Alteration			
Correction:	Install Kelley Dock Communication System			
Notes:	The foundation wall to the face of the metal bumper is 5", SOG to the bottom of the dock leveler 28.5", over all dock height 51". The dock face below the leveler is inadequate. There is an existing Red/Green light and signage mounted to the exterior wall, and a comm. box mounted the interior side. Install a new communications system only, including manual truck chocks. Removal of the existing Red/Green light and signage mounted to the exterior wall, and a comm. box mounted the interior side.

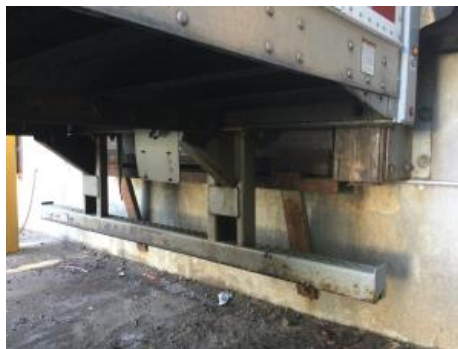
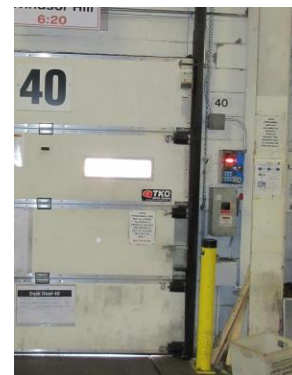
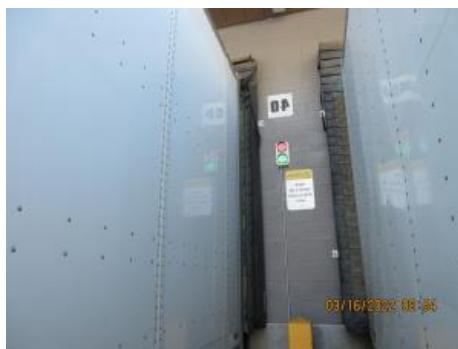
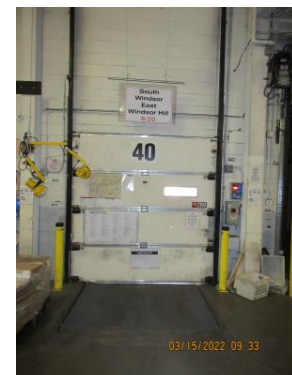
USPS TRSP\Atlantic\Connecticut \Hartford P - DC 083367-G04\DOOR 40

Subsystem Code:	E1030310	Surveyor / Update:	Brendan Baranek-Olmstead	03/28/2022
Subsystem Description:	Loading Dock Equipment, EACH	Qty:	1.00	
Material:				
Distress:	Inadequate	Deficiency Id:	316408	
Priority:	1 - Currently Critical (Immediate)	Location:	DOOR 40	
Category:	Repair - Alteration			
Correction:	Install Kelley Dock Communication System			
Notes:	The foundation wall to the face of the rubber bumper is 13.5", SOG to the bottom of the dock leveler 25", over all dock height 51". Dock leveler extends 7.5" from foundation wall. The dock face below the leveler is inadequate. Beneath dock leveler ramp extension from foundation wall are angled supports. 49" clearance between supports. 26" clearance height to bottom plate. There is an existing Red/Green light and signage mounted to the exterior wall, and a comm. box mounted to the interior side. Install a new communications system only, including manual truck chocks. Removal of the existing Red/Green light and signage mounted to the exterior wall, and a comm. box mounted to the interior side. The dock was partially obstructed from view, the full condition of all dock components could not be verified. The assumption of partial condition is based on the condition of adjacent docks.

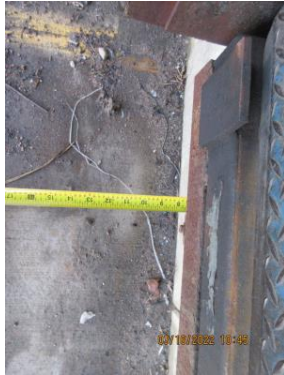
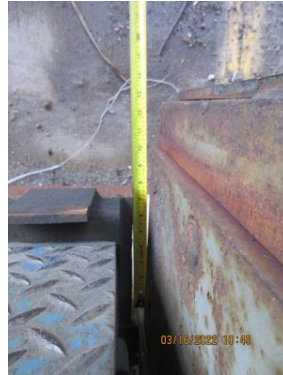
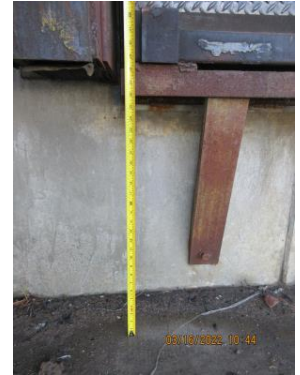
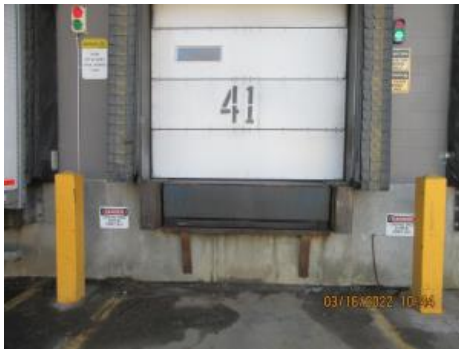
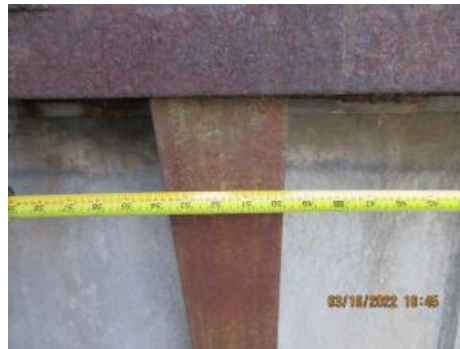
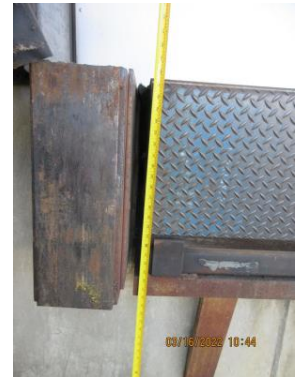
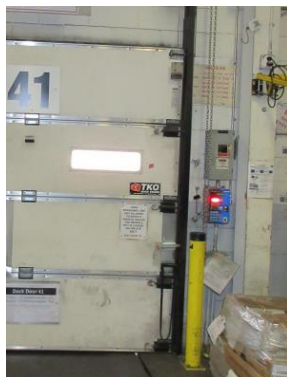
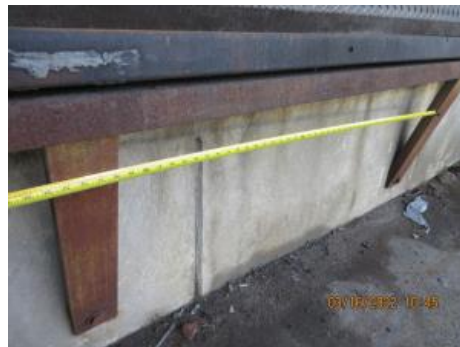
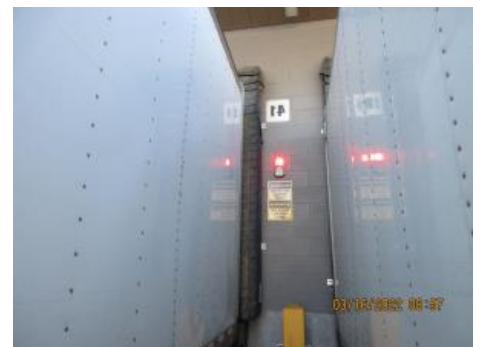
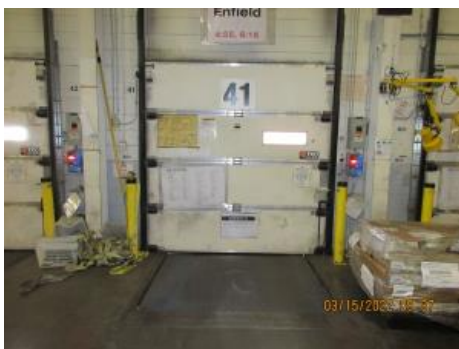
USPS TRSP\Atlantic\Connecticut \Hartford P - DC 083367-G04\DOOR 41

Subsystem Code:	E1030310	Surveyor / Update:	Brendan Baranek-Olmstead	03/28/2022
Subsystem Description:	Loading Dock Equipment, EACH	Qty:	1.00	
Material:				
Distress:	Inadequate	Deficiency Id:	316410	
Priority:	1 - Currently Critical (Immediate)	Location:	DOOR 41	
Category:	Repair - Alteration			
Correction:	Install Kelley Dock Communication System

Notes: The foundation wall to the face of the rubber bumper is 13.5", SOG to the bottom of the dock leveler 29", over all dock height 51". Dock leveler extends 7.5" from foundation wall. The dock face below the leveler is inadequate. Beneath dock leveler ramp extension from foundation wall are angled supports. 49" clearance between supports. 26" clearance height to bottom plate. There is an existing Red/Green light and signage mounted to the exterior wall, and a comm. box mounted to the interior side. Install a new communications system only, including manual truck chocks. Removal of the existing Red/Green light and signage mounted to the exterior wall, and a comm. box mounted to the interior side. The dock was partially obstructed from view, the full condition of all dock components could not be verified. The assumption of partial condition is based on the condition of adjacent docks.

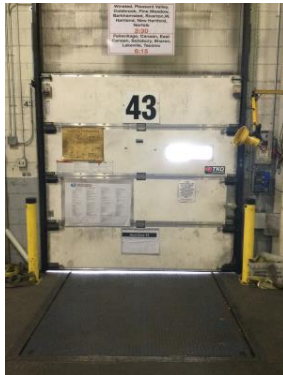
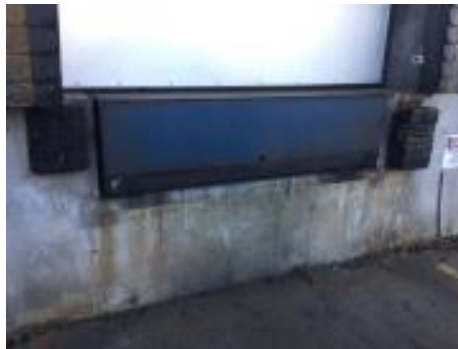
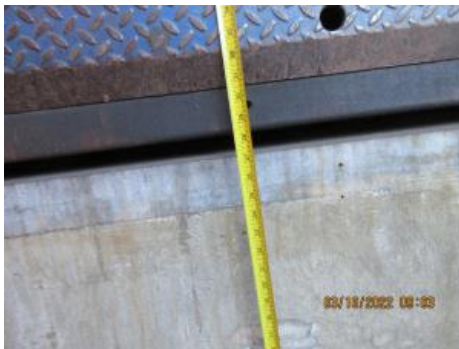
Subsystem Code:	E1030310	Surveyor / Update:	Brendan Baranek-Olmstead	03/16/2022
Subsystem Description:	Loading Dock Equipment, EACH	Qty:	1.00	
Material:				
Distress:	Missing	Deficiency Id:	315962	
Priority:	1 - Currently Critical (Immediate)	Location:	DOOR 43	
Category:	Repair - Alteration			
Correction:	Install Star 4 Truck Restraint			
Notes:	The foundation wall to the face of the rubber bumper is 4", SOG to the bottom of the dock leveler 30.5", SOG to top of leveler clip 31.5", over all dock height 48". The dock face below the leveler is adequate. Dock lip pivot guard should be mounted to outer edge of leveler clip. There is an existing Red/Green light and signage mounted to the exterior wall, and a comm. box mounted to the interior side. Removal of the existing Red/Green light and signage mounted to the exterior wall, and a comm. box mounted to the interior side.

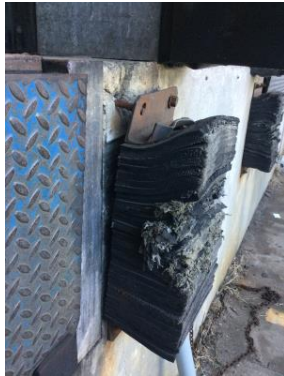
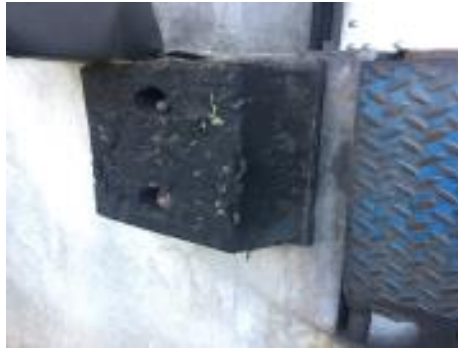
Left bumper

Subsystem Code:	E1030310	Surveyor / Update:	Brendan Baranek-Olmstead	03/16/2022
Subsystem Description:	Loading Dock Equipment, EACH	Qty:	1.00	
Material:				
Distress:	Damaged	Deficiency Id:	315963	
Priority:	2 - Potentially Critical (Year 1)	Location:	DOOR 43	
Category:	Repair - Alteration			
Correction:	Provide and Replace Rubber Dock Bumper			
Notes:	The rubber dock bumpers are damaged on both sides of the dock.

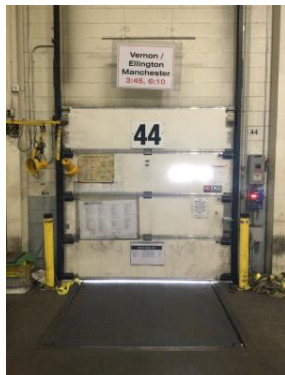
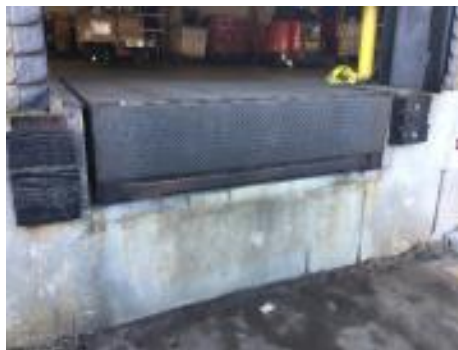
Subsystem Code:	E1030310	Surveyor / Update:	Brendan Baranek-Olmstead	03/16/2022
Subsystem Description:	Loading Dock Equipment, EACH	Qty:	1.00	
Material:				
Distress:	Missing	Deficiency Id:	315966	
Priority:	1 - Currently Critical (Immediate)	Location:	DOOR 44	
Category:	Repair - Alteration			
Correction:	Install Star 4 Truck Restraint			
Notes:	The foundation wall to the face of the rubber bumper is 5.5", SOG to the bottom of the dock leveler 32", over all dock height 47.75". The dock face below the leveler is adequate. There is an existing Red/Green light and signage mounted to the exterior wall, and a comm. box mounted to the interior side. Removal of the existing Red/Green light and signage mounted to the exterior wall, and a comm. box mounted to the interior side.

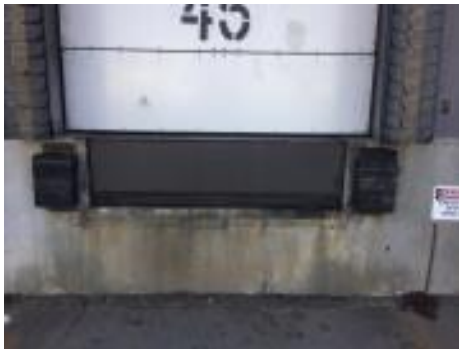
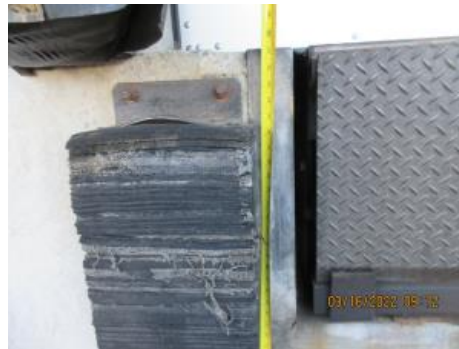
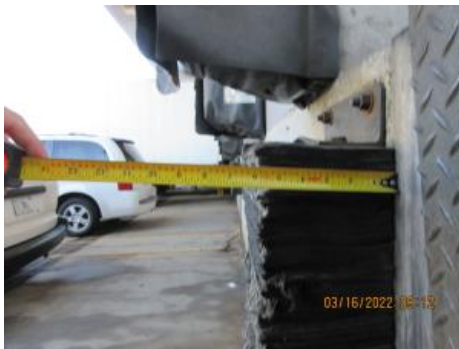
Subsystem Code:	E1030310	Surveyor / Update:	Brendan Baranek-Olmstead	03/16/2022
Subsystem Description:	Loading Dock Equipment, EACH	Qty:	1.00	
Material:				
Distress:	Missing	Deficiency Id:	315972	
Priority:	1 - Currently Critical (Immediate)	Location:	DOOR 45	
Category:	Repair - Alteration			
Correction:	Install Star 4 Truck Restraint			
Notes:	The foundation wall to the face of the rubber bumper is 6", SOG to the bottom of the dock leveler 30.5", SOG to top of leveler clip 31.5", over all dock height 48". The dock face below the leveler is adequate. Dock lip pivot guard should be mounted to outer edge of leveler clip. There is an existing Red/Green light and signage mounted to the exterior wall, and a comm. box mounted to the interior side. Removal of the existing Red/Green light and signage mounted to the exterior wall, and a comm. box mounted to the interior side.

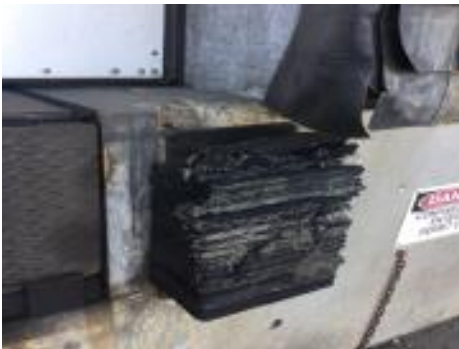
Right bumper

Subsystem Code:	E1030310	Surveyor / Update:	Brendan Baranek-Olmstead	03/16/2022
Subsystem Description:	Loading Dock Equipment, EACH	Qty:	1.00	
Material:				
Distress:	Failing	Deficiency Id:	315974	
Priority:	1 - Currently Critical (Immediate)	Location:	DOOR 45	
Category:	Repair - Alteration			
Correction:	Provide and Replace Rubber Dock Bumper			
Notes:	The rubber dock bumper located on the right side of the loading dock is damaged. missing top left connection bolt. Concrete behind bolt missing.

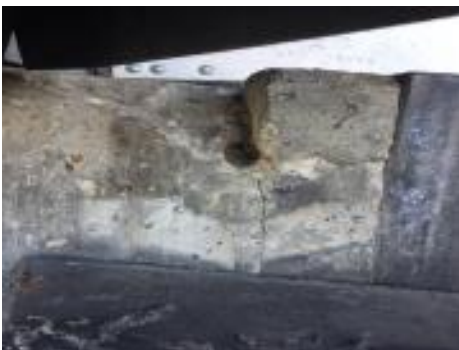
Left bumper top bolt spot

Subsystem Code:	B2010101	Surveyor / Update:	Brendan Baranek-Olmstead	03/16/2022
Subsystem Description:	Cast In Place Concrete	Qty:	1.00	
Material:				
Distress:	Damaged	Deficiency Id:	315977	
Priority:	1 - Currently Critical (Immediate)	Location:	DOOR 46	
Category:	Repair - Alteration			
Correction:	Repair Spalled Concrete			
Notes:	Gap in concrete from missing bolt to left bumper.

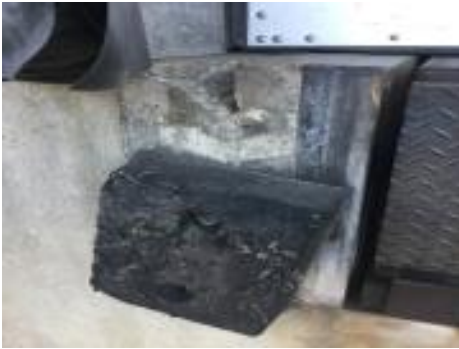
Left bumper

Subsystem Code:	E1030310	Surveyor / Update:	Brendan Baranek-Olmstead	03/16/2022
Subsystem Description:	Loading Dock Equipment, EACH	Qty:	1.00	
Material:				
Distress:	Failing	Deficiency Id:	315975	
Priority:	1 - Currently Critical (Immediate)	Location:	DOOR 46	
Category:	Repair - Alteration			
Correction:	Provide and Replace Rubber Dock Bumper			
Notes:	The rubber dock bumper located on the left side of the loading dock is damaged. missing top connection bolt. Concrete behind bolt missing.

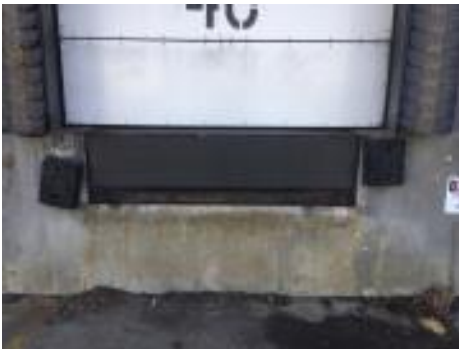
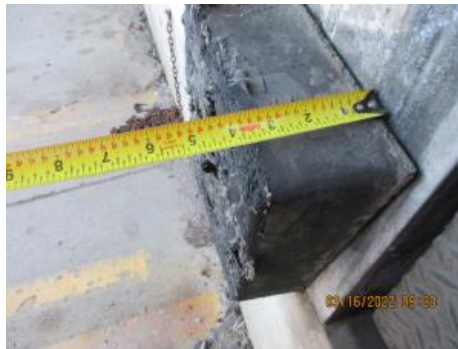
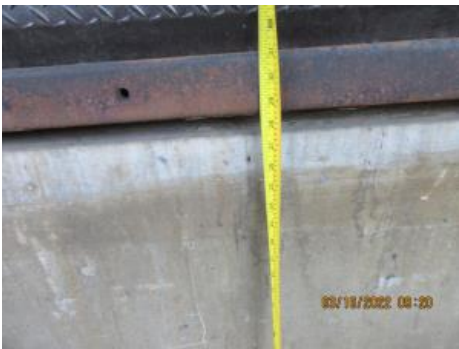
Subsystem Code:	E1030310	Surveyor / Update:	Brendan Baranek-Olmstead	03/16/2022
Subsystem Description:	Loading Dock Equipment, EACH	Qty:	1.00	
Material:				
Distress:	Missing	Deficiency Id:	315976	
Priority:	1 - Currently Critical (Immediate)	Location:	DOOR 46	
Category:	Repair - Alteration			
Correction:	Install Star 4 Truck Restraint			
Notes:	The foundation wall to the face of the rubber bumper is 6", SOG to the bottom of the dock leveler 31", SOG to top of leveler clip 31.5", over all dock height 48". The dock face below the leveler is adequate. Dock lip pivot guard should be mounted to outer edge of leveler clip. There is an existing Red/Green light and signage mounted to the exterior wall, and a comm. box mounted to the interior side. Removal of the existing Red/Green light and signage mounted to the exterior wall, and a comm. box mounted to the interior side.
