TRUCK RESTRAINT PROGRAM – USPS P&DC- Hartford, CT
141 Weston ST, Hartford, CT 06101-9612

SCOPE OF WORK PACKAGE (RFP 743672-31678P) Date 08/5/2022

General Findings and Condition Report (eCOMET Enhanced Deficiency Sheet Report)

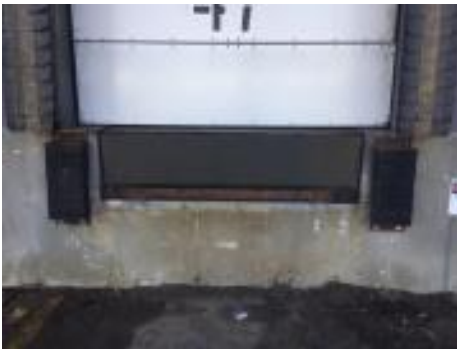
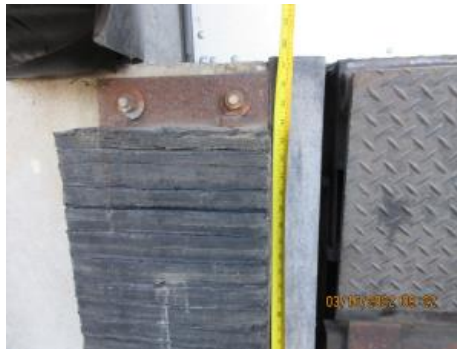
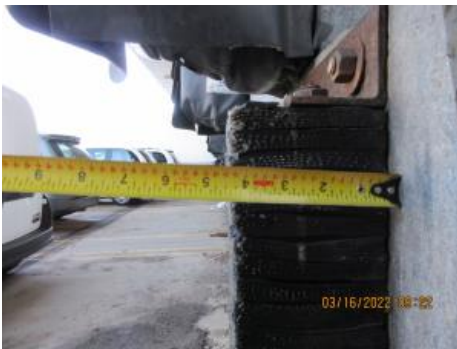
Subsystem Code:	E1030310	Surveyor / Update:	Brendan Baranek-Olmstead	03/16/2022
Subsystem Description:	Loading Dock Equipment, EACH	Qty:	1.00	
Material:				
Distress:	Missing	Deficiency Id:	315978	
Priority:	1 - Currently Critical (Immediate)	Location:	DOOR 47	
Category:	Repair - Alteration			
Correction:	Install Star 4 Truck Restraint			
Notes:	The foundation wall to the face of the rubber bumper is 5", SOG to the bottom of the dock leveler 30.5", SOG to top of leveler clip 31.5", over all dock height 48". The dock face below the leveler is adequate. Dock lip pivot guard should be mounted to outer edge of leveler clip. There is an existing Red/Green light and signage mounted to the exterior wall, and a comm. box mounted to the interior side. Removal of the existing Red/Green light and signage mounted to the exterior wall, and a comm. box mounted to the interior side.

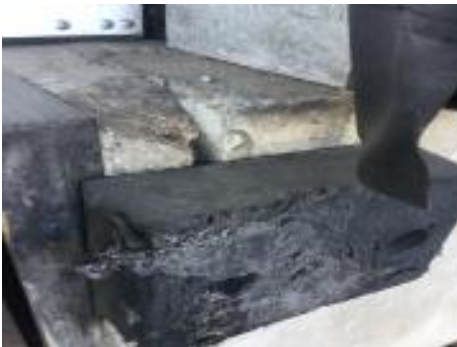
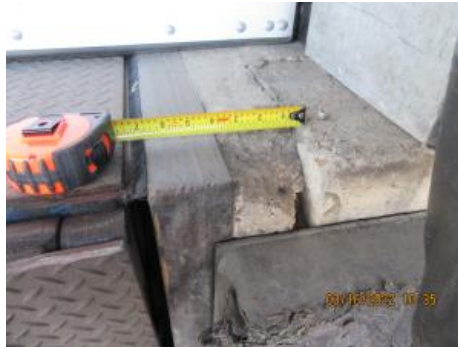
Subsystem Code:	B2010101	Surveyor / Update:	Brendan Baranek-Olmstead	03/16/2022
Subsystem Description:	Cast In Place Concrete	Qty:	1.00	
Material:				
Distress:	Damaged	Deficiency Id:	315980	
Priority:	1 - Currently Critical (Immediate)	Location:	DOOR 48	
Category:	Repair - Alteration			
Correction:	Repair Spalled Concrete			
Notes:	Gap in concrete where right bumper top connection bolt should be.

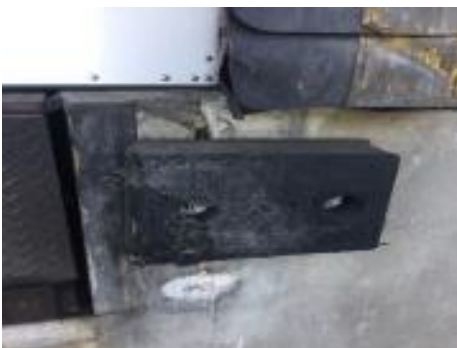
Right bumper

Subsystem Code:	E1030310	Surveyor / Update:	Brendan Baranek-Olmstead	03/16/2022
Subsystem Description:	Loading Dock Equipment, EACH	Qty:	1.00	
Material:				
Distress:	Damaged	Deficiency Id:	315981	
Priority:	3 - Necessary/Not Yet Critical (Years 2-5)	Location:	DOOR 48	
Category:	Repair - Alteration			
Correction:	Provide and Replace Rubber Dock Bumper			
Notes:	The rubber dock bumper located on the right side of the loading dock is damaged. bumper is rotated 90 degrees. Top connection bolt location is missing concrete

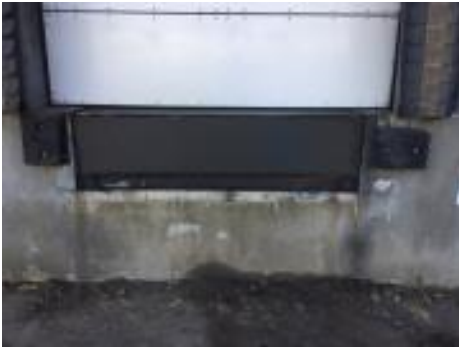
Subsystem Code:	E1030310	Surveyor / Update:	Brendan Baranek-Olmstead	03/16/2022
Subsystem Description:	Loading Dock Equipment, EACH	Qty:	1.00	
Material:				
Distress:	Missing	Deficiency Id:	315979	
Priority:	1 - Currently Critical (Immediate)	Location:	DOOR 48	
Category:	Repair - Alteration			
Correction:	Install Star 4 Truck Restraint			
Notes:	The foundation wall to the face of the rubber bumper is 5", SOG to the bottom of the dock leveler 30.5", SOG to top of leveler clip 31.5", over all dock height 48". The dock face below the leveler is adequate. Dock lip pivot guard should be mounted to outer edge of leveler clip. There is an existing Red/Green light and signage mounted to the exterior wall, and a comm. box mounted to the interior side. Removal of the existing Red/Green light and signage mounted to the exterior wall, and a comm. box mounted to the interior side.

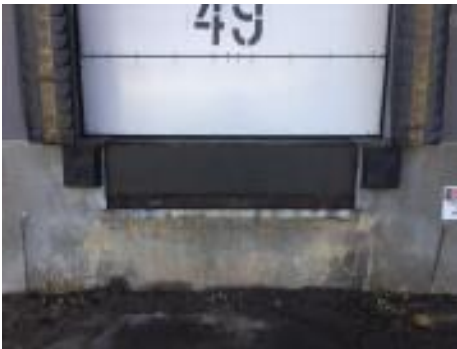
Subsystem Code:	E1030310	Surveyor / Update:	Brendan Baranek-Olmstead	03/16/2022
Subsystem Description:	Loading Dock Equipment, EACH	Qty:	1.00	
Material:				
Distress:	Missing	Deficiency Id:	315982	
Priority:	1 - Currently Critical (Immediate)	Location:	DOOR 49	
Category:	Repair - Alteration			
Correction:	Install Star 4 Truck Restraint			
Notes:	The foundation wall to the face of the rubber bumper is 4", SOG to the bottom of the dock leveler 30.5", SOG to top of leveler clip 31.5", over all dock height 48". The dock face below the leveler is adequate. Dock lip pivot guard should be mounted to outer edge of leveler clip. There is an existing Red/Green light and signage mounted to the exterior wall, and a comm. box mounted to the interior side. Removal of the existing Red/Green light and signage mounted to the exterior wall, and a comm. box mounted to the interior side.

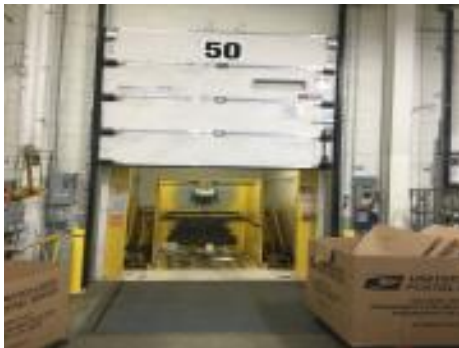
Subsystem Code:	B2030240	Surveyor / Update:	Brendan Baranek-Olmstead	03/16/2022
Subsystem Description:	Overhead & Rollup Doors	Qty:		
Material:				
Distress:	N/A	Deficiency Id:	315860	
Priority:		Location:	DOOR 50 & 51	
Category:	N/A			
Correction:				
Notes:	No deficiencies observed. DOOR 50 is for compactors. Trucks do not use this doors.

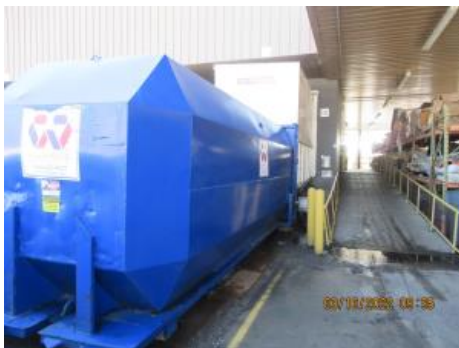
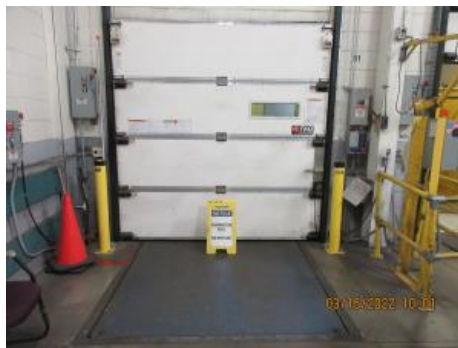
Subsystem Code:	B2030240	Surveyor / Update:	Brendan Baranek-Olmstead	03/28/2022
Subsystem Description:	Overhead & Rollup Doors	Qty:		
Material:				
Distress:	N/A	Deficiency Id:	316427	
Priority:		Location:	DOOR 51	
Category:	N/A			
Correction:				
Notes:	No deficiencies observed. DOOR 51 is for compactors. Trucks do not use this door.
