## **Mail Processing Facilities**

TRUCK RESTRAINT PROGRAM – USPS P&DC- Stamford, CT  
427 West Ave., Stamford, CT 06910-1002

SCOPE OF WORK PACKAGE (RFP 743672-31678P) Date: 08/05/2022

## eCOMET USPS Detailed Deficiency Sheet

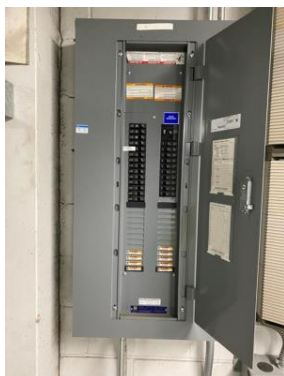
Subsystem Code:	D5010	Surveyor / Update:	Todd Murphy	04/07/2022
Subsystem Description:	Electrical Service/Distribution	Qty:	4.00	
Material:				
Distress:	Inadequate	Deficiency Id:	317591	
Priority:	3 - Necessary/Not Yet Critical (Years 2-5)	Location:	DOORS 4 - 17	
Category:	Repair - Alteration			
Correction:	Add New 1 Pole 20A Circuit Breaker (1 for every 4 Doors)			
Notes:	Add new 20A, 1-pole circuit breakers in existing power panel RPM.5-2.7. Circuit breakers to match existing type and KAIC rating. Connect no more than 4 TRS per circuit breaker. Maximum distance to farthest door from the power panel is 150'.

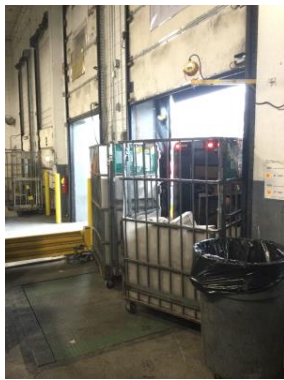
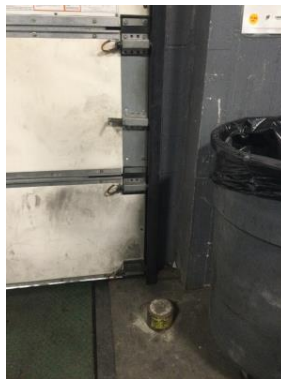
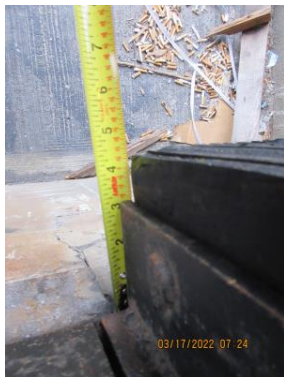
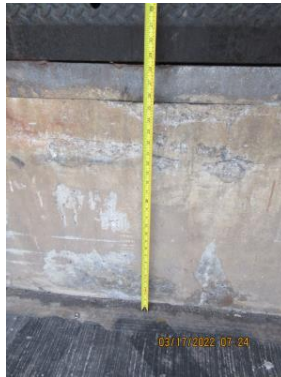
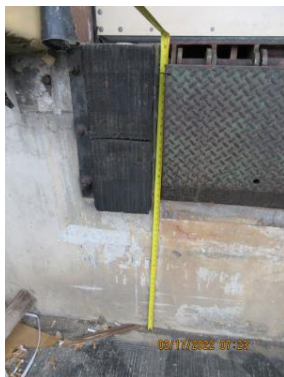
Subsystem Code:	E1030310	Surveyor / Update:	Brendan Baranek-Olmstead	03/29/2022
Subsystem Description:	Loading Dock Equipment, EACH	Qty:	1.00	
Material:				
Distress:	Inadequate	Deficiency Id:	316449	
Priority:	1 - Currently Critical (Immediate)	Location:	DOOR 04	
Category:	Repair - Alteration			
Correction:	Install Kelley Dock Communication System			
Notes:	Door 4 is used by carrier vehicles and vendors box trucks. Trailers and large trucks do not use this door. The foundation wall to the face of the rubber bumper is 4.5", SOG to the bottom of the dock leveler 28", over all dock height 48". The dock face below the leveler is inadequate. Install a Red Light/Green Light Kelley communication system to include manual wheel chocks.

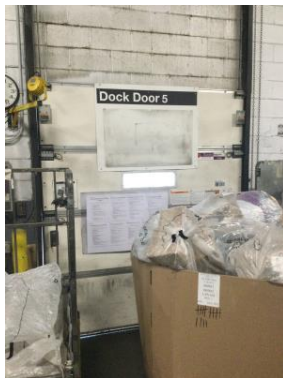
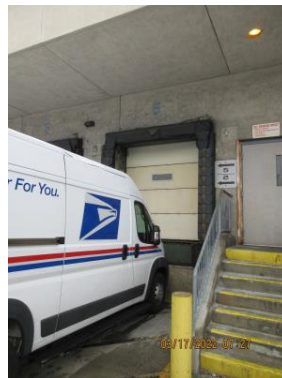
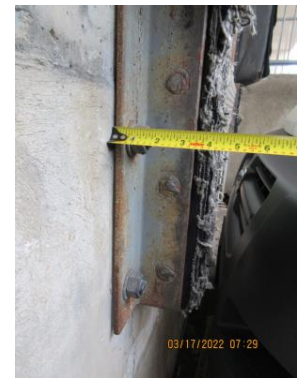
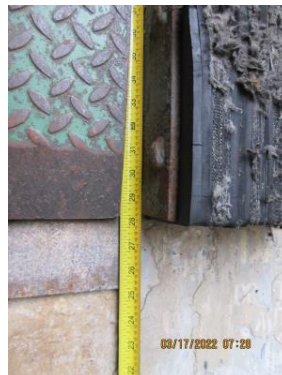
Subsystem Code:	E1030310	Surveyor / Update:	Brendan Baranek-Olmstead	03/29/2022
Subsystem Description:	Loading Dock Equipment, EACH	Qty:	1.00	
Material:				
Distress:	Inadequate	Deficiency Id:	316450	
Priority:	1 - Currently Critical (Immediate)	Location:	DOOR 05	
Category:	Repair - Alteration			
Correction:	Install Kelley Dock Communication System			
Notes:	Door 5 is used by carrier vehicles and vendors box trucks. Trailers and large trucks do not use this door. The foundation wall to the face of the rubber bumper is 4", SOG to the bottom of the dock leveler 28", over all dock height 48". The dock face below the leveler is inadequate. Install a Red Light/Green Light Kelley communication system to include manual wheel chocks.

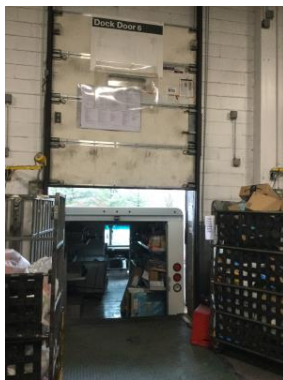
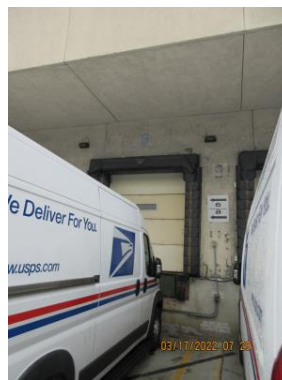
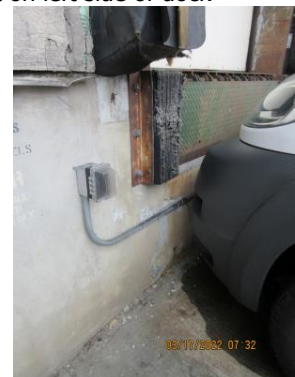
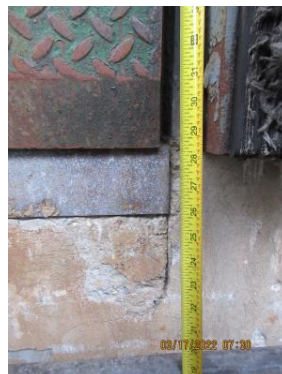
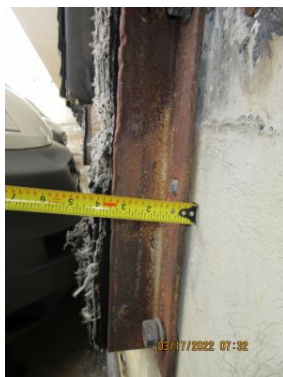
Subsystem Code:	E1030310	Surveyor / Update:	Brendan Baranek-Olmstead	03/29/2022
Subsystem Description:	Loading Dock Equipment, EACH	Qty:	1.00	
Material:				
Distress:	Inadequate	Deficiency Id:	316451	
Priority:	1 - Currently Critical (Immediate)	Location:	DOOR 06	
Category:	Repair - Alteration			
Correction:	Install Kelley Dock Communication System			
Notes:	Door 6 is used by carrier vehicles and vendors box trucks. Trailers and large trucks do not use this door. The foundation wall to the face of the rubber bumper is 4", SOG to the bottom of the dock leveler 28", over all dock height 48". The dock face below the leveler is inadequate. Install a Red Light/Green Light Kelley communication system to include manual wheel chocks.

conduit on left side of dock

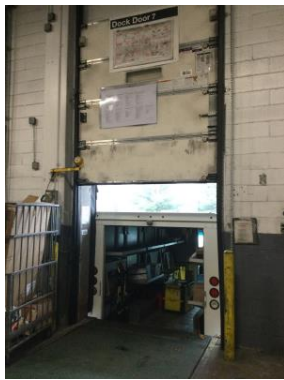
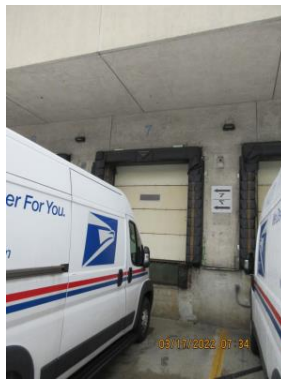
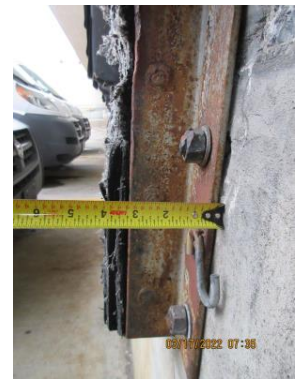
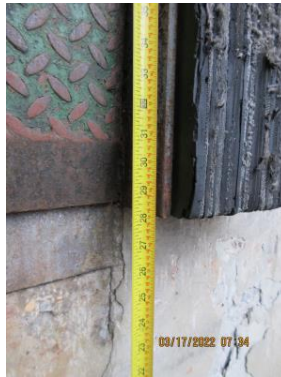
Subsystem Code:	E1030310	Surveyor / Update:	Brendan Baranek-Olmstead	03/29/2022
Subsystem Description:	Loading Dock Equipment, EACH	Qty:	1.00	
Material:				
Distress:	Inadequate	Deficiency Id:	316452	
Priority:	1 - Currently Critical (Immediate)	Location:	DOOR 07	
Category:	Repair - Alteration			
Correction:	Install Kelley Dock Communication System			
Notes:	Door 7 is used by carrier vehicles and vendors box trucks. Trailers and large trucks do not use this door. The foundation wall to the face of the rubber bumper is 4", SOG to the bottom of the dock leveler 28", over all dock height 48". The dock face below the leveler is inadequate. Install a Red Light/Green Light Kelley communication system to include manual wheel chocks.

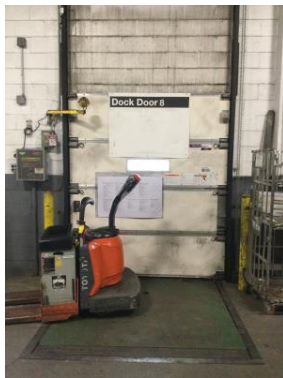
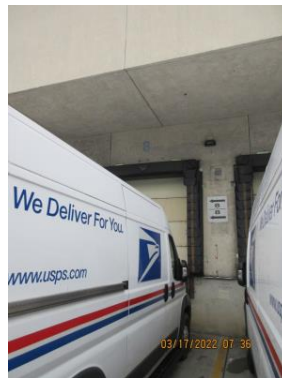
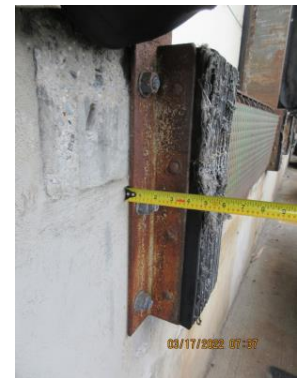
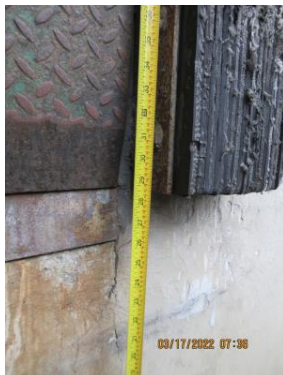
Subsystem Code:	E1030310	Surveyor / Update:	Brendan Baranek-Olmstead	03/29/2022
Subsystem Description:	Loading Dock Equipment, EACH	Qty:	1.00	
Material:				
Distress:	Inadequate	Deficiency Id:	316456	
Priority:	1 - Currently Critical (Immediate)	Location:	DOOR 08	
Category:	Repair - Alteration			
Correction:	Install Kelley Dock Communication System			
Notes:	Door 8 is used by carrier vehicles and vendors box trucks. Trailers and large trucks do not use this door. The foundation wall to the face of the rubber bumper is 4", SOG to the bottom of the dock leveler 28", over all dock height 48". The dock face below the leveler is inadequate. Install a Red Light/Green Light Kelley communication system to include manual wheel chocks.

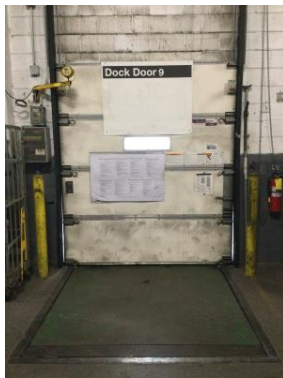
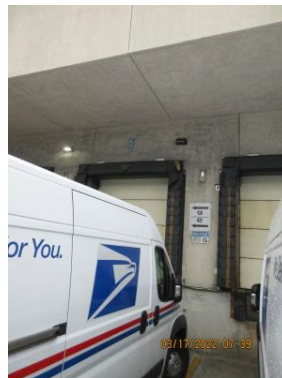
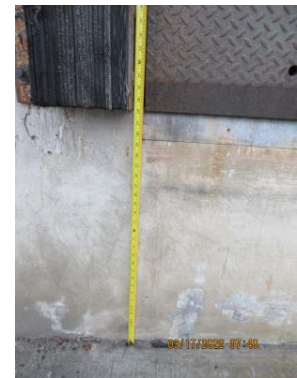
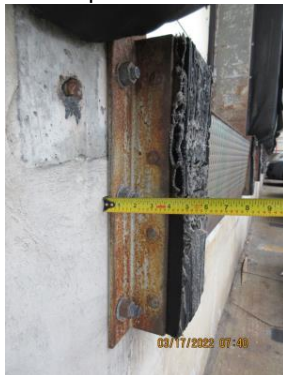
Subsystem Code:	E1030310	Surveyor / Update:	Brendan Baranek-Olmstead	03/29/2022
Subsystem Description:	Loading Dock Equipment, EACH	Qty:	1.00	
Material:				
Distress:	Inadequate	Deficiency Id:	316458	
Priority:	1 - Currently Critical (Immediate)	Location:	DOOR 09	
Category:	Repair - Alteration			
Correction:	Install Kelley Dock Communication System			
Notes:	Door 9 is used by carrier vehicles and vendors box trucks. Trailers and large trucks do not use this door. The foundation wall to the face of the rubber bumper is 3.5" - 4.5", SOG to the bottom of the dock leveler 28", over all dock height 48". The dock face below the leveler is inadequate. Install a Red Light/Green Light Kelley communication system to include manual wheel chocks.

Left side 4.5" depth

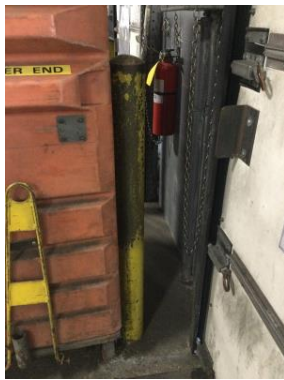
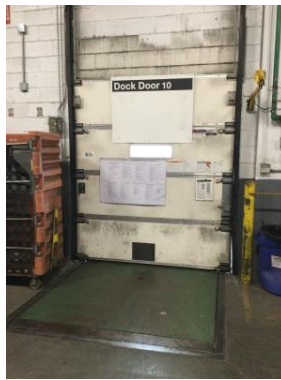
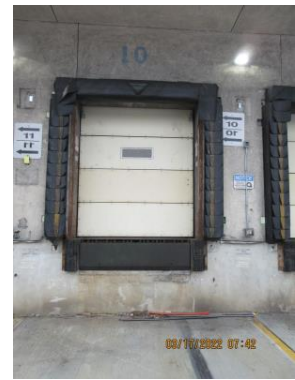
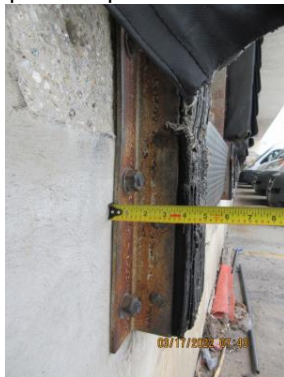
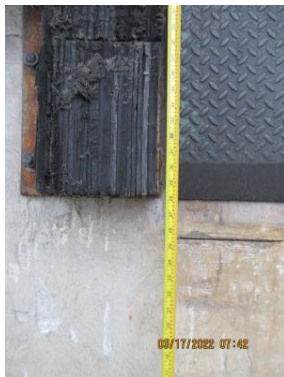
Subsystem Code:	E1030310	Surveyor / Update:	Brendan Baranek-Olmstead	03/29/2022
Subsystem Description:	Loading Dock Equipment, EACH	Qty:	1.00	
Material:				
Distress:	Inadequate	Deficiency Id:	316460	
Priority:	1 - Currently Critical (Immediate)	Location:	DOOR 10	
Category:	Repair - Alteration			
Correction:	Install Kelley Dock Communication System			
Notes:	Door 10 is used by carrier vehicles and vendors box trucks. Trailers and large trucks do not use this door. The foundation wall to the face of the rubber bumper is 3.5" - 4", SOG to the bottom of the dock leveler 28", over all dock height 48". The dock face below the leveler is inadequate. Install a Red Light/Green Light Kelley communication system to include manual wheel chocks.

Left bumper 4" depth

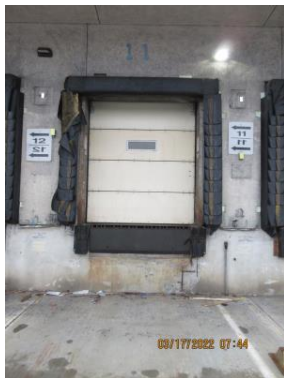
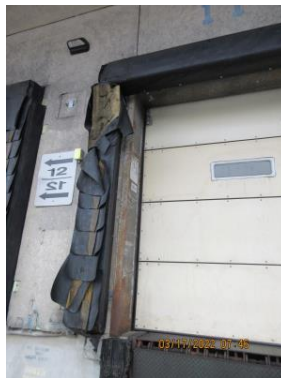
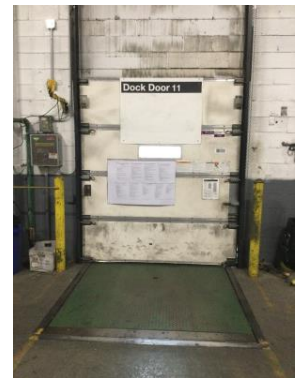
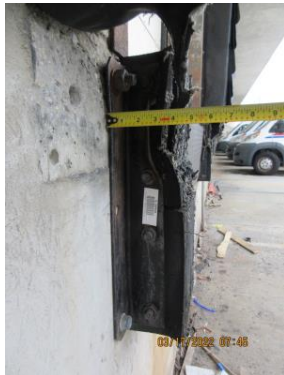
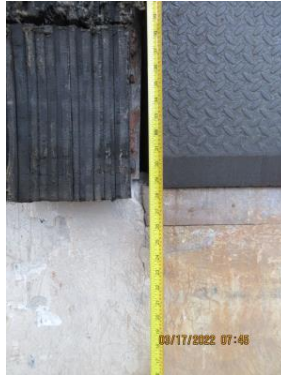
Subsystem Code:	E1030310	Surveyor / Update:	Brendan Baranek-Olmstead	03/29/2022
Subsystem Description:	Loading Dock Equipment, EACH	Qty:	1.00	
Material:				
Distress:	Inadequate	Deficiency Id:	316462	
Priority:	1 - Currently Critical (Immediate)	Location:	DOOR 11	
Category:	Repair - Alteration			
Correction:	Install Kelley Dock Communication System			
Notes:	Door 11 is used by carrier vehicles and vendors box trucks. Trailers and large trucks do not use this door. The foundation wall to the face of the rubber bumper is 3.5", SOG to the bottom of the dock leveler 28.5", over all dock height 48". The dock face below the leveler is inadequate. Install a Red Light/Green Light Kelley communication system to include manual wheel chocks.

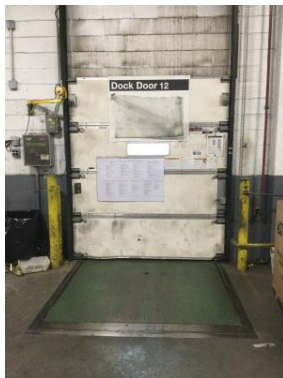
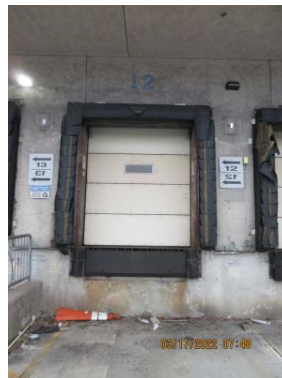
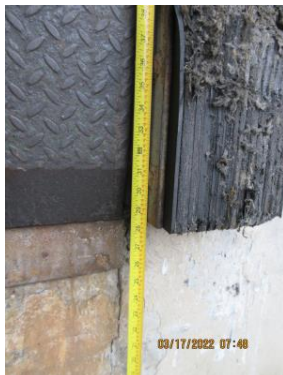
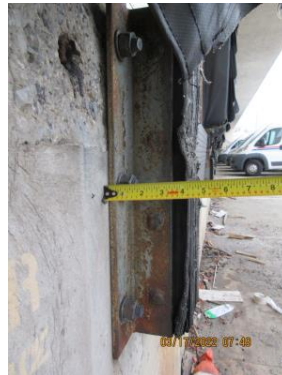
Subsystem Code:	E1030310	Surveyor / Update:	Brendan Baranek-Olmstead	03/30/2022
Subsystem Description:	Loading Dock Equipment, EACH	Qty:	1.00	
Material:				
Distress:	Inadequate	Deficiency Id:	316667	
Priority:	1 - Currently Critical (Immediate)	Location:	DOOR 12	
Category:	Repair - Alteration			
Correction:	Install Kelley Dock Communication System			
Notes:	Door 12 is used by carrier vehicles and vendors box trucks. Trailers and large trucks do not use this door. The foundation wall to the face of the rubber bumper is 3.5", SOG to the bottom of the dock leveler 28.5", over all dock height 48". The dock face below the leveler is inadequate. Install a Red Light/Green Light Kelley communication system to include manual wheel chocks.

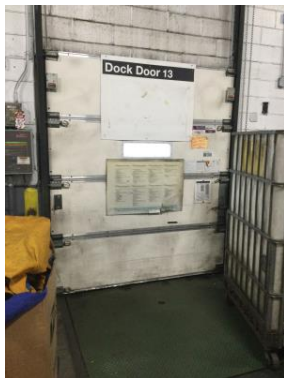
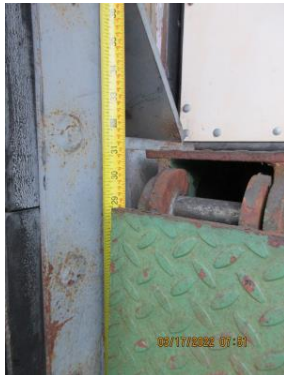
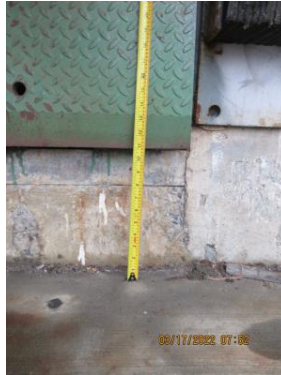
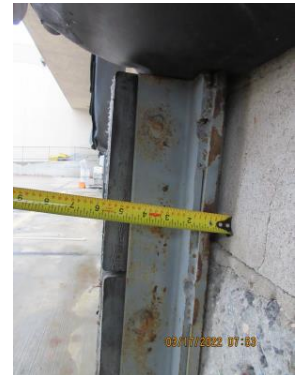
Subsystem Code:	E1030310	Surveyor / Update:	Brendan Baranek-Olmstead	03/30/2022
Subsystem Description:	Loading Dock Equipment, EACH	Qty:	1.00	
Material:				
Distress:	Inadequate	Deficiency Id:	316669	
Priority:	1 - Currently Critical (Immediate)	Location:	DOOR 13	
Category:	Repair - Alteration			
Correction:	Install Kelley Dock Communication System			
Notes:	Door 13 is used by carrier vehicles and vendors box trucks. Trailers and large trucks do not use this door. The foundation wall to the face of the rubber bumper is 6", SOG to the bottom of the dock leveler 10.5", over all dock height 31". The dock face below the leveler is inadequate. Install a Red Light/Green Light Kelley communication system to include manual wheel chocks.

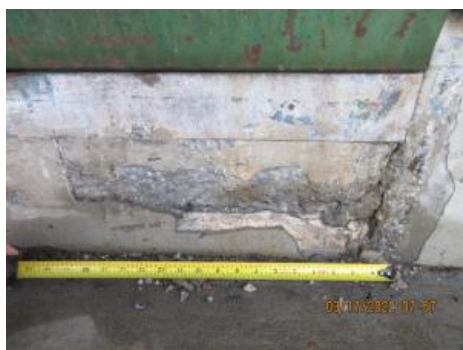
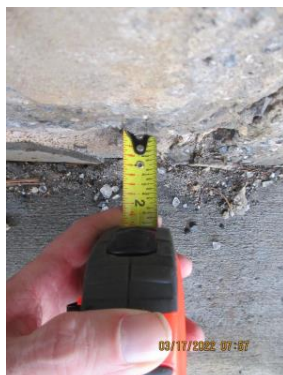
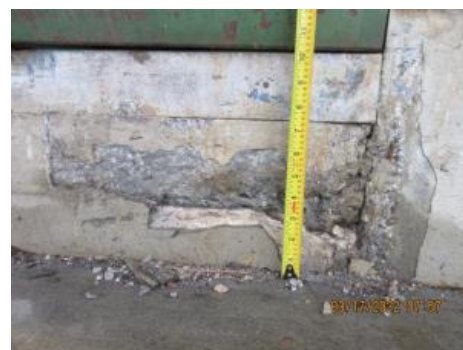
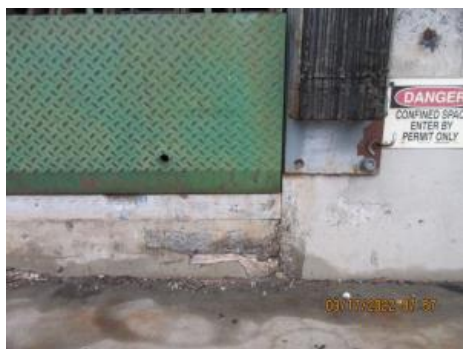
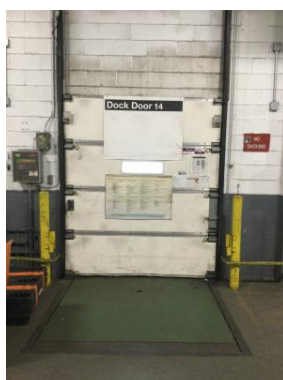
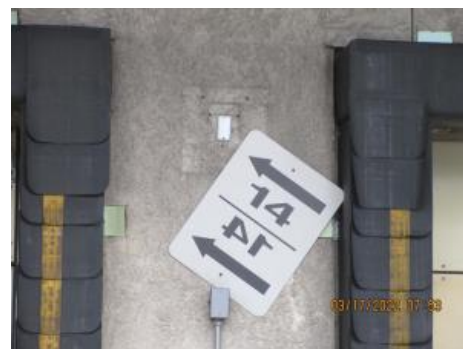
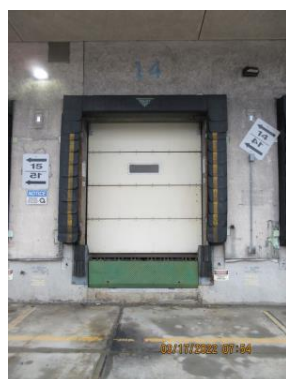
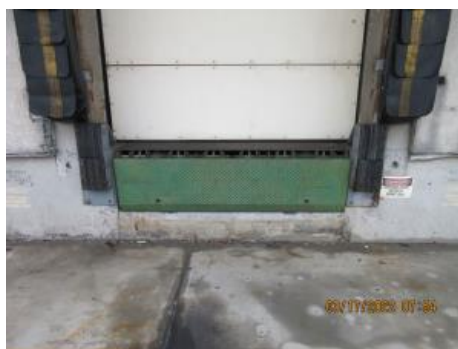
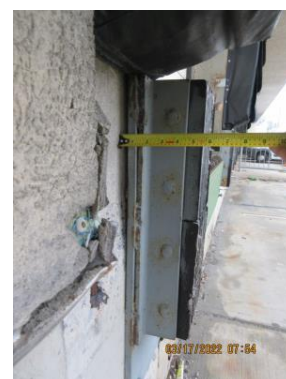
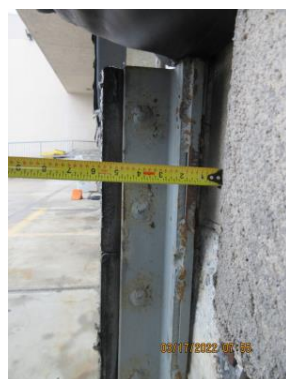
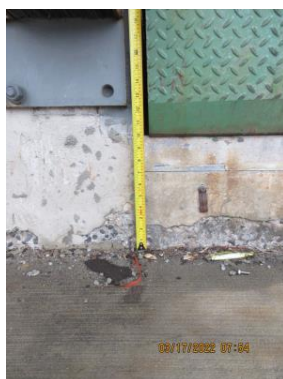
Subsystem Code:	E1030310	Surveyor / Update:	Brendan Baranek-Olmstead	03/30/2022
Subsystem Description:	Loading Dock Equipment, EACH	Qty:	1.00	
Material:				
Distress:	Inadequate	Deficiency Id:	316670	
Priority:	1 - Currently Critical (Immediate)	Location:	DOOR 14	
Category:	Repair - Alteration			
Correction:	Install Kelley Dock Communication System			
Notes:	Door 14 is used by carrier vehicles and vendors box trucks. Trailers and large trucks do not use this door. The foundation wall to the face of the rubber bumper is 5.5", SOG to the bottom of the dock leveler 10", over all dock height 31". The dock face below the leveler is inadequate. Install a Red Light/Green Light Kelley communication system to include manual wheel chocks.

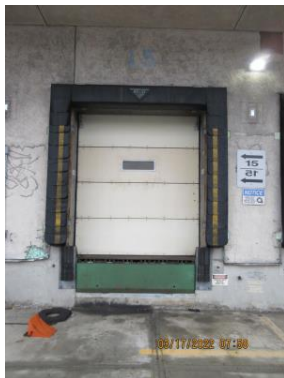
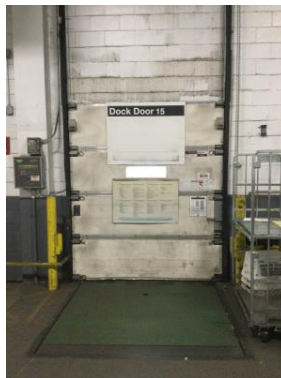
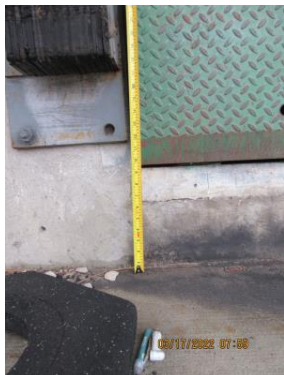
Subsystem Code:	E1030310	Surveyor / Update:	Brendan Baranek-Olmstead	03/30/2022
Subsystem Description:	Loading Dock Equipment, EACH	Qty:	1.00	
Material:				
Distress:	Inadequate	Deficiency Id:	316673	
Priority:	1 - Currently Critical (Immediate)	Location:	DOOR 15	
Category:	Repair - Alteration			
Correction:	Install Kelley Dock Communication System			
Notes:	Door 15 is used by carrier vehicles and vendors box trucks. Trailers and large trucks do not use this door. The foundation wall to the face of the rubber bumper is 5.5", SOG to the bottom of the dock leveler 9.5", over all dock height 30.5". The dock face below the leveler is inadequate. Install a Red Light/Green Light Kelley communication system to include manual wheel chocks.

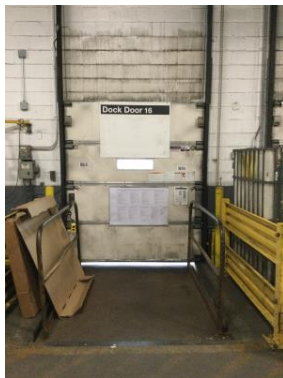
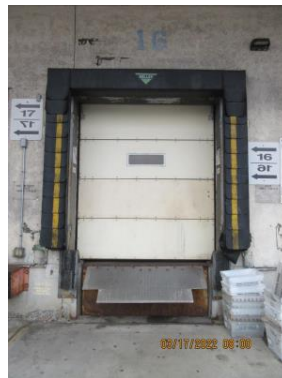
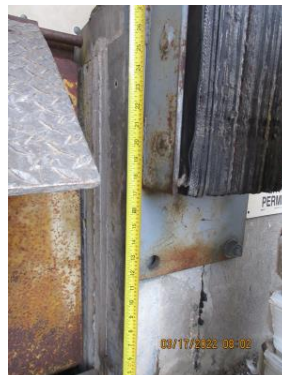
Subsystem Code:	E1030310	Surveyor / Update:	Brendan Baranek-Olmstead	03/30/2022
Subsystem Description:	Loading Dock Equipment, EACH	Qty:	1.00	
Material:				
Distress:	Inadequate	Deficiency Id:	316674	
Priority:	1 - Currently Critical (Immediate)	Location:	DOOR 16	
Category:	Repair - Alteration			
Correction:	Install Kelley Dock Communication System			
Notes:	The foundation wall to the face of the rubber bumper is 6", SOG to the bottom of the dock leveler 17", dock leveler stored at 45 degree and extends over 12" from foundation wall, over all dock height 30.5". The dock face below the leveler is inadequate. The dock does not except tractor trailers and is for smaller vehicles only. Install a Red/Greenlight communications system to include manual chocks.

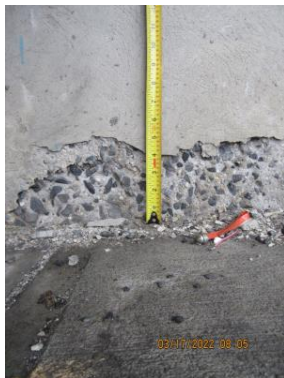
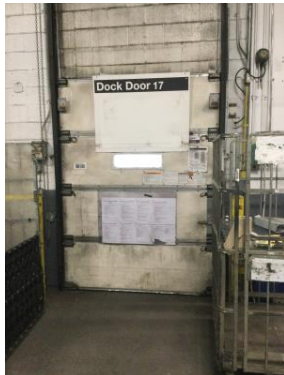
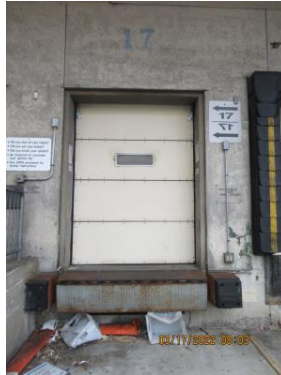
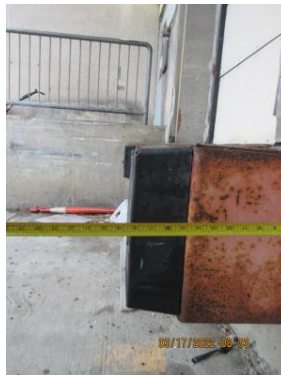
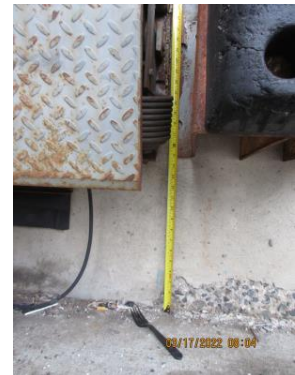
Subsystem Code:	E1030310	Surveyor / Update:	Brendan Baranek-Olmstead	03/30/2022
Subsystem Description:	Loading Dock Equipment, EACH	Qty:	1.00	
Material:				
Distress:	Inadequate	Deficiency Id:	316675	
Priority:	1 - Currently Critical (Immediate)	Location:	DOOR 17	
Category:	Repair - Alteration			
Correction:	Install Kelley Dock Communication System			
Notes:	The foundation wall to the face of the rubber bumper is 18", SOG to the bottom of the dock leveler 11", over all dock height 30". The dock face below the leveler is inadequate. The dock does not except tractor trailers and is for smaller vehicles only. Install a Red/Greenlight communications system to include manual chocks.

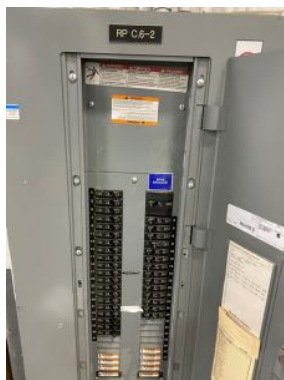
Subsystem Code:	D5010	Surveyor / Update:	Stephen Butler	04/04/2022
Subsystem Description:	Electrical Service/Distribution	Qty:	4.00	
Material:				
Distress:	Inadequate	Deficiency Id:	317366	
Priority:	3 - Necessary/Not Yet Critical (Years 2-5)	Location:	DOORS 18-33	
Category:	Repair - Alteration			
Correction:	Add New 1 Pole 20A Circuit Breaker (1 for every 4 Doors)			
Notes:	Add a new 20A, 1-pole circuit breakers or use one of the available spare circuit breakers in existing power panel RPC.6-2. Any new circuit breakers need to match the existing type and kAIC rating. Connect no more than 4 TRS per circuit breaker. Maximum distance to farthest door is 150'.

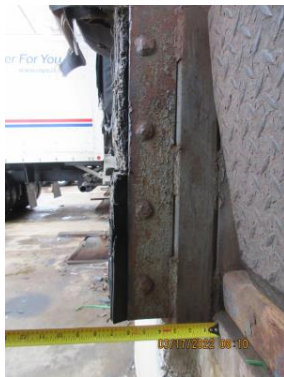
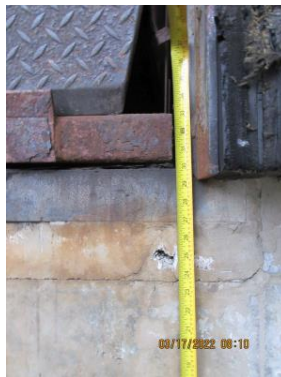
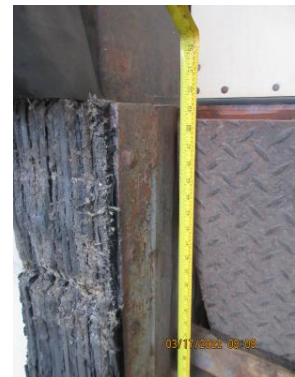
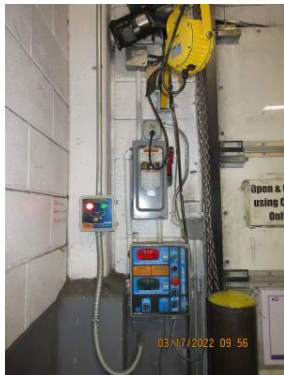
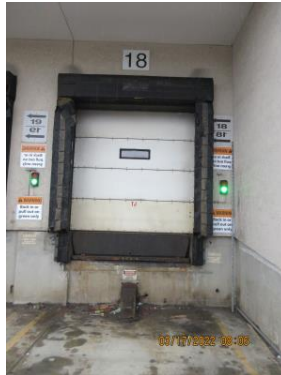
Subsystem Code:	E1030310	Surveyor / Update:	Brendan Baranek-Olmstead	03/30/2022
Subsystem Description:	Loading Dock Equipment, EACH	Qty:	1.00	
Material:				
Distress:	Beyond Service Life	Deficiency Id:	316676	
Priority:	1 - Currently Critical (Immediate)	Location:	DOOR 18	
Category:	Repair - Alteration			
Correction:	Install Star 4 Truck Restraint			
Notes:	The foundation wall to the face of the rubber bumper is 3.75", SOG to the bottom of the dock leveler 33", over all dock height 49". The dock face below the leveler is adequate. Horizontal mounting plate may be needed. There is an existing non-operational hydraulic truck restraint system, and a separate Red/Green light system on the exterior wall with a comm. box mounted to the interior side. Install a new truck restraint system. Remove the existing Red/Green light and signage mounted to exterior wall, and comm. box mounted interior side as well as the removal of the existing truck restraint system.

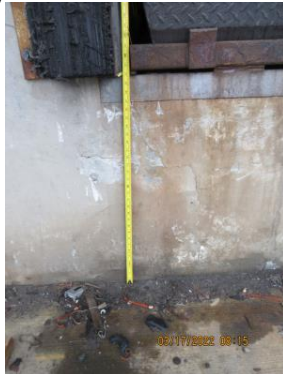
Subsystem Code:	B2010101	Surveyor / Update:	Brendan Baranek-Olmstead	04/04/2022
Subsystem Description:	Cast In Place Concrete	Qty:	6.00	
Material:				
Distress:	Damaged	Deficiency Id:	317313	
Priority:	2 - Potentially Critical (Year 1)	Location:	DOOR 19	
Category:	Repair - Alteration			
Correction:	Repair Spalled Concrete			
Notes:	Foundation wall beneath dock leveler and left bumper is cracking.

26" H by 30" W area

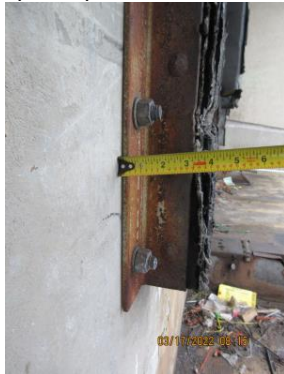
Subsystem Code:	E1030310	Surveyor / Update:	Brendan Baranek-Olmstead	04/04/2022
Subsystem Description:	Loading Dock Equipment, EACH	Qty:	1.00	
Material:				
Distress:	Beyond Service Life	Deficiency Id:	317311	
Priority:	1 - Currently Critical (Immediate)	Location:	DOOR 19	
Category:	Repair - Alteration			
Correction:	Install Star 4 Truck Restraint			
Notes:	The foundation wall to the face of the rubber bumper is 3.75", SOG to the bottom of the dock leveler 33", over all dock height 49". The dock face below the leveler is adequate. There is an existing non-operational hydraulic truck restraint system, and a separate Red/Green light system to exterior wall with a comm. box mounted interior side. Install a new truck restraint system. Remove the existing Red/Green light and signage mounted to exterior wall, and comm. box mounted interior side, as well as the removal of the existing truck restraint system.

3.75" deep bumper

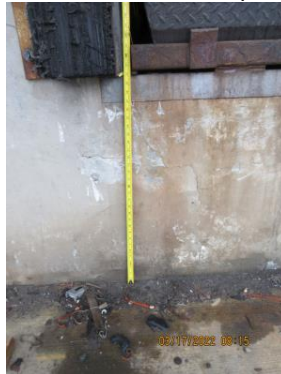
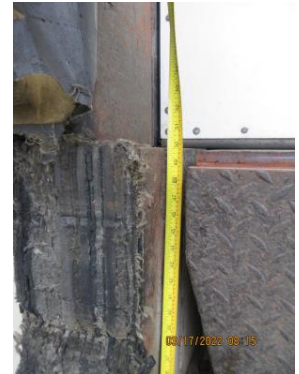
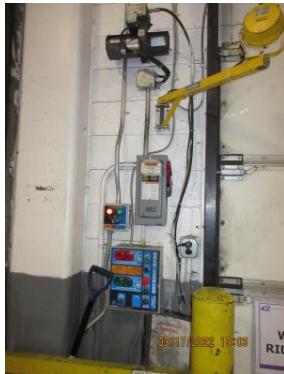
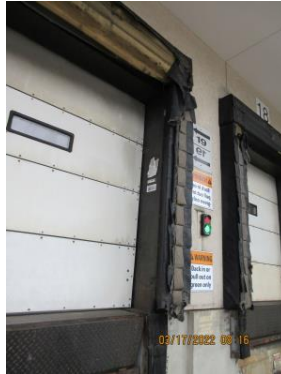
33" SOG to bottom of leveler lip

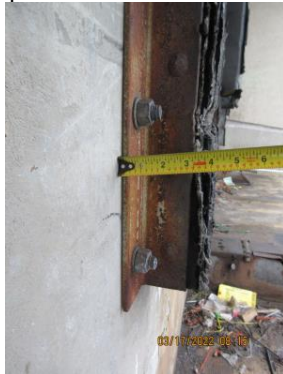
Left bumper

Subsystem Code:	E1030310	Surveyor / Update:	Brendan Baranek-Olmstead	04/04/2022
Subsystem Description:	Loading Dock Equipment, EACH	Qty:	2.00	
Material:				
Distress:	Inadequate	Deficiency Id:	317312	
Priority:	1 - Currently Critical (Immediate)	Location:	DOOR 19	
Category:	Repair - Alteration			
Correction:	Provide and Replace Rubber Dock Bumper			
Notes:	The rubber dock bumpers are damaged.

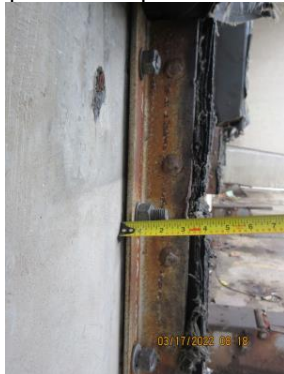
Subsystem Code:	E1030310	Surveyor / Update:	Brendan Baranek-Olmstead	04/04/2022
Subsystem Description:	Loading Dock Equipment, EACH	Qty:	2.00	
Material:				
Distress:	Damaged	Deficiency Id:	317316	
Priority:	1 - Currently Critical (Immediate)	Location:	DOOR 20	
Category:	Repair - Alteration			
Correction:	Provide and Replace Rubber Dock Bumper			
Notes:	The rubber dock bumpers are damaged.

Left bumper 3.75" depth

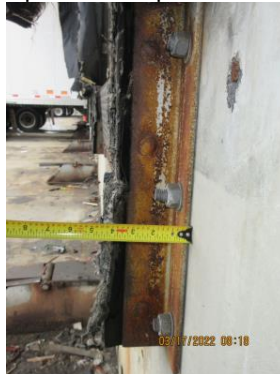
Right bumper 3.75" depth

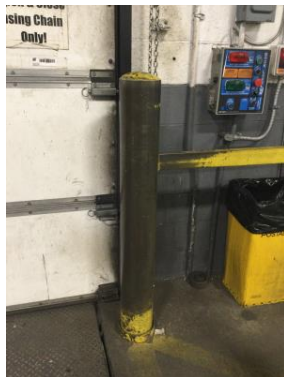
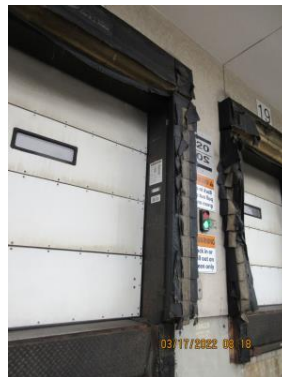
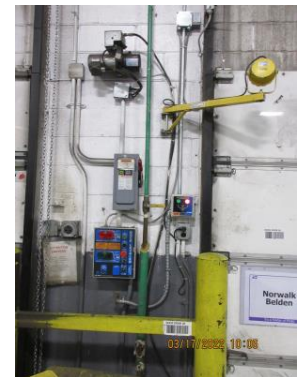
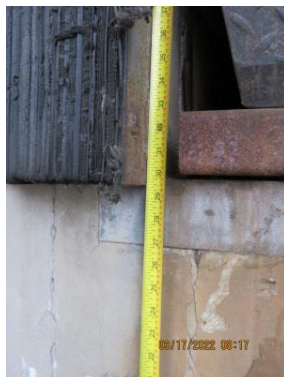
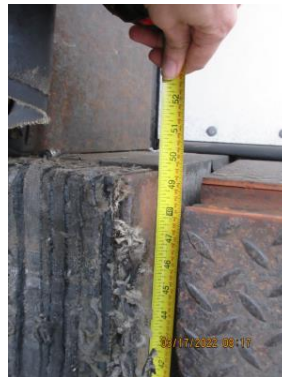
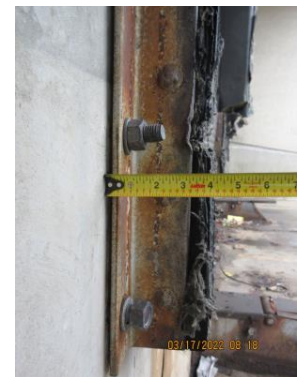
USPS TRSP\Atlantic\Connecticut \Stamford P - DC - 087719-G02\DOOR 20

Subsystem Code:	E1030310	Surveyor / Update:	Brendan Baranek-Olmstead	04/04/2022
Subsystem Description:	Loading Dock Equipment, EACH	Qty:	1.00	
Material:				
Distress:	Beyond Service Life	Deficiency Id:	317315	
Priority:	1 - Currently Critical (Immediate)	Location:	DOOR 20	
Category:	Repair - Alteration			
Correction:	Install Star 4 Truck Restraint			
Notes:	The foundation wall to the face of the rubber bumper is 3.75", SOG to the bottom of the dock leveler 33", over all dock height 49". The dock face below the leveler is adequate. Horizontal mounting plate may be needed. There is an existing non-operational hydraulic truck restraint system, and a separate Red/Green light system to exterior wall with a comm. box mounted interior side. Install a new truck restraint system. Remove the existing Red/Green light and signage mounted to exterior wall, and comm. box mounted interior side, as well as the removal of the existing truck restraint system.

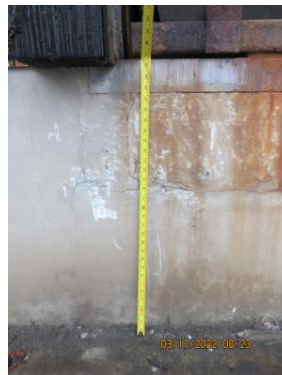
Subsystem Code:	B2010101	Surveyor / Update:	Brendan Baranek-Olmstead	04/04/2022
Subsystem Description:	Cast In Place Concrete	Qty:	12.00	
Material:				
Distress:	Damaged	Deficiency Id:	317322	
Priority:	2 - Potentially Critical (Year 1)	Location:	DOOR 21	
Category:	Repair - Alteration			
Correction:	Repair Spalled Concrete			
Notes:	Foundation wall beneath dock leveler is spalling.

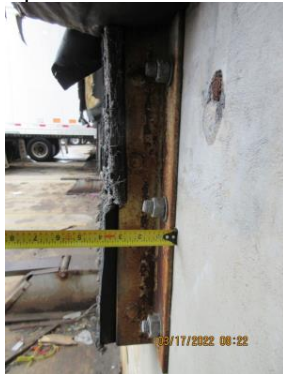
Right bumper

Subsystem Code:	E1030310	Surveyor / Update:	Brendan Baranek-Olmstead	04/04/2022
Subsystem Description:	Loading Dock Equipment, EACH	Qty:	2.00	
Material:				
Distress:	Damaged	Deficiency Id:	317324	
Priority:	1 - Currently Critical (Immediate)	Location:	DOOR 21	
Category:	Repair - Alteration			
Correction:	Provide and Replace Rubber Dock Bumper			
Notes:	The rubber dock bumpers are damaged.

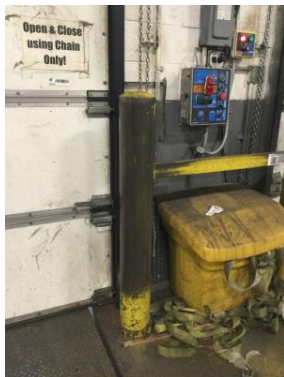
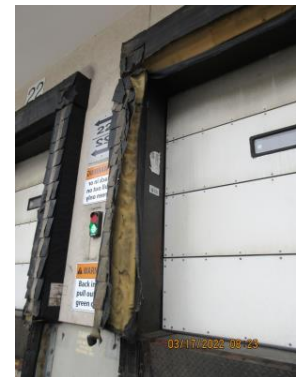
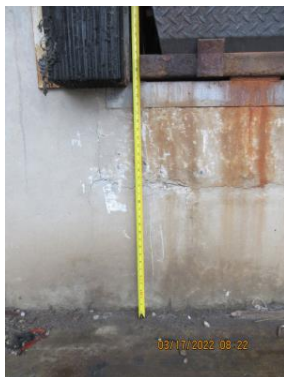
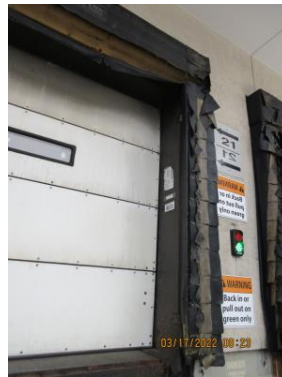
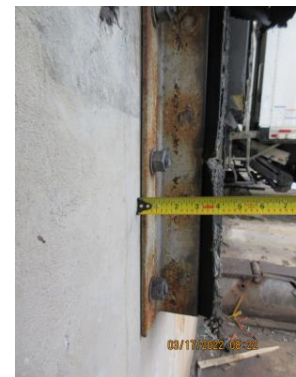
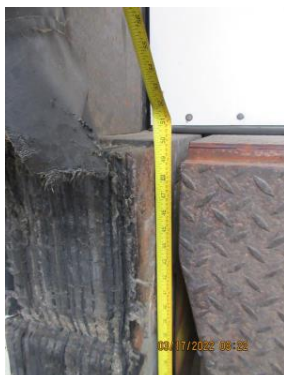
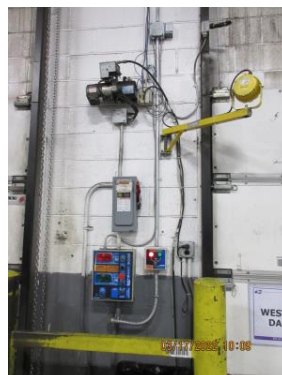
USPS TRSP\Atlantic\Connecticut \Stamford P - DC - 087719-G02\DOOR 21

Subsystem Code:	E1030310	Surveyor / Update:	Brendan Baranek-Olmstead	04/04/2022
Subsystem Description:	Loading Dock Equipment, EACH	Qty:	1.00	
Material:				
Distress:	Beyond Service Life	Deficiency Id:	317320	
Priority:	1 - Currently Critical (Immediate)	Location:	DOOR 21	
Category:	Repair - Alteration			
Correction:	Install Star 4 Truck Restraint			
Notes:	The foundation wall to the face of the rubber bumper is 3.75", SOG to the bottom of the dock leveler 33.5", over all dock height 49". The dock face below the leveler is adequate. There is an existing non-operational hydraulic truck restraint system, and a separate Red/Green light system to exterior wall with a comm. box mounted interior side. Install a new truck restraint system. Remove the existing Red/Green light and signage mounted to exterior wall, and comm. box mounted interior side, as well as the removal of the existing truck restraint system.

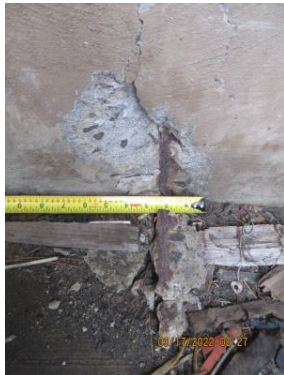
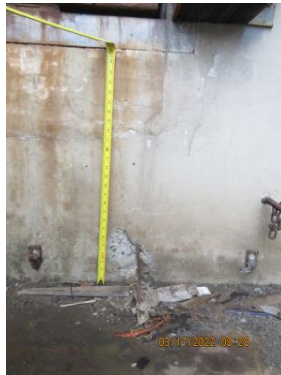
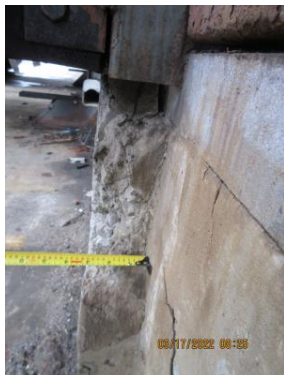
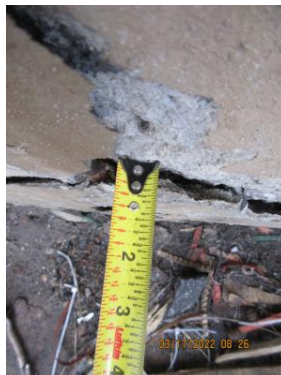
Subsystem Code:	B2010101	Surveyor / Update:	Brendan Baranek-Olmstead	04/04/2022
Subsystem Description:	Cast In Place Concrete	Qty:	12.00	
Material:				
Distress:	Damaged	Deficiency Id:	317327	
Priority:	1 - Currently Critical (Immediate)	Location:	DOOR 22	
Category:	Repair - Alteration			
Correction:	Repair Spalled Concrete			
Notes:	Foundation wall beneath dock leveler is spalling. Exposed rebar.

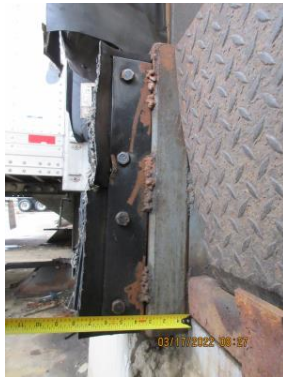
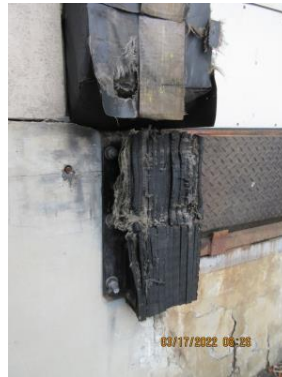
USPS TRSP\Atlantic\Connecticut \Stamford P - DC - 087719-G02\DOOR 22

Subsystem Code:	E1030310	Surveyor / Update:	Brendan Baranek-Olmstead	04/04/2022
Subsystem Description:	Loading Dock Equipment, EACH	Qty:	1.00	
Material:				
Distress:	Damaged	Deficiency Id:	317326	
Priority:	1 - Currently Critical (Immediate)	Location:	DOOR 22	
Category:	Repair - Alteration			
Correction:	Provide and Replace Rubber Dock Bumper			
Notes:	The dock bumper located on the left side of the loading dock is damaged.

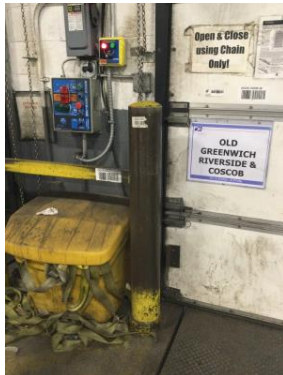
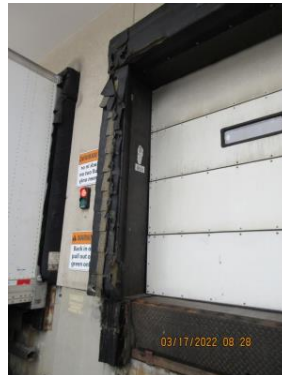
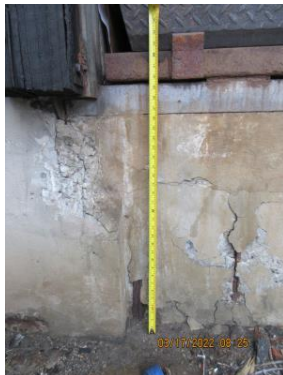
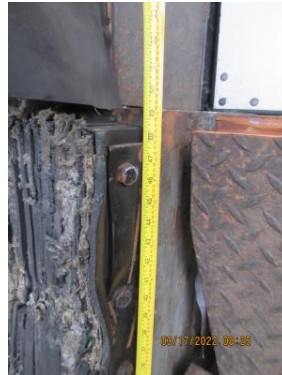
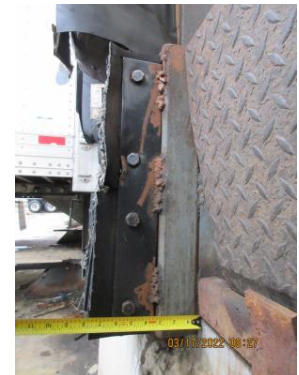
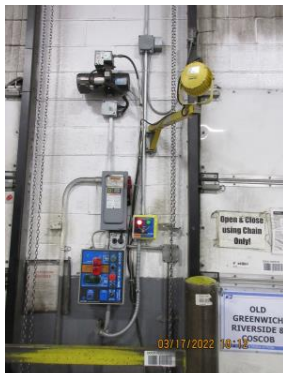
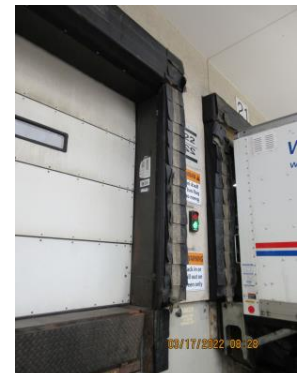
USPS TRSP\Atlantic\Connecticut \Stamford P - DC - 087719-G02\DOOR 22

Subsystem Code:	E1030310	Surveyor / Update:	Brendan Baranek-Olmstead	04/04/2022
Subsystem Description:	Loading Dock Equipment, EACH	Qty:	1.00	
Material:				
Distress:	Beyond Service Life	Deficiency Id:	317325	
Priority:	1 - Currently Critical (Immediate)	Location:	DOOR 22	
Category:	Repair - Alteration			
Correction:	Install Star 4 Truck Restraint			
Notes:	The foundation wall to the face of the rubber bumper is 6", SOG to the bottom of the dock leveler 33", over all dock height 49". The dock face below the leveler is adequate. Horizontal mounting plate may be needed. There is an existing non-operational hydraulic truck restraint system, and a separate Red/Green light system to exterior wall with a comm. box mounted interior side. Install a new truck restraint system. Remove the existing Red/Green light and signage mounted to exterior wall, and comm. box mounted interior side, as well as the removal of the existing truck restraint system.

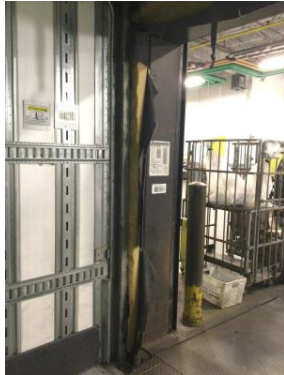
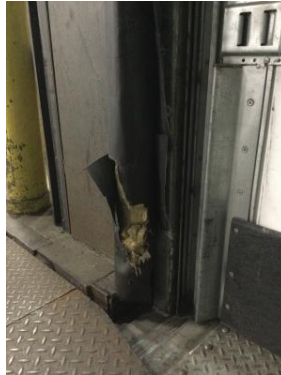
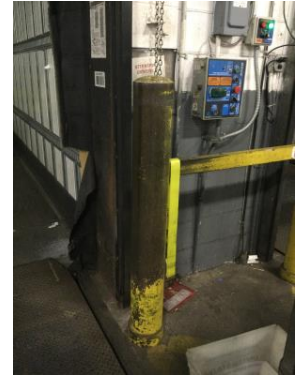
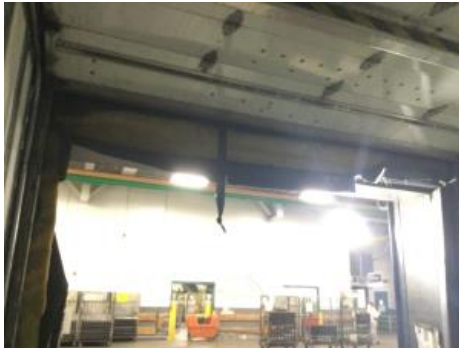
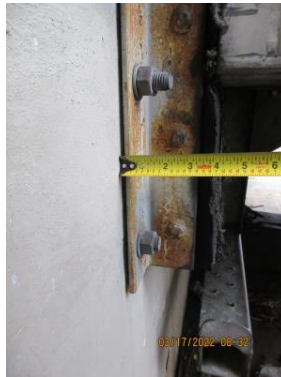
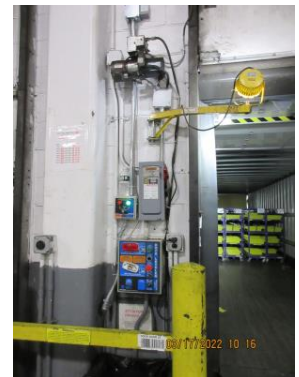
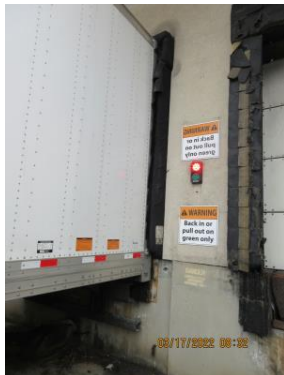
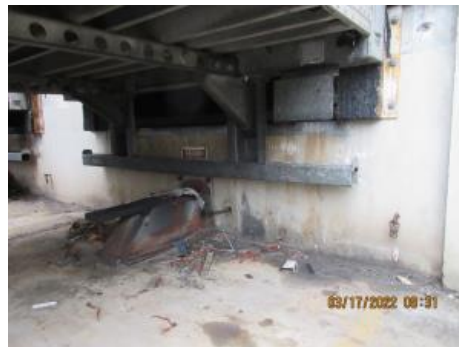
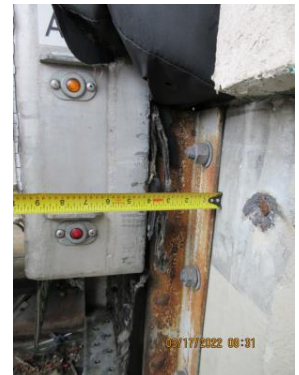
Subsystem Code:	E1030310	Surveyor / Update:	Brendan Baranek-Olmstead	04/04/2022
Subsystem Description:	Loading Dock Equipment, EACH	Qty:	1.00	
Material:				
Distress:	Beyond Service Life	Deficiency Id:	317335	
Priority:	1 - Currently Critical (Immediate)	Location:	DOOR 23	
Category:	Repair - Alteration			
Correction:	Install Star 4 Truck Restraint			
Notes:	The foundation wall to the face of the rubber bumper is 3.75", SOG to the bottom of the dock leveler 33", over all dock height 49". The dock face below the leveler is adequate. There is an existing non-operational hydraulic truck restraint system, and a separate Red/Green light system to exterior wall with a comm. box mounted interior side. Install a new truck restraint system. Remove the existing Red/Green light and signage mounted to exterior wall, and comm. box mounted interior side, as well as the removal of the existing truck restraint system. The dock was partially obstructed from view, the full condition of all dock components could not be verified. The assumption of partial condition is based on the condition of adjacent docks.

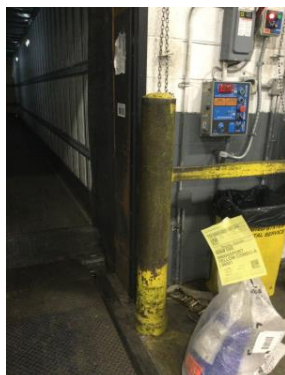
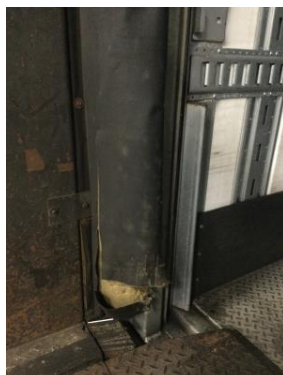
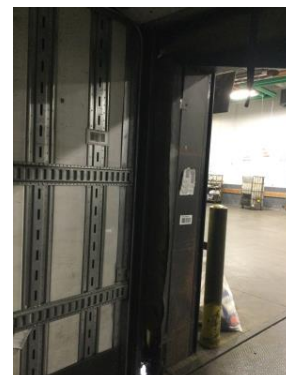
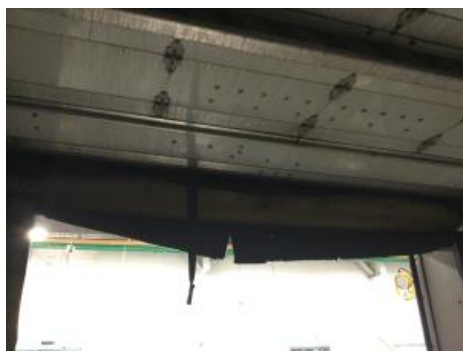
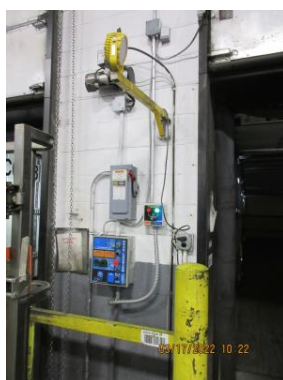
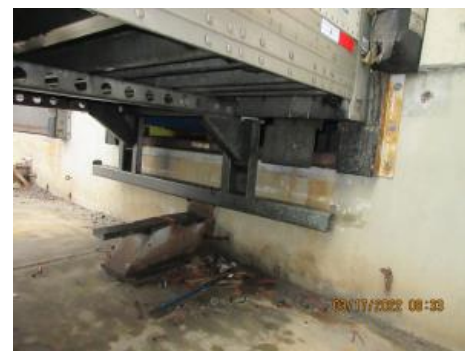
Subsystem Code:	E1030310	Surveyor / Update:	Brendan Baranek-Olmstead	03/17/2022
Subsystem Description:	Loading Dock Equipment, EACH	Qty:	1.00	
Material:				
Distress:	Beyond Service Life	Deficiency Id:	316050	
Priority:	1 - Currently Critical (Immediate)	Location:	DOOR 24	
Category:	Repair - Alteration			
Correction:	Install Star 4 Truck Restraint			
Notes:	The foundation wall to the face of the rubber bumper is 3.75", SOG to the bottom of the dock leveler 33", over all dock height 49". The dock face below the leveler is adequate. Horizontal mounting plate may be needed. There is an existing non-operational hydraulic truck restraint system, and a separate Red/Green light system to exterior wall with a comm. box mounted interior side. Install a new truck restraint system. Remove the existing Red/Green light and signage mounted to exterior wall, and comm. box mounted interior side, as well as the removal of the existing truck restraint system. The dock was partially obstructed from view, the full condition of all dock components could not be verified. The assumption of partial condition is based on the condition of adjacent docks.

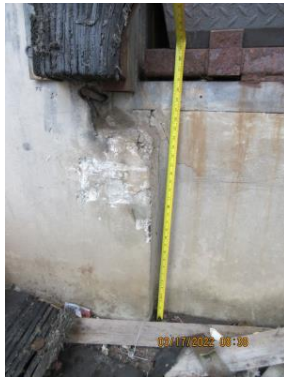
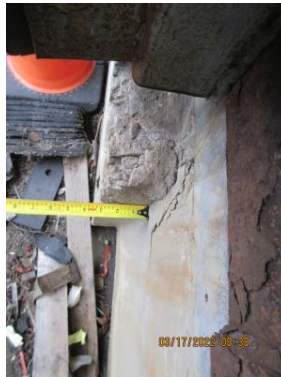
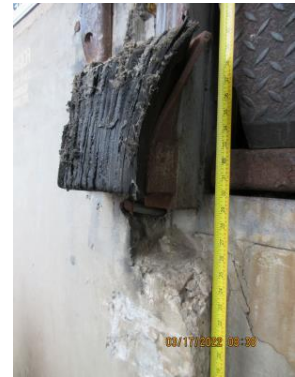
Subsystem Code:	B2010101	Surveyor / Update:	Brendan Baranek-Olmstead	04/04/2022
Subsystem Description:	Cast In Place Concrete	Qty:	4.00	
Material:				
Distress:	Damaged	Deficiency Id:	317339	
Priority:	1 - Currently Critical (Immediate)	Location:	DOOR 25	
Category:	Repair - Alteration			
Correction:	Repair Spalled Concrete			
Notes:	Foundation wall beneath dock leveler is spalling.

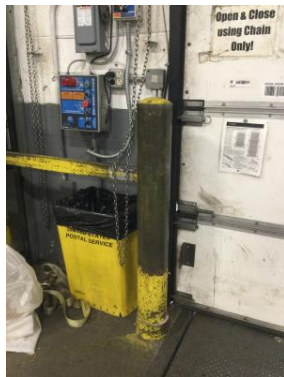
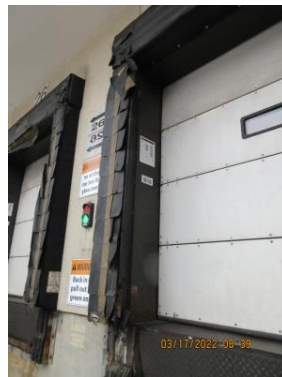
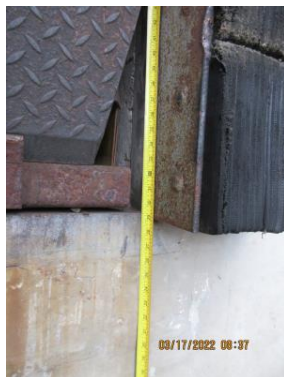
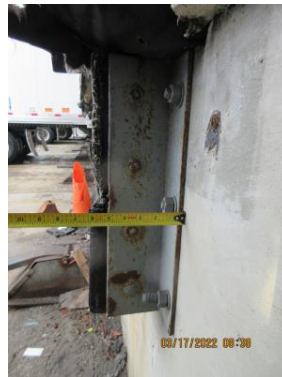
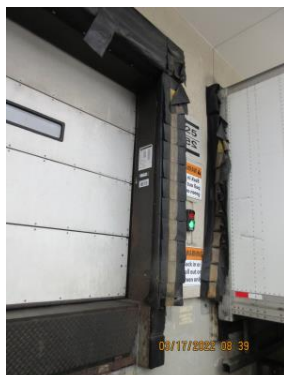
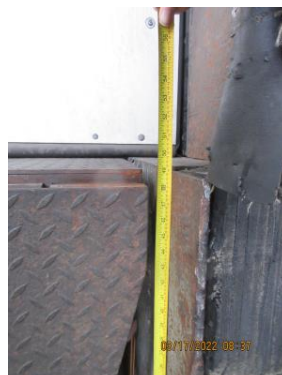
Subsystem Code:	E1030310	Surveyor / Update:	Brendan Baranek-Olmstead	04/04/2022
Subsystem Description:	Loading Dock Equipment, EACH	Qty:	1.00	
Material:				
Distress:	Beyond Service Life	Deficiency Id:	317336	
Priority:	1 - Currently Critical (Immediate)	Location:	DOOR 25	
Category:	Repair - Alteration			
Correction:	Install Star 4 Truck Restraint			
Notes:	The foundation wall to the face of the rubber bumper is 3.75", SOG to the bottom of the dock leveler 33", over all dock height 49". The dock face below the leveler is adequate. There is an existing non-operational hydraulic truck restraint system, and a separate Red/Green light system to exterior wall with a comm. box mounted interior side. Install a new truck restraint system. Remove the existing Red/Green light and signage mounted to exterior wall, and comm. box mounted interior side, as well as the removal of the existing truck restraint system.

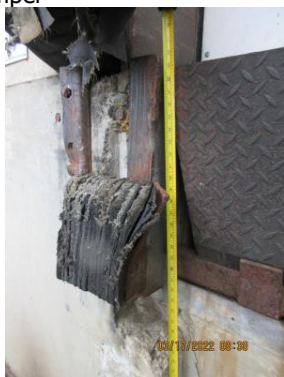
Left bumper

Subsystem Code:	E1030310	Surveyor / Update:	Brendan Baranek-Olmstead	04/04/2022
Subsystem Description:	Loading Dock Equipment, EACH	Qty:	1.00	
Material:				
Distress:	Missing	Deficiency Id:	317337	
Priority:	1 - Currently Critical (Immediate)	Location:	DOOR 25	
Category:	Repair - Alteration			
Correction:	Provide and Replace Rubber Dock Bumper			
Notes:	The rubber dock bumper located on the left side of the loading dock is missing.

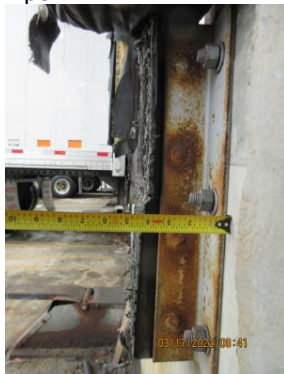
Right bumper

Subsystem Code:	E1030310	Surveyor / Update:	Brendan Baranek-Olmstead	04/04/2022
Subsystem Description:	Loading Dock Equipment, EACH	Qty:	2.00	
Material:				
Distress:	Damaged	Deficiency Id:	317345	
Priority:	1 - Currently Critical (Immediate)	Location:	DOOR 26	
Category:	Repair - Alteration			
Correction:	Provide and Replace Rubber Dock Bumper			
Notes:	The rubber dock bumpers are damaged.
