## **Mail Processing Facilities**

TRUCK RESTRAINT PROGRAM – USPS P&DC- Stamford, CT  
427 West Ave., Stamford, CT 06910-1002

SCOPE OF WORK PACKAGE (RFP 743672-31678P) Date: 08/05/2022

## eCOMET USPS Detailed Deficiency Sheet

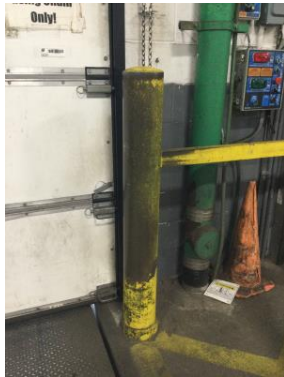
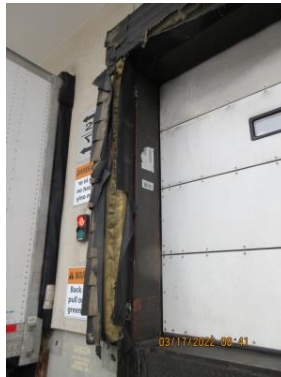
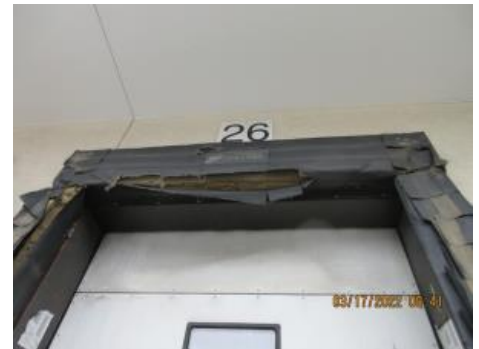
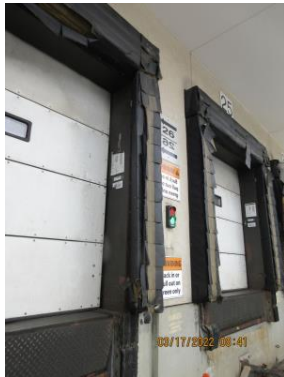
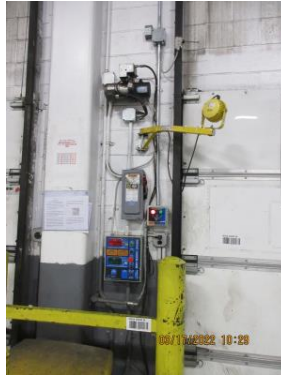
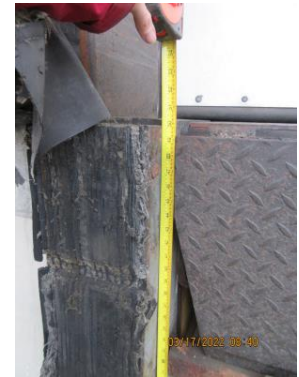
Subsystem Code:	E1030310	Surveyor / Update:	Brendan Baranek-Olmstead	04/04/2022
Subsystem Description:	Loading Dock Equipment, EACH	Qty:	1.00	
Material:				
Distress:	Beyond Service Life	Deficiency Id:	317343	
Priority:	1 - Currently Critical (Immediate)	Location:	DOOR 26	
Category:	Repair - Alteration			
Correction:	Install Star 4 Truck Restraint			
Notes:	The foundation wall to the face of the rubber bumper is 3.75", SOG to the bottom of the dock leveler 33.5", over all dock height 49". The dock face below the leveler is adequate. There is an existing non-operational hydraulic truck restraint system, and a separate Red/Green light system to exterior wall with a comm. box mounted interior side. Install a new truck restraint system. Remove the existing Red/Green light and signage mounted to exterior wall, and comm. box mounted interior side, as well as the removal of the existing truck restraint system.

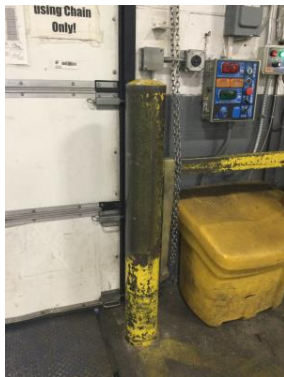
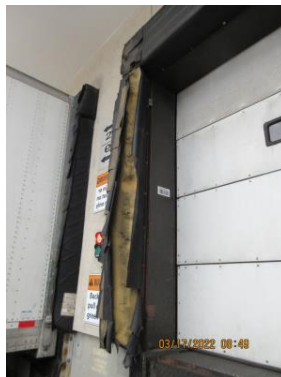
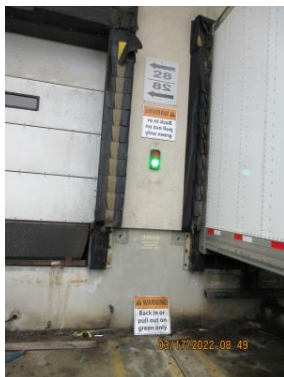
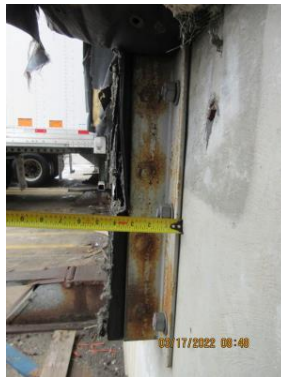
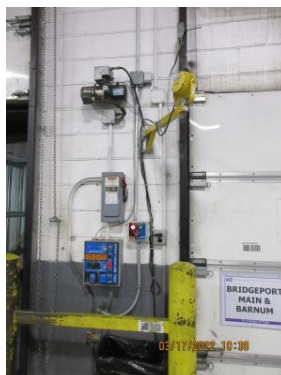
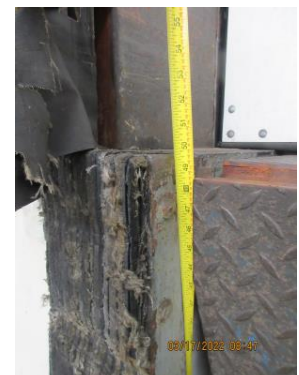
Subsystem Code:	E1030310	Surveyor / Update:	Brendan Baranek-Olmstead	04/04/2022
Subsystem Description:	Loading Dock Equipment, EACH	Qty:	1.00	
Material:				
Distress:	Beyond Service Life	Deficiency Id:	317348	
Priority:	1 - Currently Critical (Immediate)	Location:	DOOR 28	
Category:	Repair - Alteration			
Correction:	Install Star 4 Truck Restraint			
Notes:	The foundation wall to the face of the rubber bumper is 3.75", SOG to the bottom of the dock leveler 33", over all dock height 49". The dock face below the leveler is adequate. There is an existing non-operational hydraulic truck restraint system, and a separate Red/Green light system to exterior wall with a comm. box mounted interior side. Install a new truck restraint system. Remove the existing Red/Green light and signage mounted to exterior wall, and comm. box mounted interior side, as well as the removal of the existing truck restraint system.

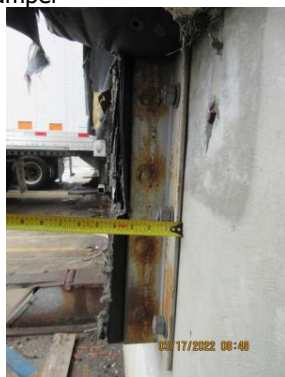
Right bumper

Subsystem Code:	E1030310	Surveyor / Update:	Brendan Baranek-Olmstead	04/04/2022
Subsystem Description:	Loading Dock Equipment, EACH	Qty:	2.00	
Material:				
Distress:	Damaged	Deficiency Id:	317349	
Priority:	1 - Currently Critical (Immediate)	Location:	DOOR 28	
Category:	Repair - Alteration			
Correction:	Provide and Replace Rubber Dock Bumper			
Notes:	The rubber dock bumpers are damaged.

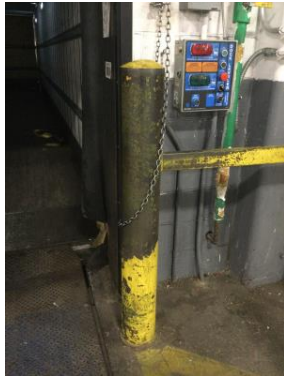
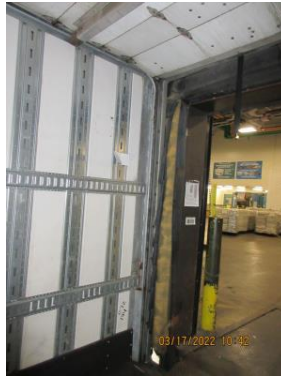
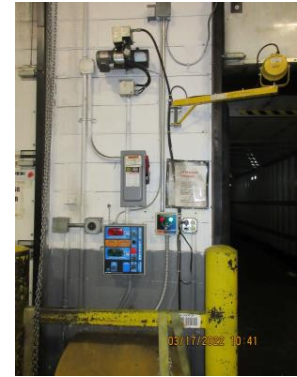
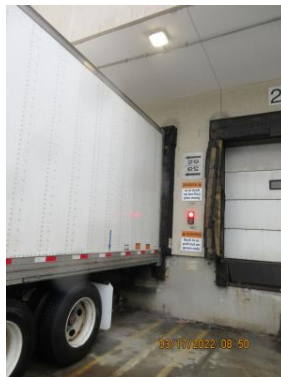
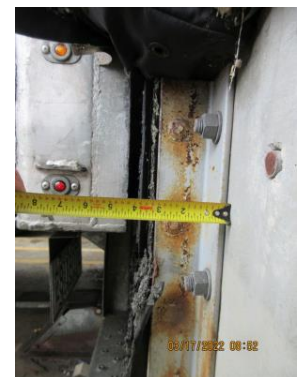
Subsystem Code:	E1030310	Surveyor / Update:	Brendan Baranek-Olmstead	04/04/2022
Subsystem Description:	Loading Dock Equipment, EACH	Qty:	1.00	
Material:				
Distress:	Beyond Service Life	Deficiency Id:	317350	
Priority:	1 - Currently Critical (Immediate)	Location:	DOOR 29	
Category:	Repair - Alteration			
Correction:	Install Star 4 Truck Restraint			
Notes:	The foundation wall to the face of the rubber bumper is 4", SOG to the bottom of the dock leveler 33", over all dock height 49". The dock face below the leveler is adequate. There is an existing non-operational hydraulic truck restraint system, and a separate Red/Green light system to exterior wall with a comm. box mounted interior side. Install a new truck restraint system. Remove the existing Red/Green light and signage mounted to exterior wall, and comm. box mounted interior side, as well as the removal of the existing truck restraint system. The dock was partially obstructed from view, the full condition of all dock components could not be verified. The assumption of partial condition is based on the condition of adjacent docks.

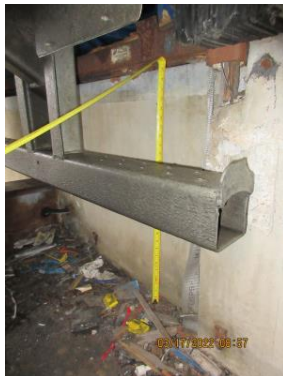
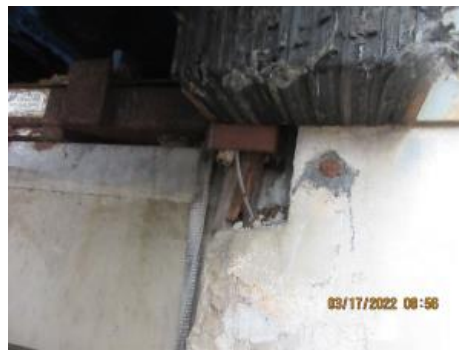
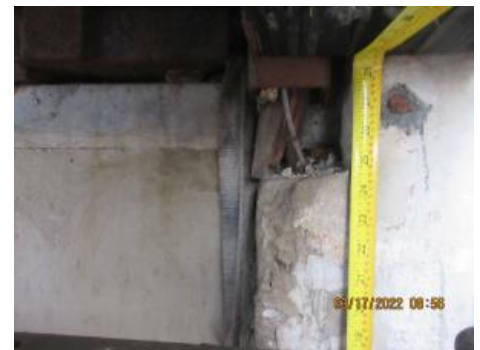
Subsystem Code:	B2010101	Surveyor / Update:	Brendan Baranek-Olmstead	04/04/2022
Subsystem Description:	Cast In Place Concrete	Qty:	4.00	
Material:				
Distress:	Damaged	Deficiency Id:	317353	
Priority:	1 - Currently Critical (Immediate)	Location:	DOOR 30	
Category:	Repair - Alteration			
Correction:	Repair Spalled Concrete			
Notes:	The foundation wall beneath the dock leveler is damaged. The bumper depth needs to be increased to prevent the trailer bumpers from hitting the foundation wall.

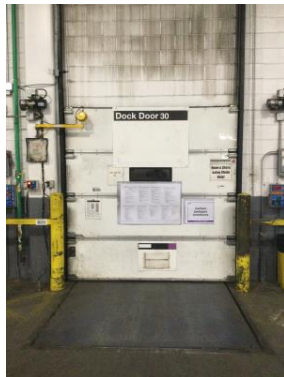
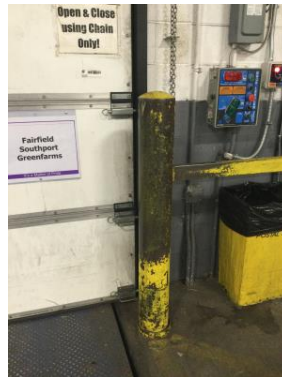
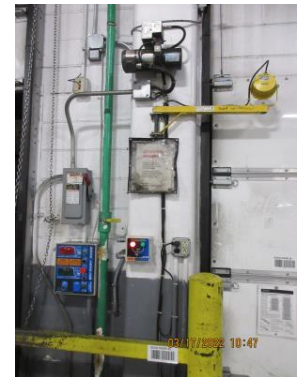
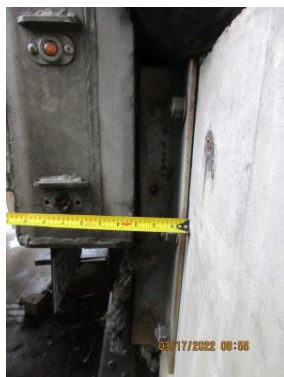
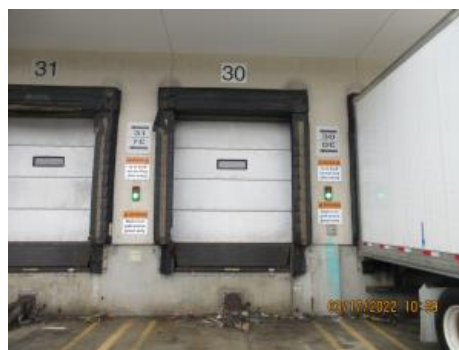
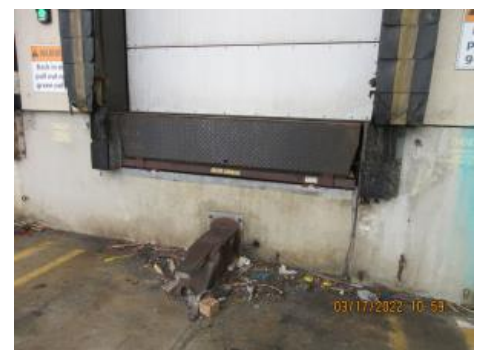
Subsystem Code:	E1030310	Surveyor / Update:	Brendan Baranek-Olmstead	04/04/2022
Subsystem Description:	Loading Dock Equipment, EACH	Qty:	1.00	
Material:				
Distress:	Beyond Service Life	Deficiency Id:	317351	
Priority:	1 - Currently Critical (Immediate)	Location:	DOOR 30	
Category:	Repair - Alteration			
Correction:	Install Star 4 Truck Restraint			
Notes:	The foundation wall to the face of the rubber bumper is 3.25", SOG to the bottom of the dock leveler 33", over all dock height 49". The dock face below the leveler is adequate. There is an existing non-operational hydraulic truck restraint system, and a separate Red/Green light system to exterior wall with a comm. box mounted interior side. Install a new truck restraint system. Remove the existing Red/Green light and signage mounted to exterior wall, and comm. box mounted interior side, as well as the removal of the existing truck restraint system. The dock was partially obstructed from view, the full condition of all dock components could not be verified. The assumption of partial condition is based on the condition of adjacent docks.

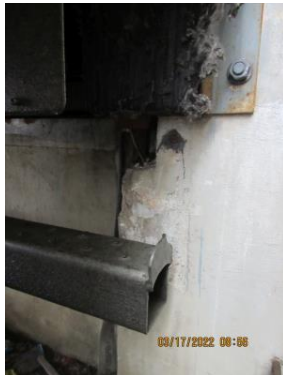
Subsystem Code:	E1030310	Surveyor / Update:	Brendan Baranek-Olmstead	04/04/2022
Subsystem Description:	Loading Dock Equipment, EACH	Qty:	1.00	
Material:				
Distress:	Damaged	Deficiency Id:	317352	
Priority:	1 - Currently Critical (Immediate)	Location:	DOOR 30	
Category:	Repair - Alteration			
Correction:	Provide and Replace Rubber Dock Bumper			
Notes:	The dock bumper located on the right side of the loading dock is damaged. The right bumper depth needs to be increased to prevent the trailer bumpers from hitting the foundation wall.

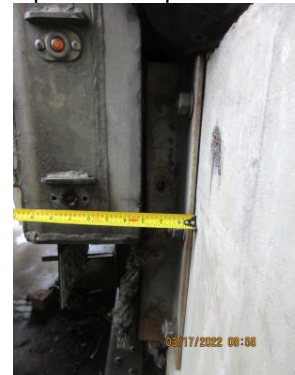
Right bumper 3.25" depth

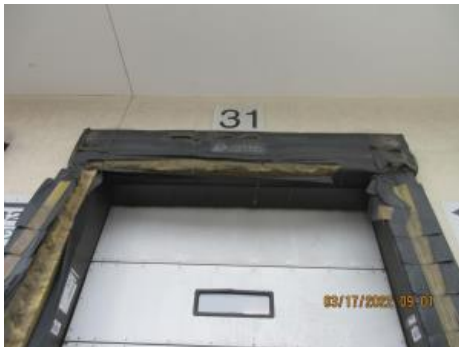
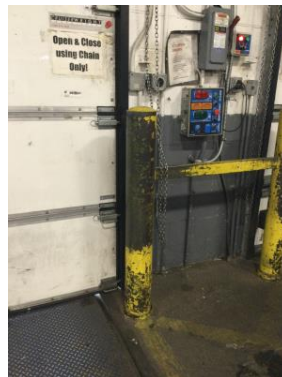
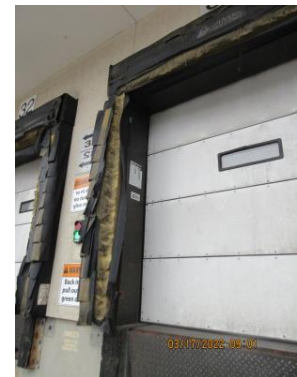
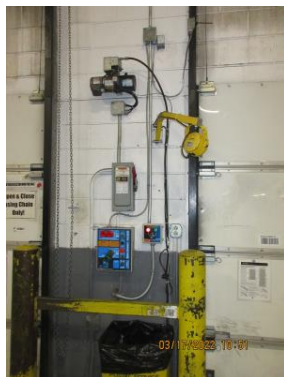
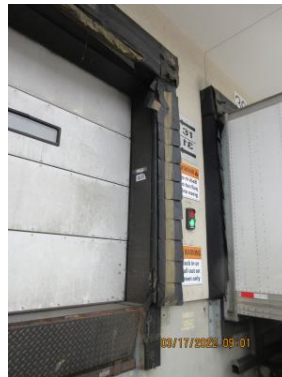
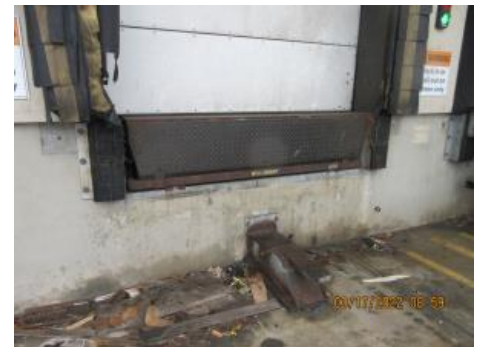
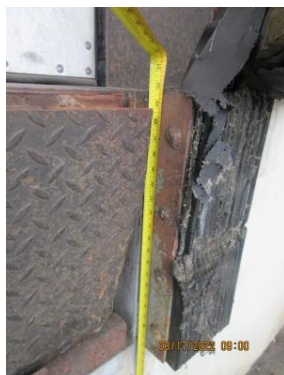
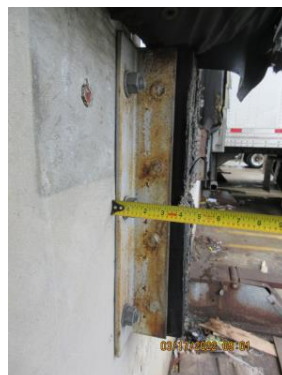
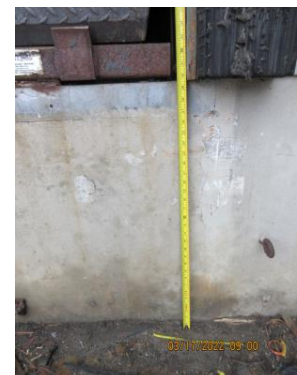
Subsystem Code:	E1030310	Surveyor / Update:	Brendan Baranek-Olmstead	04/04/2022
Subsystem Description:	Loading Dock Equipment, EACH	Qty:	1.00	
Material:				
Distress:	Beyond Service Life	Deficiency Id:	317354	
Priority:	1 - Currently Critical (Immediate)	Location:	DOOR 31	
Category:	Repair - Alteration			
Correction:	Install Star 4 Truck Restraint			
Notes:	The foundation wall to the face of the rubber bumper is 4", SOG to the bottom of the dock leveler 33", over all dock height 49". The dock face below the leveler is adequate. There is an existing non-operational hydraulic truck restraint system, and a separate Red/Green light system to exterior wall with a comm. box mounted interior side. Install a new truck restraint system. Remove the existing Red/Green light and signage mounted to exterior wall, and comm. box mounted interior side, as well as the removal of the existing truck restraint system.

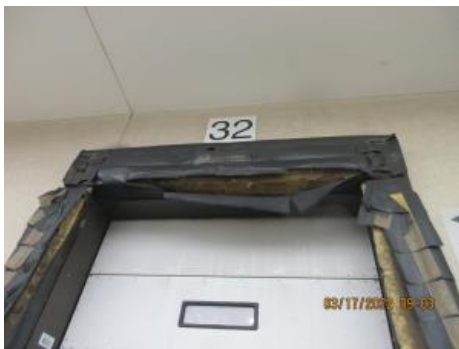
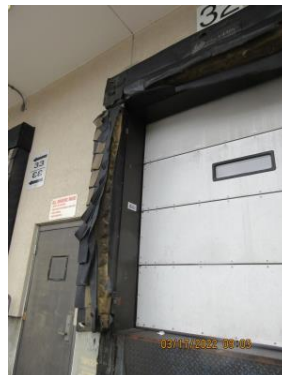
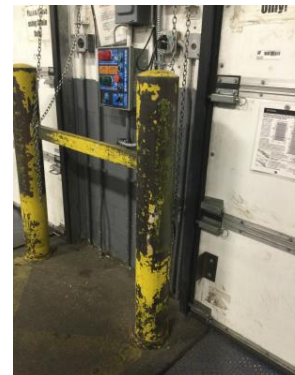
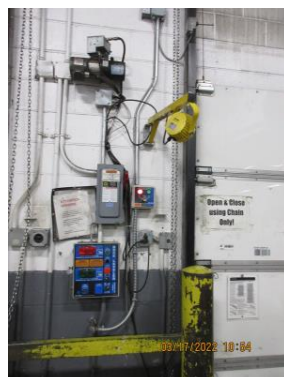
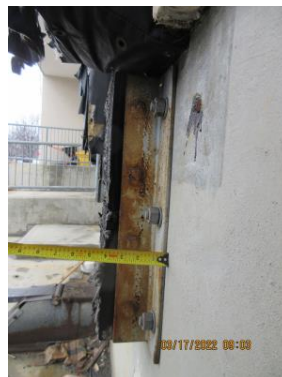
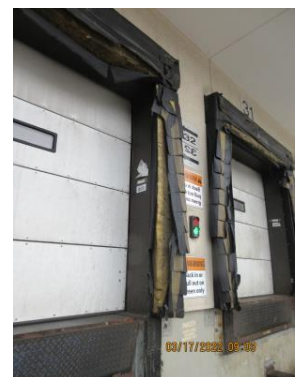
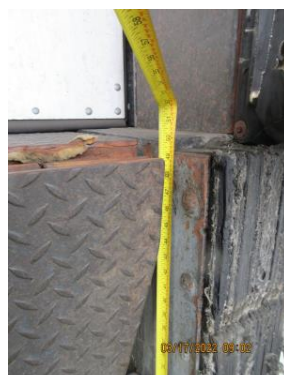
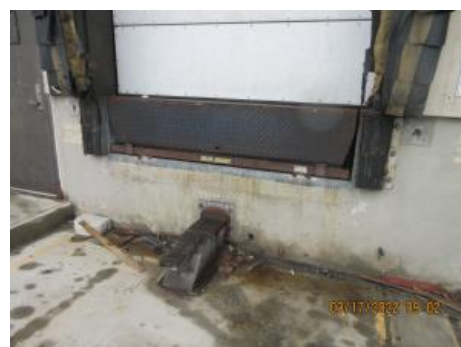
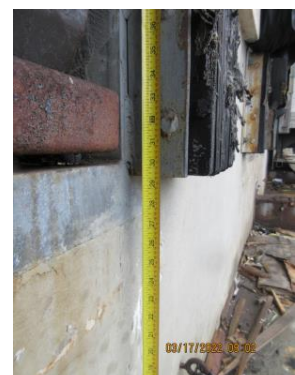
Subsystem Code:	E1030310	Surveyor / Update:	Brendan Baranek-Olmstead	04/04/2022
Subsystem Description:	Loading Dock Equipment, EACH	Qty:	1.00	
Material:				
Distress:	Beyond Service Life	Deficiency Id:	317355	
Priority:	1 - Currently Critical (Immediate)	Location:	DOOR 32	
Category:	Repair - Alteration			
Correction:	Install Star 4 Truck Restraint			
Notes:	The foundation wall to the face of the rubber bumper is 4", SOG to the bottom of the dock leveler 33", over all dock height 49". The dock face below the leveler is adequate. There is an existing non-operational hydraulic truck restraint system, and a separate Red/Green light system to exterior wall with a comm. box mounted interior side. Install a new truck restraint system. Remove the existing Red/Green light and signage mounted to exterior wall, and comm. box mounted interior side, as well as the removal of the existing truck restraint system.

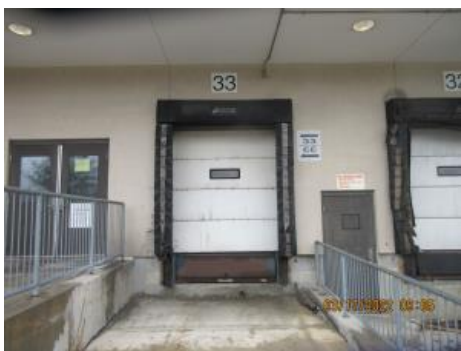
Subsystem Code:	E1030310	Surveyor / Update:	Brendan Baranek-Olmstead	04/04/2022
Subsystem Description:	Loading Dock Equipment, EACH	Qty:	1.00	
Material:				
Distress:	Inadequate	Deficiency Id:	317356	
Priority:	1 - Currently Critical (Immediate)	Location:	DOOR 33	
Category:	Repair - Alteration			
Correction:	Install Kelley Dock Communication System			
Notes:	Door 33 is for BMU. Trailers and large trucks do not use this door. The foundation wall to the face of the rubber bumper is 4", SOG to the bottom of the dock leveler 10.5", over all dock height 31". The dock face below the leveler is inadequate. Install a Red Light/Green Light Kelley communication system to include manual wheel chocks.
